INSPECTION OF A FIRE-DAMAGED  
RADIATION SOURCE

UCRL-9291  
UC-41 Health and Safety  
TID-4500 (15th Ed.)

INSPECTION OF A FIRE-DAMAGED RADIATION SOURCE

June 29, 1960

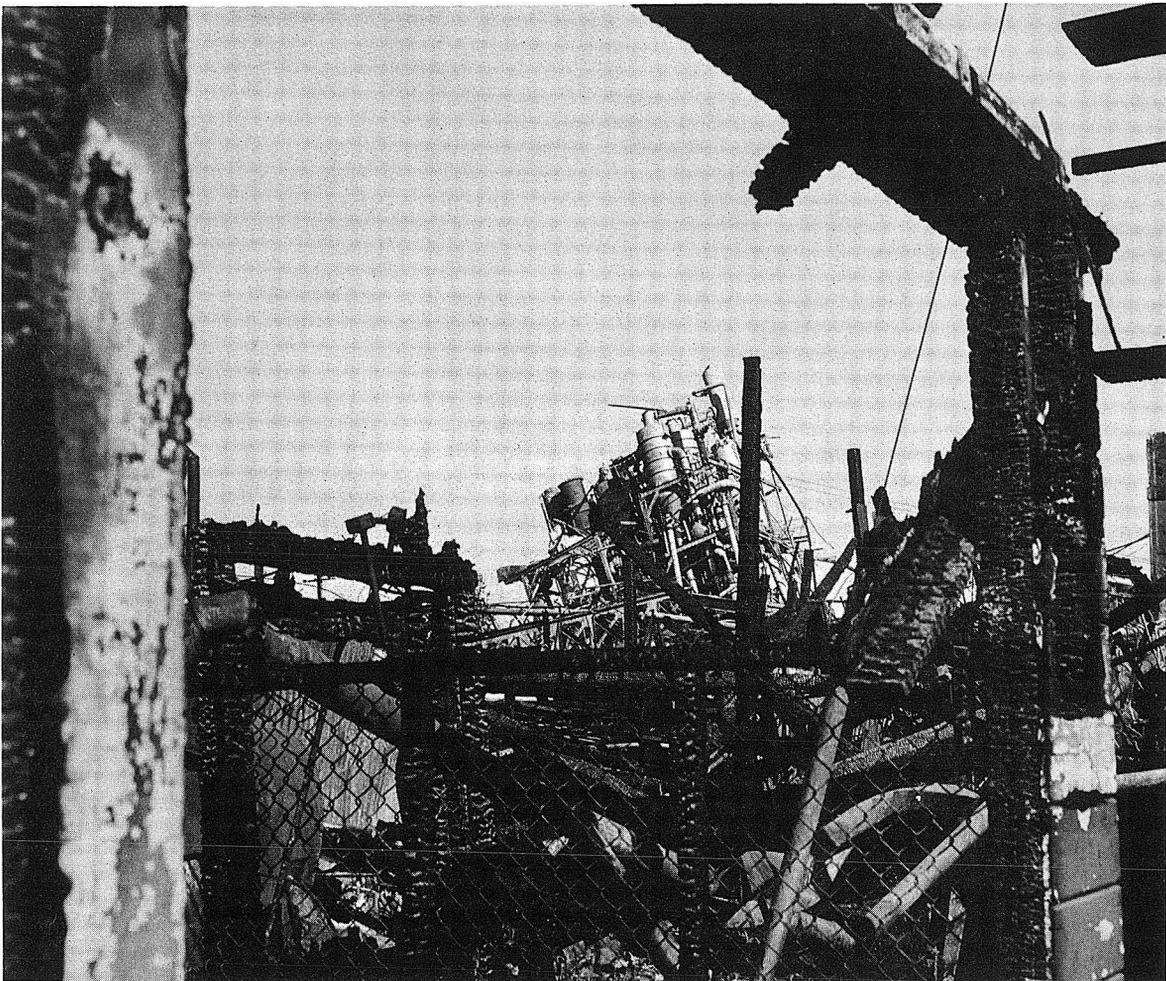
ZN-2535

On the night of October 17, 1959, fire broke out in the Booth Company cannery in Fremont, California. The fire was far advanced before an alarm was turned in and the cannery was totally destroyed. The magnitude of the fire is indicated in Fig. 1; the Fremont fire chief estimated a fire temperature of 2500°F.

Fig. 1. General view of ruins.

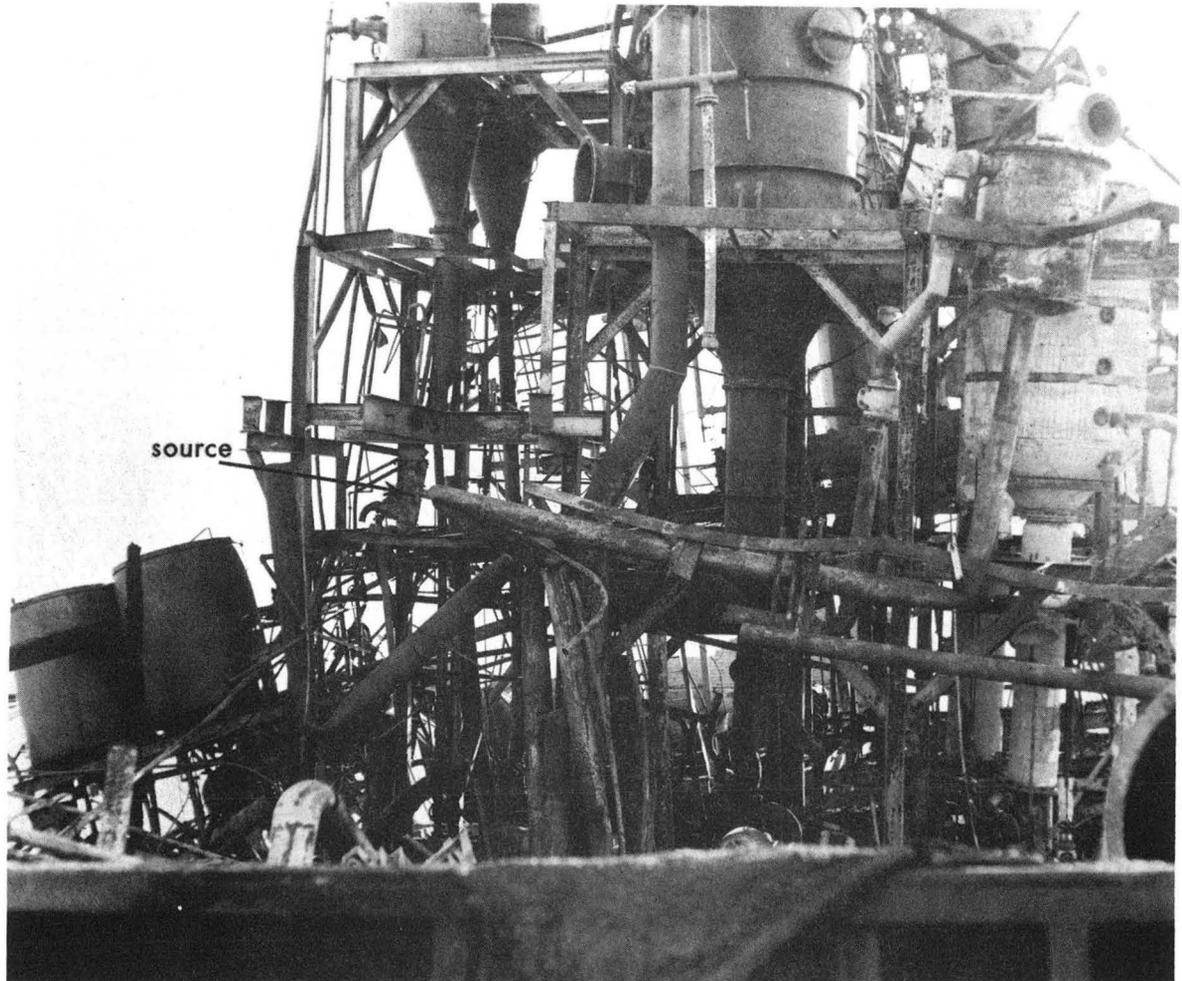
ZN-2540

The owner was licensed by the Atomic Energy Commission (License 4-2743-1) to use a commercial radiation density gauge containing cesium-137. The position of the gauge is shown in Figs. 2 and 3. A private consultant to the owner made a radiation survey of the ruins and found no contamination. The San Francisco Operations Office, USAEC, requested the Health Chemistry Department, Lawrence Radiation Laboratory, to dismantle the device as necessary to determine if the activity was still confined to the primary container.

Fig. 2. Process area, showing position of source.

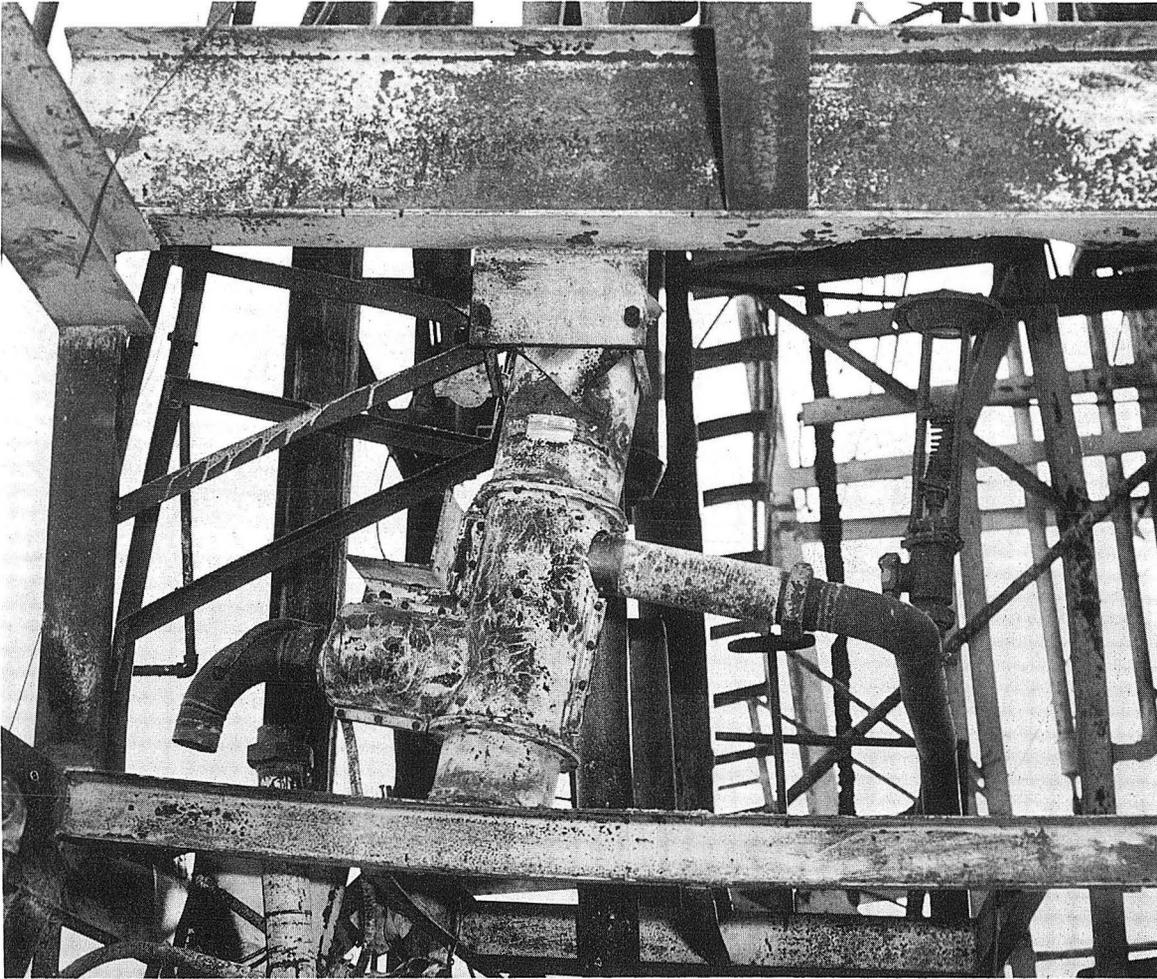
ZN-2536

Fig. 3. Structural mounting of source.

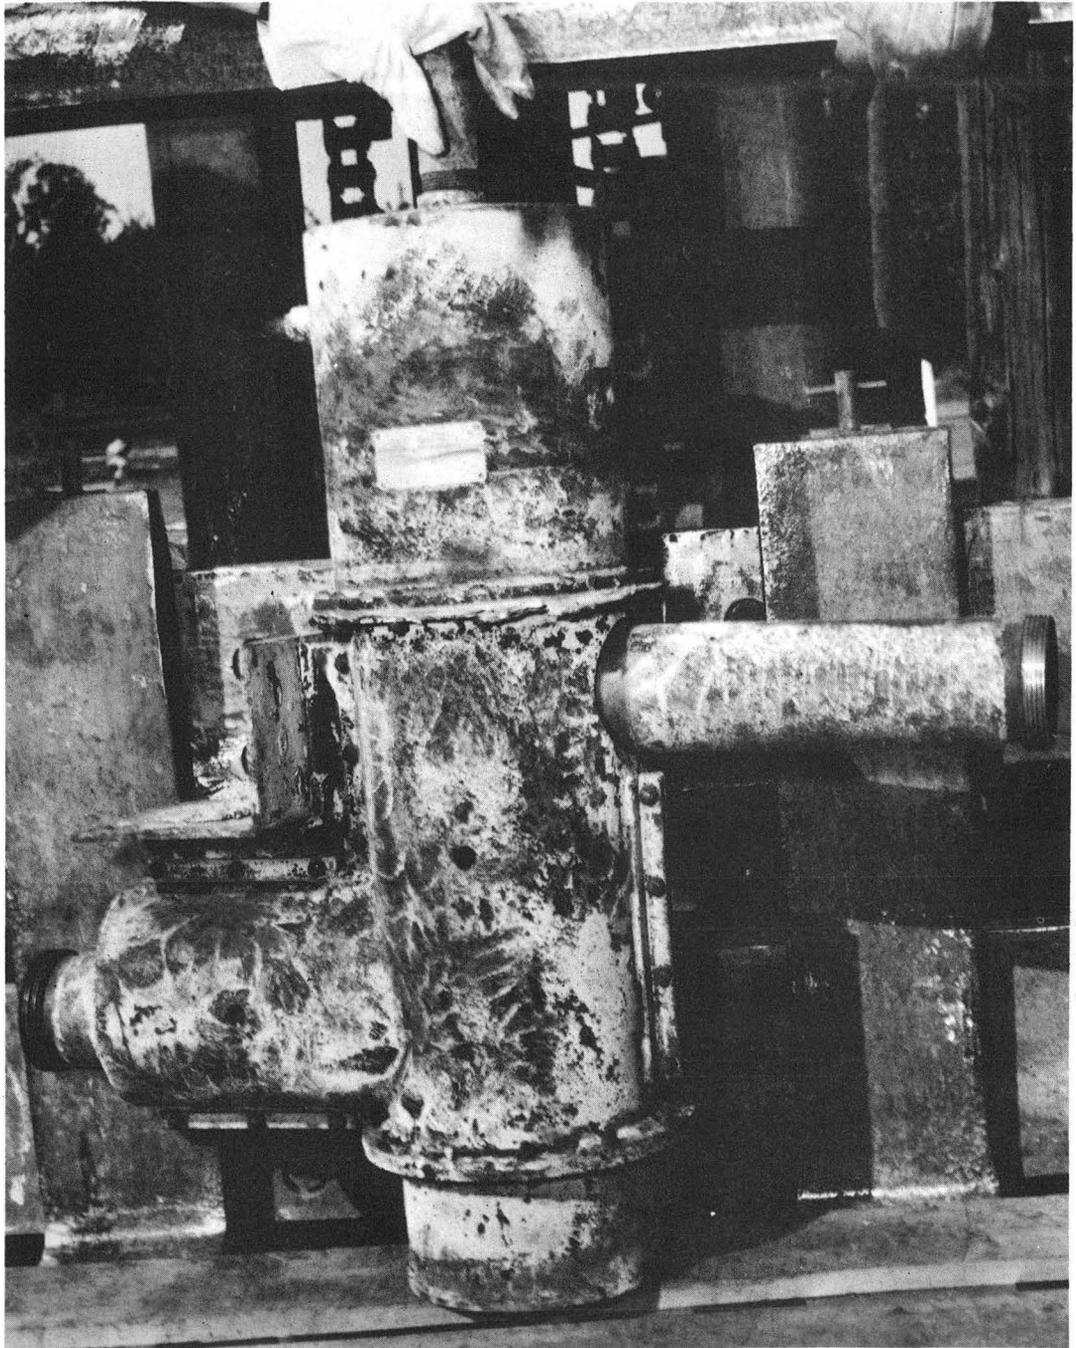
ZN-2539

The radiation gauge at time of removal to the Radiation Laboratory on October 30 is shown in Fig. 4. Swipes of the outside showed no contamination detectable on conventional portable beta-gamma detection instruments. Dose-rate measurements were not significant except on the bottom of the device at the axis.

Fig. 4. Source assembly as removed to Radiation Laboratory.

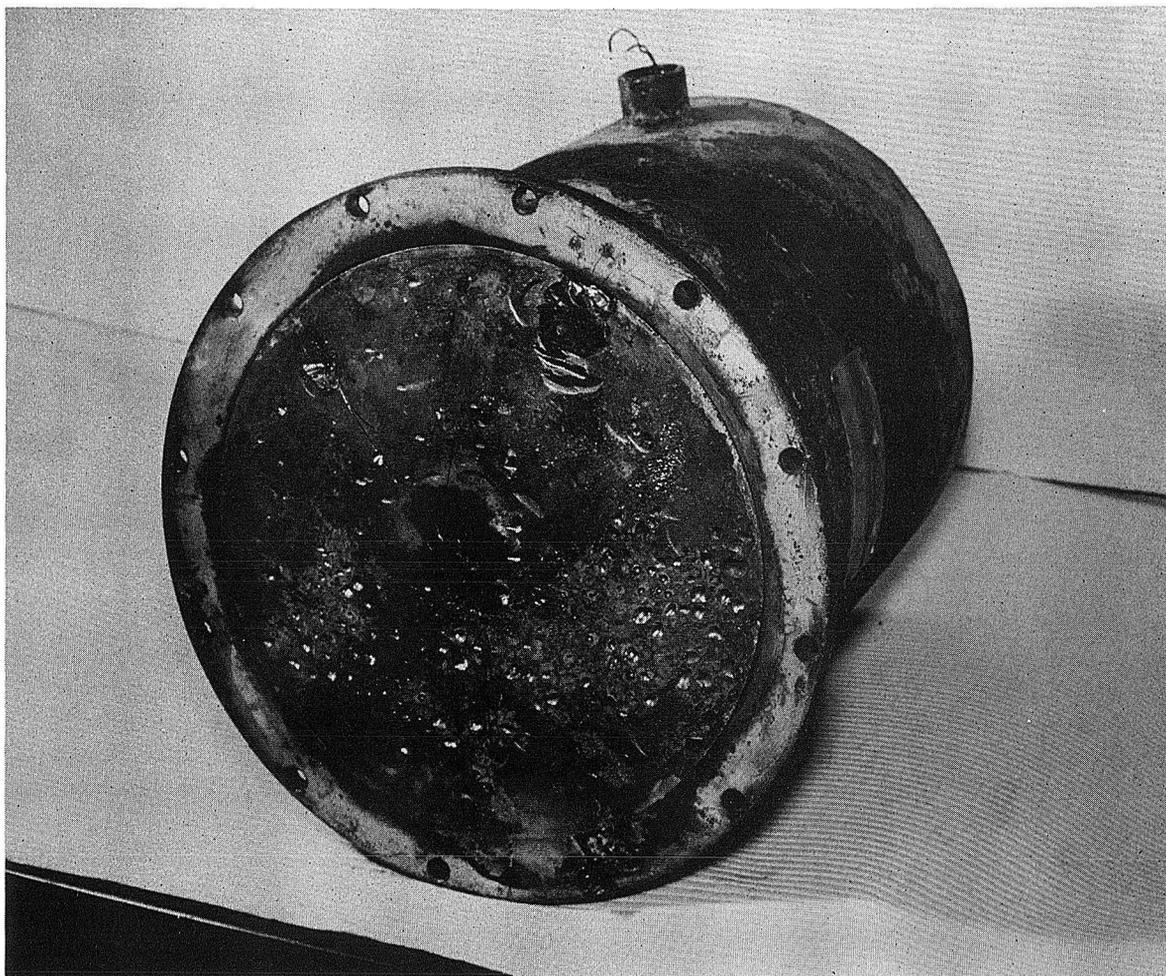
ZN-2538

The detector housing was unbolted, and when a thin aluminum cover plate was removed from the bottom a mass of lead was revealed (Fig. 5). Discussion with the manufacturer confirmed that this lead was not an intentional absorber for the detector head, but rather solidified lead from a melted collimator around the detector head.

Fig. 5. Detector housing from beneath, showing fused lead.

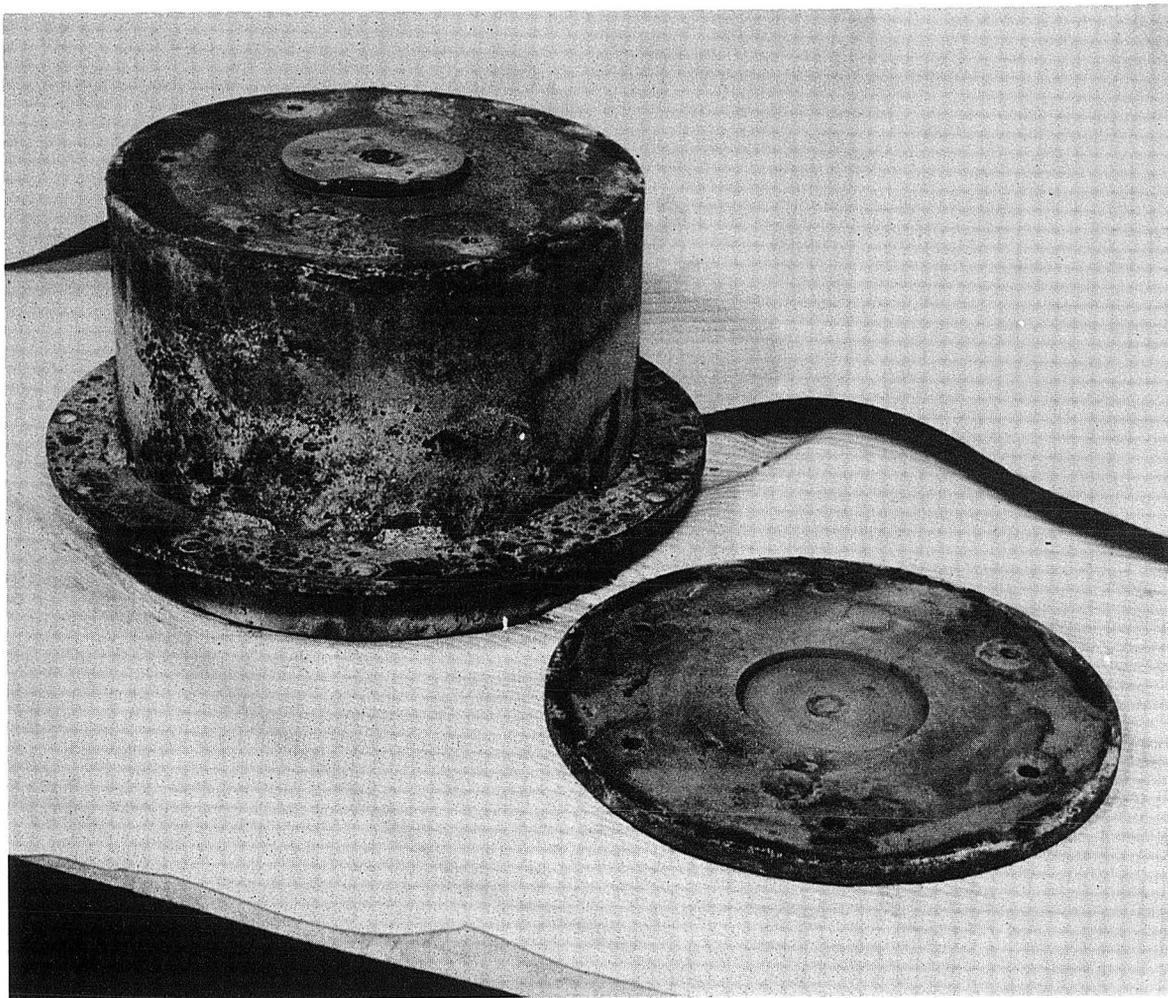
ZN-2537

In structure, the source housing was a steel cylinder completely closed except for two plugged pour holes in the top, and cored out on the axis. No plug was found in the top of the core hole. The lower end of the core hole was closed off (Fig. 6) by a large steel plate screwed to the source housing and a small steel plate screwed and soldered to the pot. A lead washer was between the two plates, pressed onto the smaller one. After the screws were removed the small plate was easily pried loose from the source housing in spite of the solder.

Fig. 6. Source housing with end plate removed.

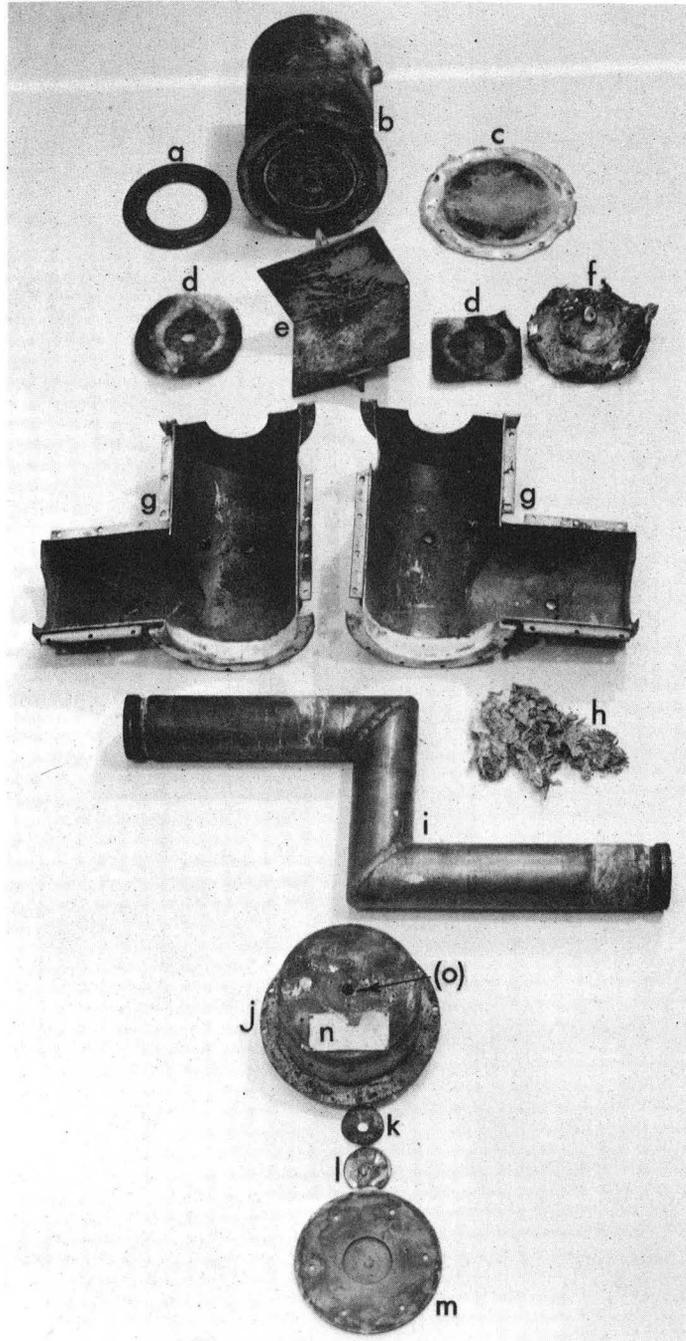
ZN-2541

Figure 7 is an exploded view of the device. The components are (a) ring from detector housing; (b) detector housing; (c) aluminum end plate from detector housing; (d) insulating material; (e) structural bracket; (f) solidified lead pried loose from detector housing; (g) split housing for process piping; (h) lead scrap found loose inside split housing; (i) process piping; (j) source housing; (k) small steel plate; (l) lead washer; (m) large steel end plate; (n) radiation label mounted on end plate. The arrow (o) indicates the space from which the primary capsule was removed.

1. The cesium-137 capsule came through the fire with no spread of radioactivity.
2. The minimum shielding over the cesium capsule was 1/8 in. of steel plus 1/16 in. of lead. A radiation warning label, attached near this minimum shielding spot, had started to melt.

Fig. 7. Exploded view of source assembly. (See text.)

The "Radioactive Material" warning on devices of this sort should be stamped into the metal.
