SURFACE RUPTURES EAST OF MEXICALI FROM THE IMPERIAL VALLEY EARTHQUAKE OF 15 OCTOBER 1979

Stephen Vonder Haar

May 1981

OBSERVATIONS AND COMMENTS

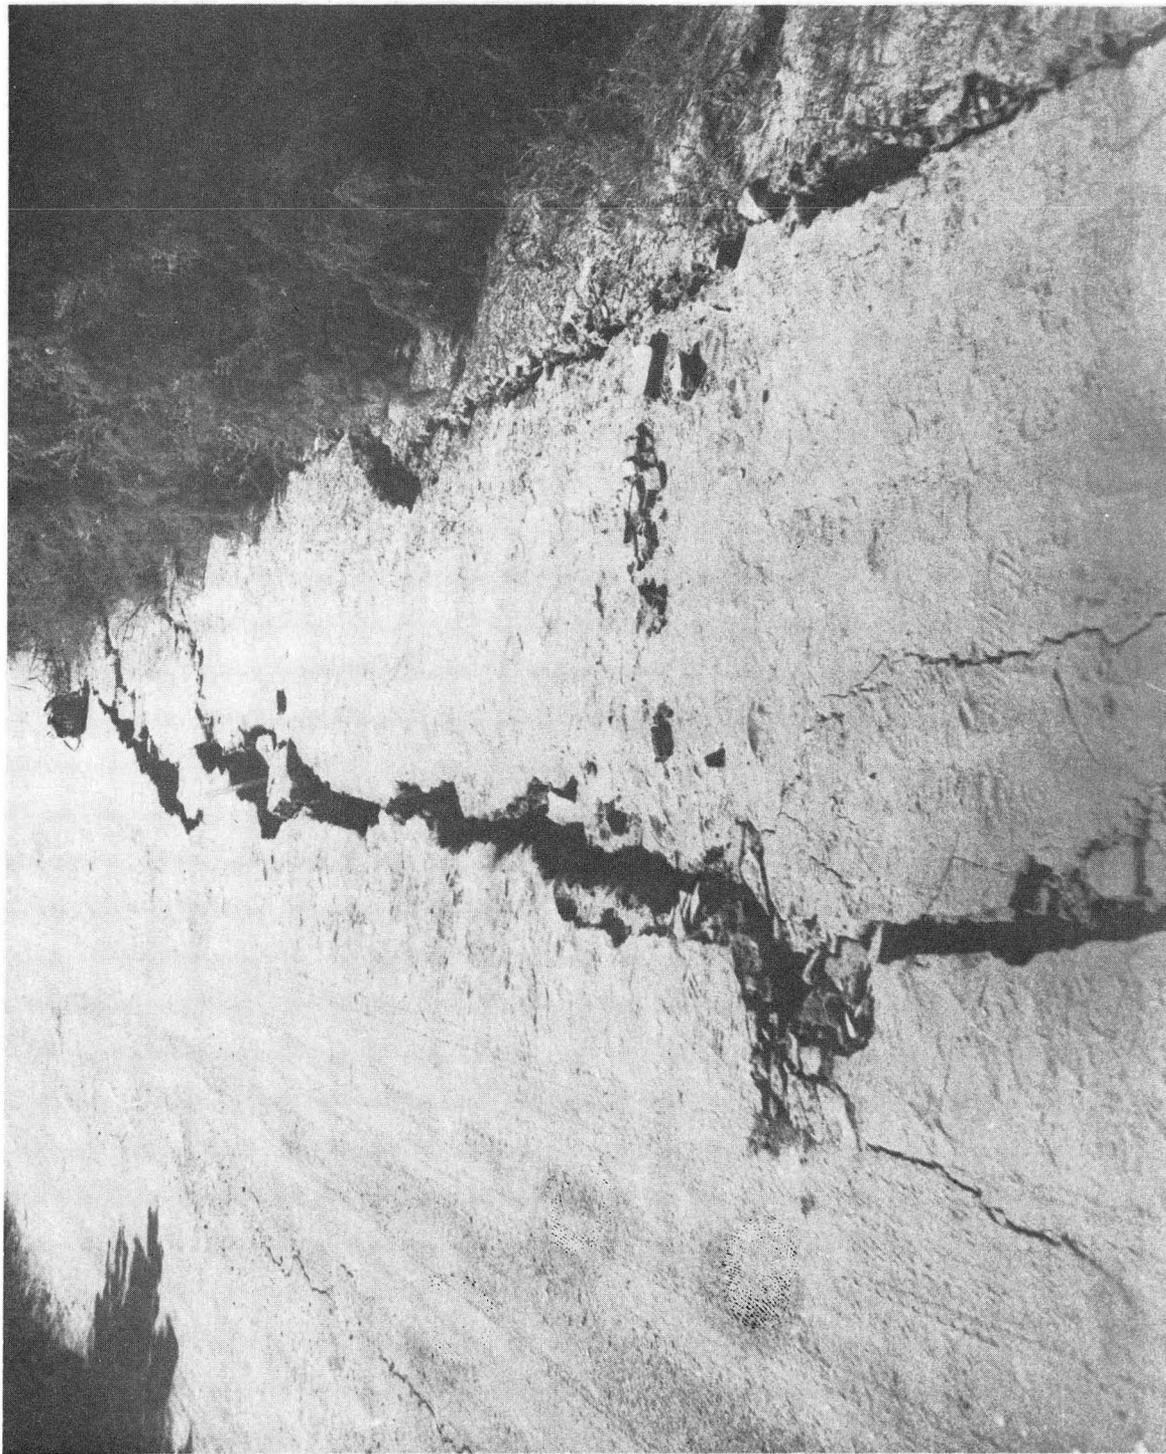
Figure 3

Slumps and fissures were best developed at location "A" (Figure 2) along an unimproved road that parallels a north-south earthen canal, a portion of Canal Principal del Oeste (Figure 3). Many of these rotational slumps of earth into the canal were up to 10 m³. Approximately 5 to 25 m from this canal, three faint fissures were found with strikes of 330°, 340°, and 345°. Each fissure was about 4 m long, but no reliable displacements could be obtained from them.

- Figure 2. Map of the study area east of Mexicali. Letters "A" through "E" mark the locations of the features described in the text.
- Figure 3. Fissures due to slumping of the dirt road into the earth-lined canal located to the right. Scale shown by backpack (1 ft wide) on the road in the upper center of the photograph; view is south at location "A" of Figure 2.

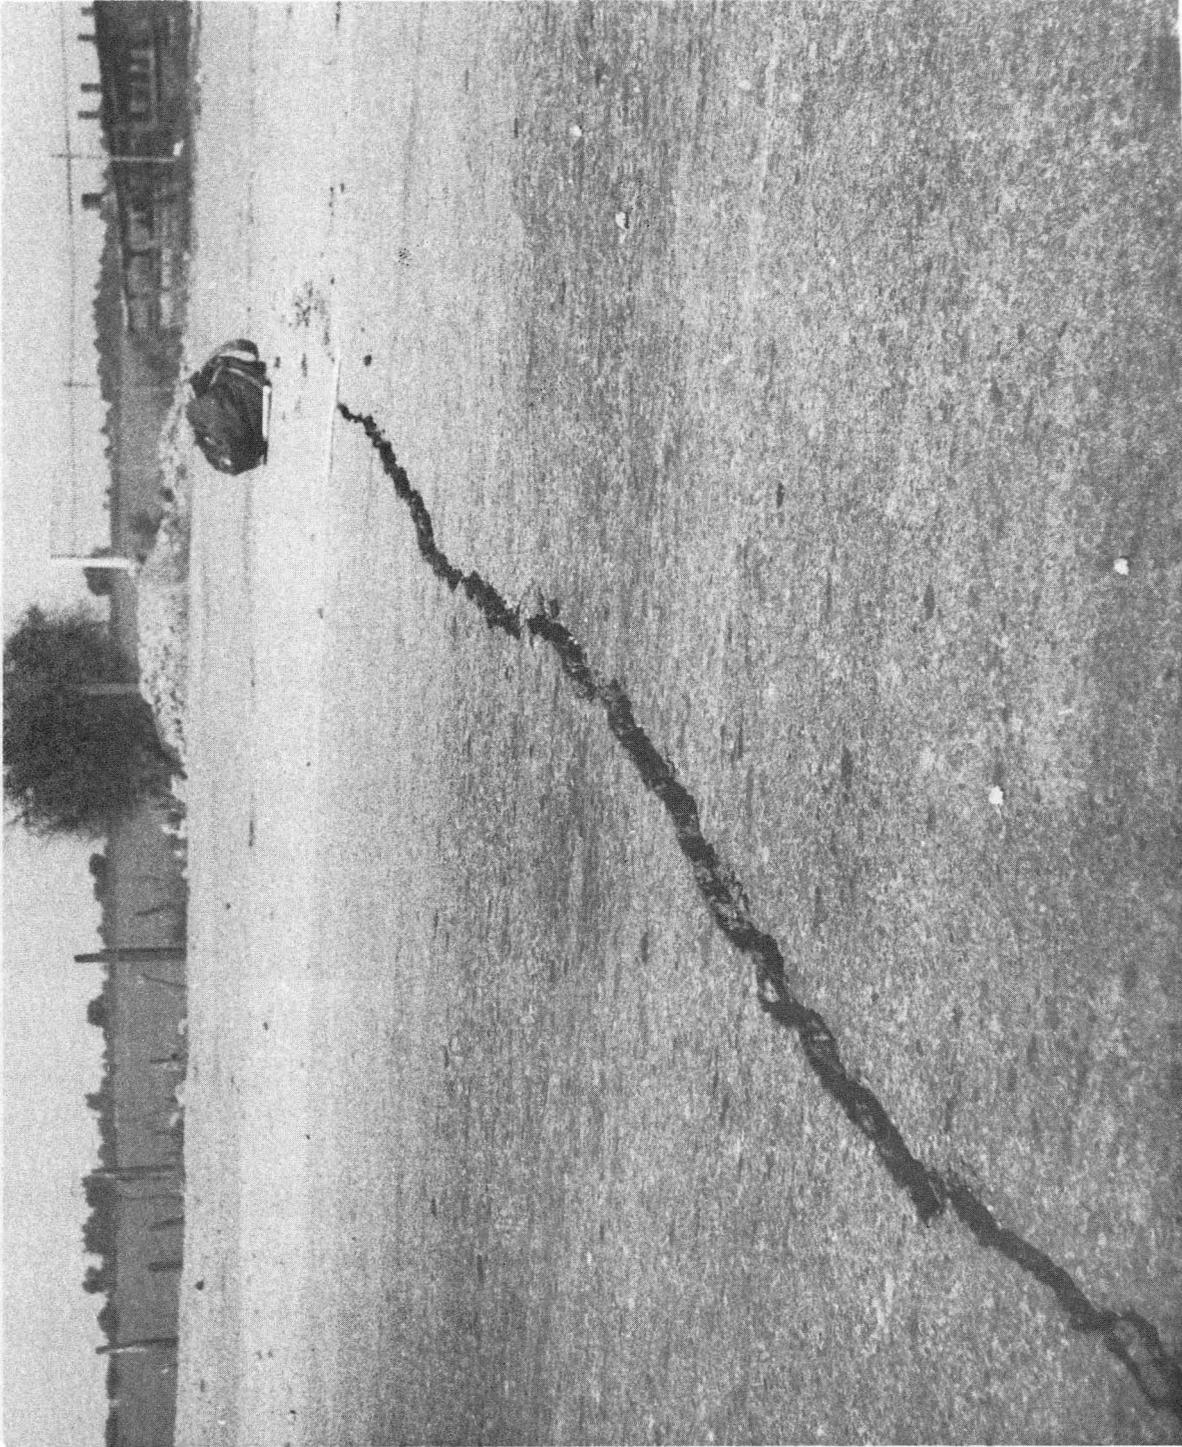
Figure 4

The only crack found in the paved highway was at location "B" of Figure 2, and is illustrated in Figure 4. This crack, on the north side of the divided highway, was downthrown 2.5 cm to the east and showed 1 cm of right-lateral

displacement. This crack and two nearby cracks showing less displacement had strikes of 331° , 326° , and 331° . The crack in the pavement was patched the second day after the quake.

- Figure 4. Crack in paved highway at location "B" of Figure 2; view northwest. Backpack at far side of road shows scale (1 ft wide). Displacement is down 2.5 to the east with 1 cm of right lateral movement.

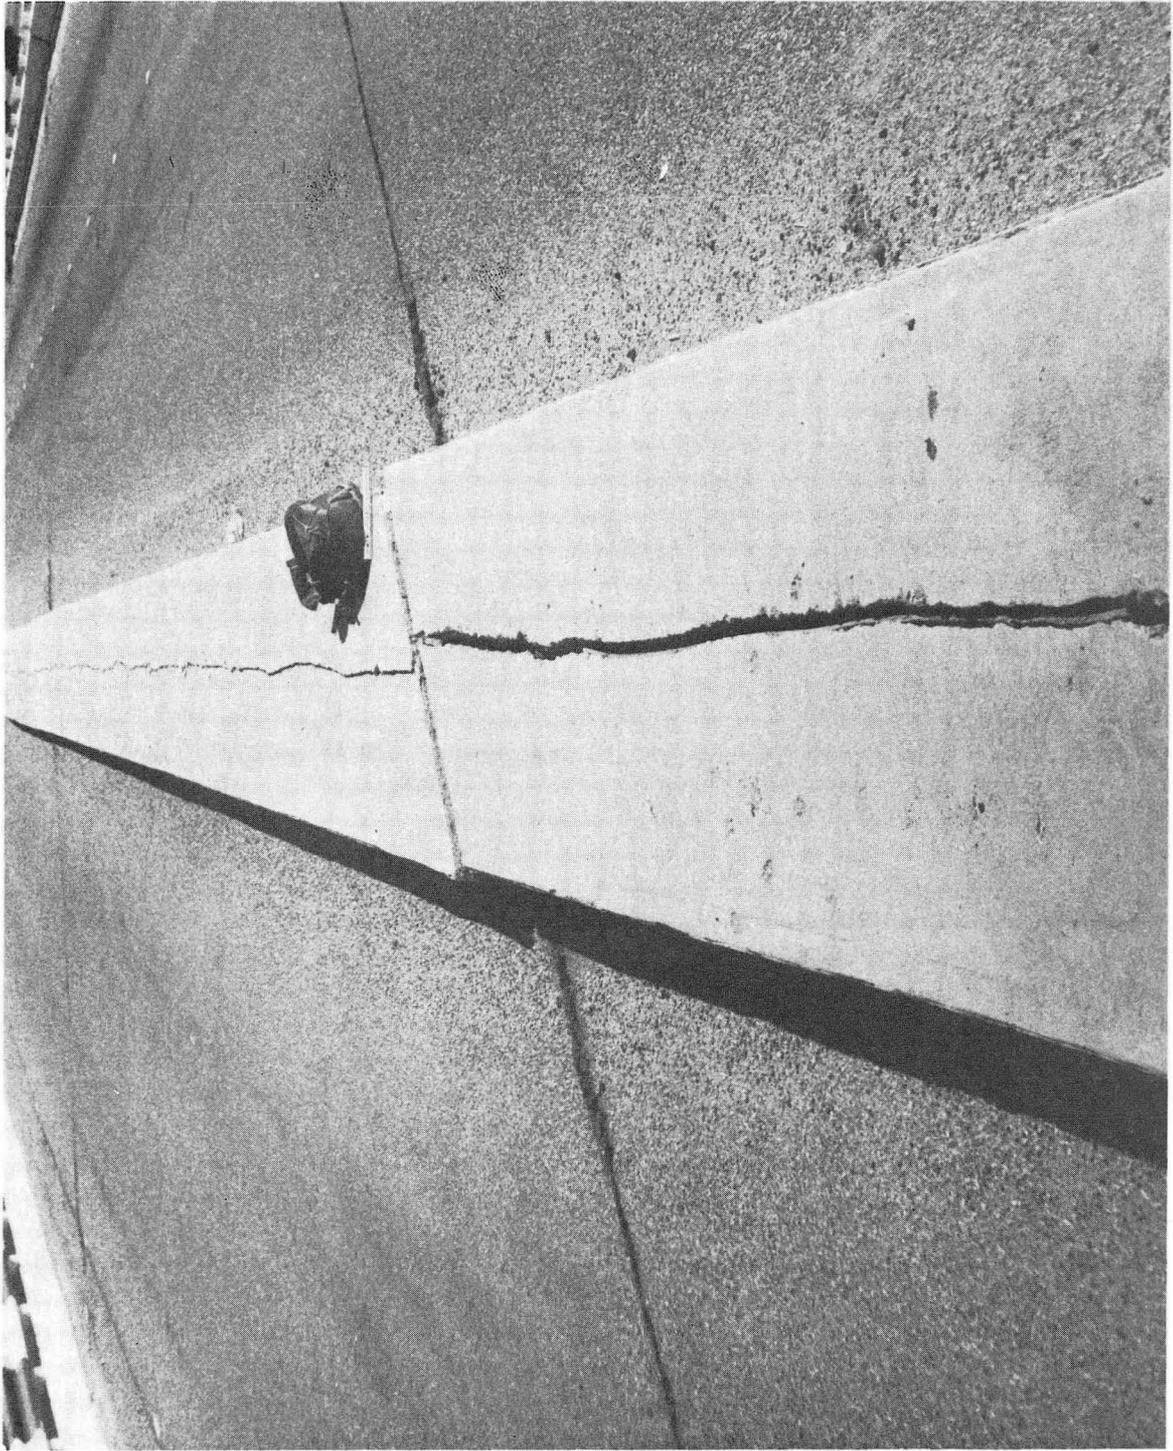
Figure 5

Structural damage to the overpass 50 m east of the break in the highway was considerable (Figure 5). The cracks showed 5.5 cm of left-lateral displacement and 2 to 8 cm of east-west separation. These breaks, however, appeared to follow lines of engineering weakness, and were thus unreliable indicators of fault direction.

- Figure 5. Overpass damaged by earthquake at location "B" of Figure 2. See text for discussion; view southwest.
- Figure 6. Cemetery parking lot at location "C" of Figure 2. View is west; white 1-ft ruler shows scale. Note the apparent overthrusting of the step to the south-southwest.

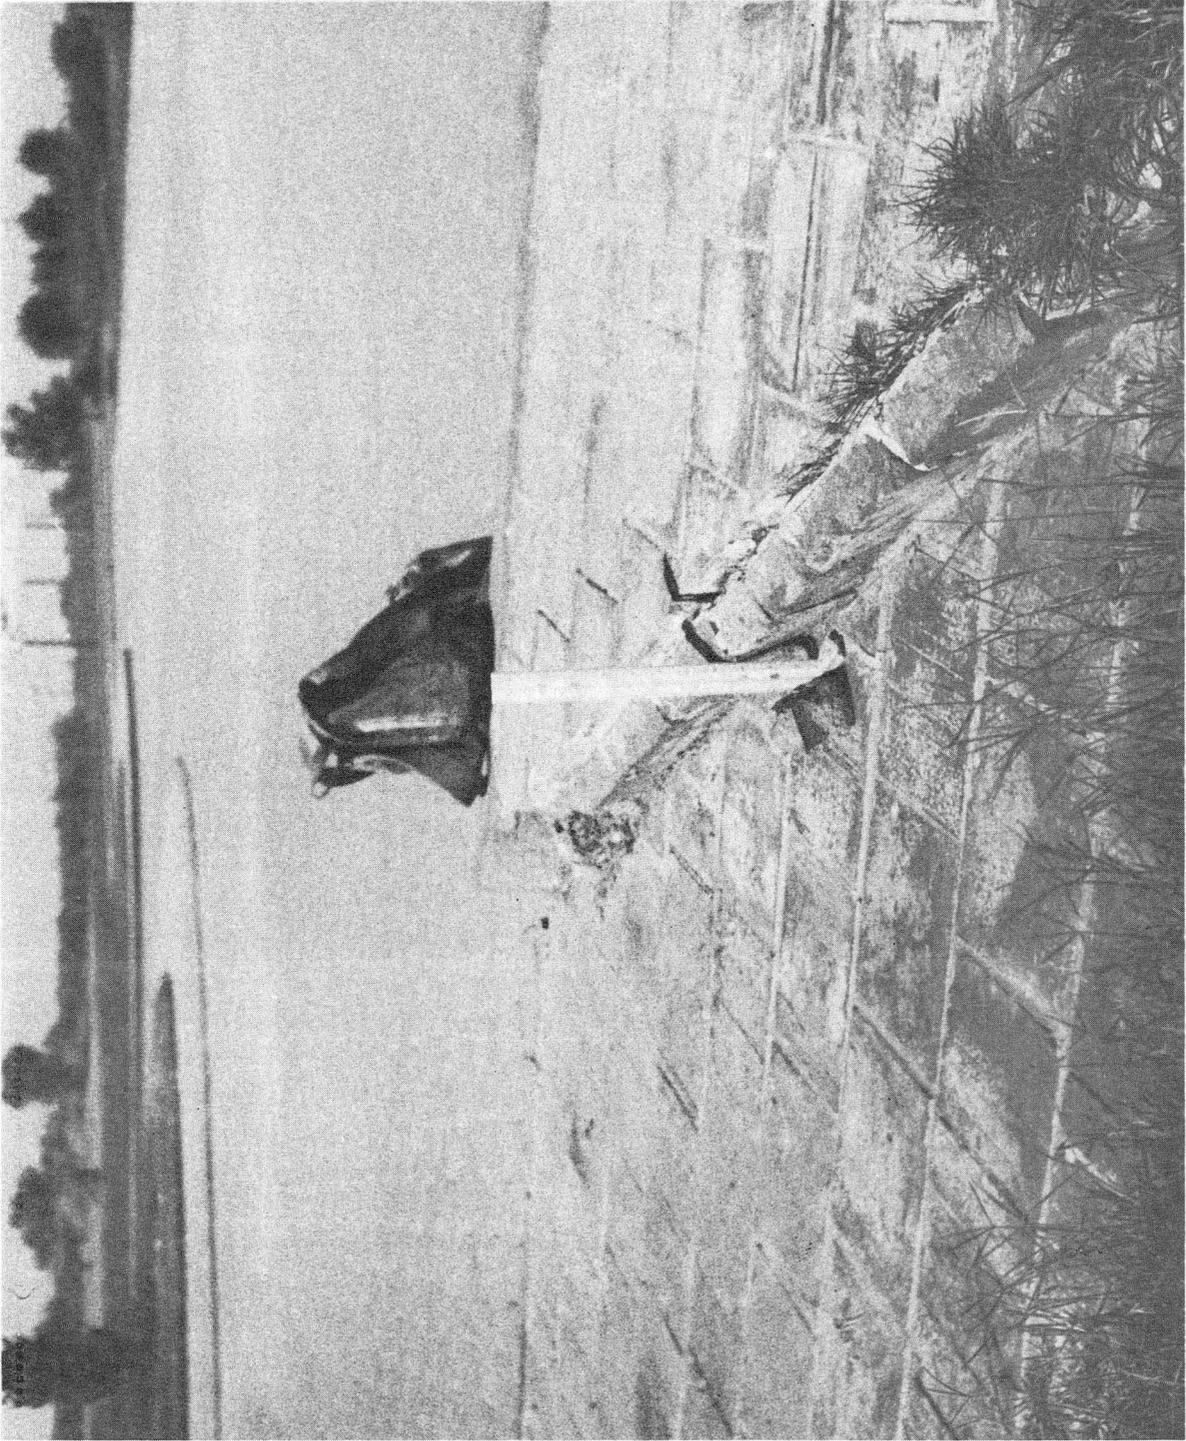
Figure 6

Approximately 9 km west of the international Airport, a cemetery with extensive new masonry walkways and parking areas was visited to look for signs of the temblor (location "C," Figure 2). Curbs were cracked and offset 1 to 3 cm. One of the more notable features is shown in Figure 6. This man-made step, higher to the northeast, was pushed 3.5 cm horizontally to the southwest.
