ELEVATED TEMPERATURE COMBINED
EROSION-CORROSION OF STEELS

A. Levy, E. Slamovich, and N. Jee

April 1984

LBL-17243
c.2

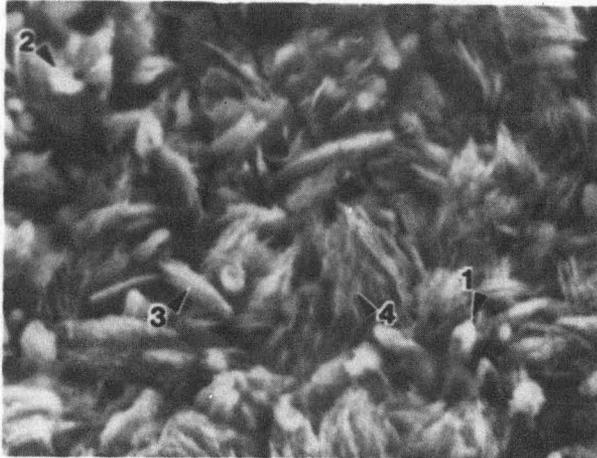
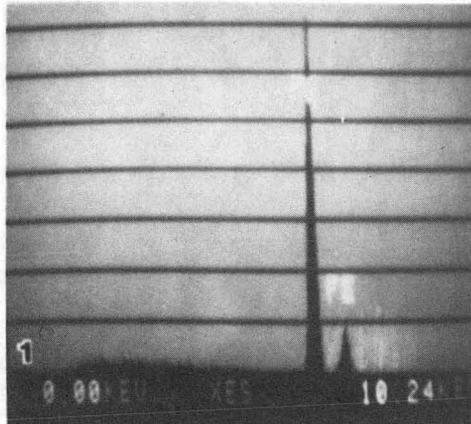
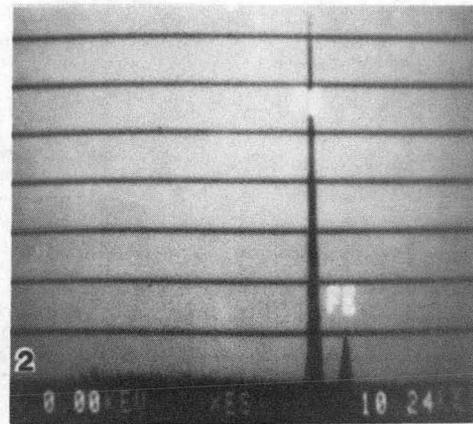
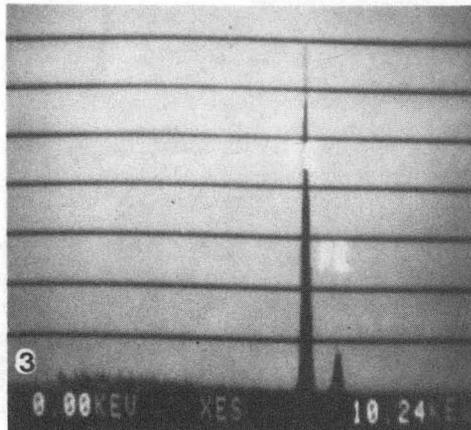
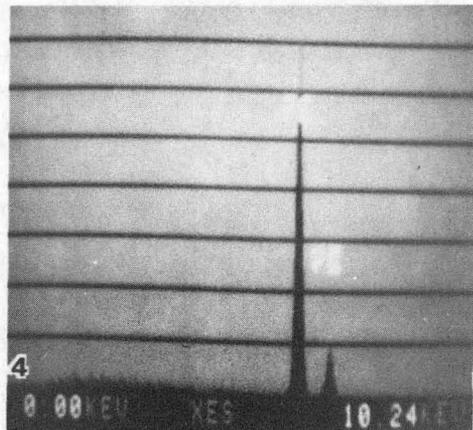
Fig. 1. Peak analyses of composition of needle shape surface scale of 2 1/4Cr1Mo steel on eroded-corroded surface after 810°C test.
XBB 841-102

Reference 20 reports on the behavior of a series of chromium containing steels containing 0 to 18% chromium, all eroded with small, 5 μ m flyash particles. Analysis of the scale surface on all of the steels tested in that study indicates the presence of only iron oxide, Fe₂O₃⁽⁶⁾. Figure 1 shows the surface of the scale formed on the eroded-corroded side of 2 1/4Cr1Mo steel with the KEVEX peak analyses at several points that only show the presence of iron indicating only chromium free iron oxide.

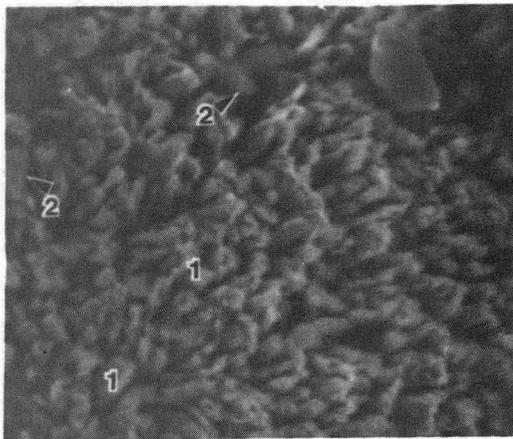
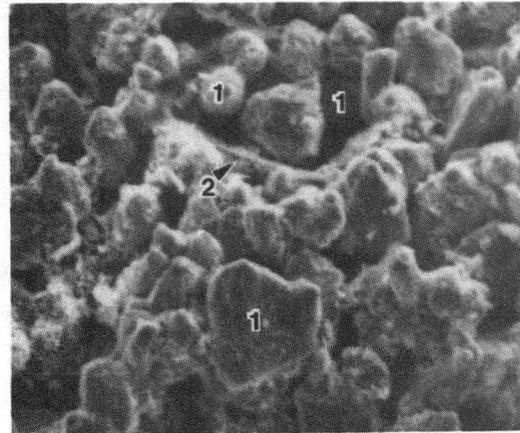
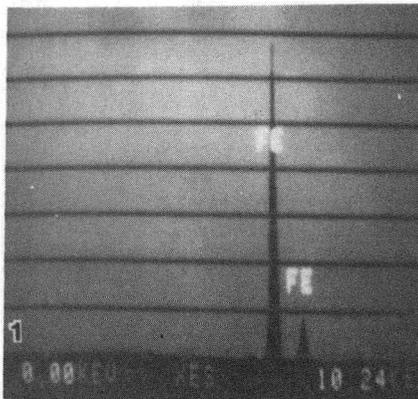
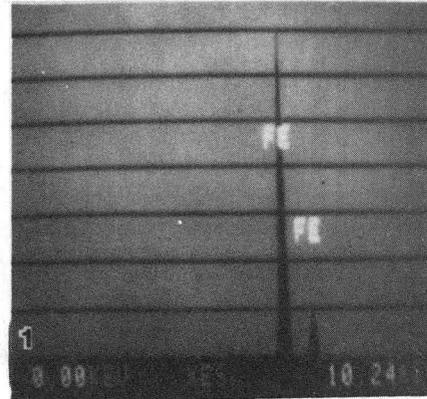
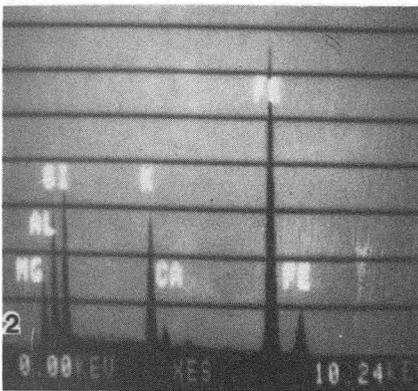
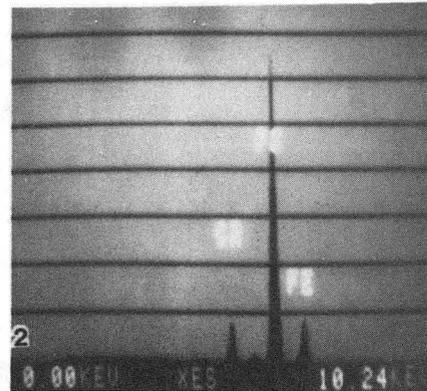
Fig. 2. Peak analyses of composition of surface scales on 410SS after 950°C test.

Figure 2 shows the same condition existing at the surface for the 12Cr steel, 410SS. In Figure 2 both the corroded and eroded corroded sides of the same specimen are shown. KEVEX peak analyses No. 1 for each side show only the presence of iron oxide. KEVEX peak No. 2 for the corroded only side shows that particles of the flyash have been embedded in the small diameter iron oxide columns. The flyash is composed of oxides of magnesium, aluminum, silicon, potassium and calcium. The particles are slowed down considerably in the wakes on

The KEVEX peak no. 2 for the eroded-corroded side identifies a crystal of oxide that contains some chromium that is located somewhat below the average surface of the iron oxide columns. The location of the chromium is seen better in figure 3 which shows the cross sections of the scale formed on 410SS on both the corroded and eroded-corroded sides. The iron and chromium maps in the figure show that the scale formed is duplex with a top layer of iron oxide ($\alpha\text{-Fe}_2\text{O}_3$) and an underlayer of iron-chromium oxide spinel.⁽⁶⁾ The iron oxide layer on the eroded-corroded side of the specimen is thin compared to the iron oxide layer on the corroded side. The surface of the eroded-corroded side is made up of relatively large diameter columns of $\alpha\text{-Fe}_2\text{O}_3$ with void areas between them that extend down to the iron-chromium spinel layer. It is for this reason that there is a chromium peak in Figure 2 on the eroded-corroded side. Figure 4 shows that morphology of the corroded and eroded-corroded surfaces more clearly. The major differences that occurred in their morphology is one of the effects of combining erosion with the corrosion.

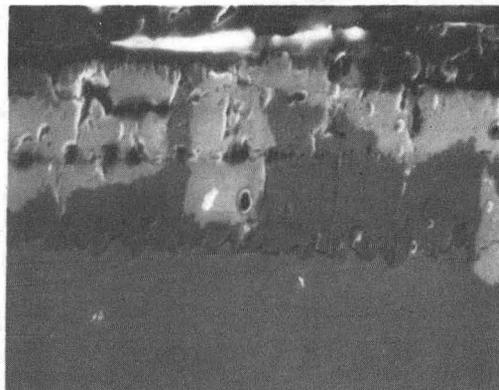
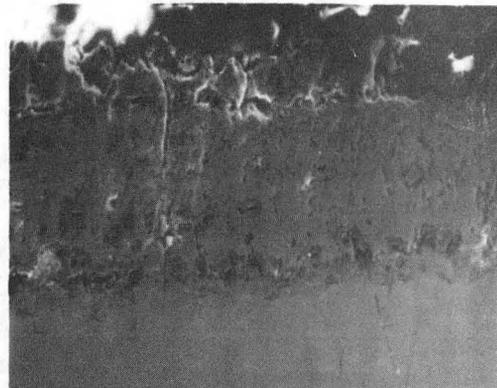
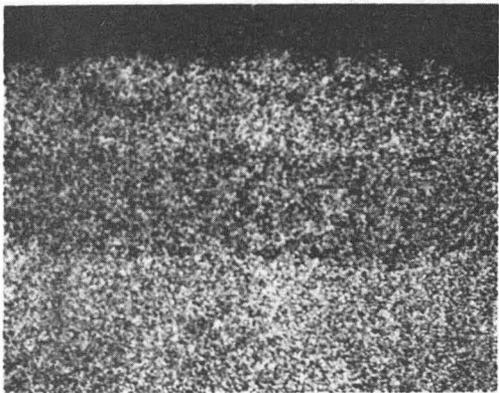
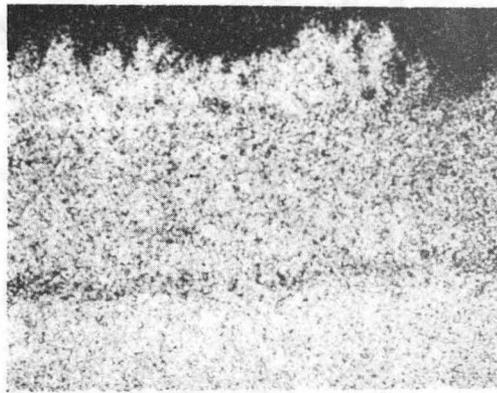
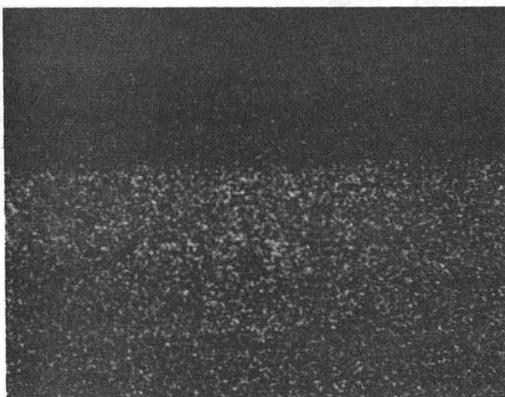
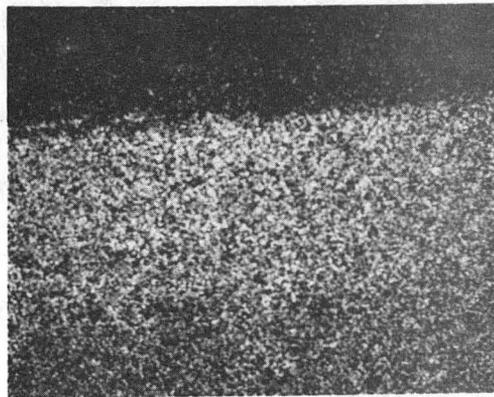
Fig. 3. Cross section of 410SS scales formed at 950°C.

Figures 3 and 4 indicate that the erosion process significantly modifies the corrosion process. On the corroded only scale cross section in Figure 3, the small diameter, pointed columns of iron oxide shown in Figure 4 can be seen in cross section. On the eroded-corroded side of Figure 3 the large diameter columns of iron oxide shown in

The thickness of the upper and lower scale layers has been changed as a result of the erosion process. On the corroded only side of the specimen in Figure 3 both scale layers have approximately the same thickness. The contact zone between the lower scale layer and the substrate metal is intimate with no voids present. On the eroded-corroded side the thickness distribution between the upper, iron oxide layer and lower, iron-chromium oxide spinel layer is markedly different. The overall scale thickness is different on both sides. The large increase in the spinel layer on the eroded-corroded side apparently has depleted the substrate surface in chromium sufficiently to cause some Kirkendall type voids to occur at the scale-metal interface. The amount of voids between the upper and lower scales is near the same for both the corroded and eroded-corroded sides.

The distribution of the iron oxide and iron-chromium oxide scale layers was changed between the eroded-corroded scale in the 5 μ m flyash test, Figure 3, and the 100 μ m Al₂O₃ test shown in Figure 7. The iron oxide, upper layer is now the thicker layer with not as much iron-chromium oxide spinel forming, relatively, as occurred in the 5 μ m flyash test. Small diameter voids occurred throughout the scale layers on the eroded-corroded side but did not occur on the corroded side.

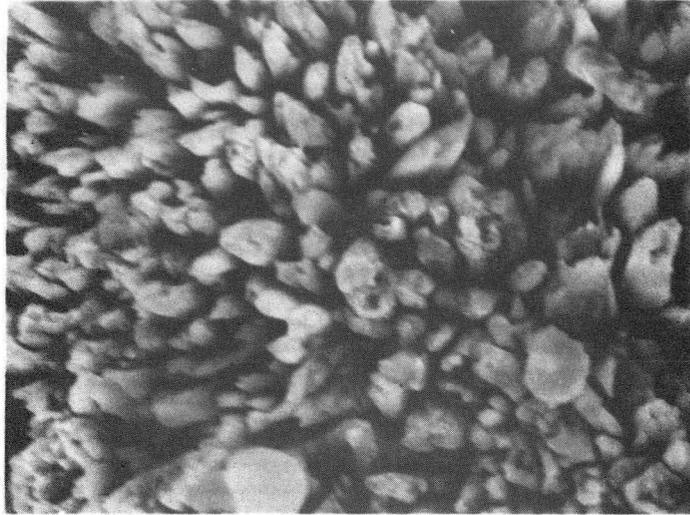
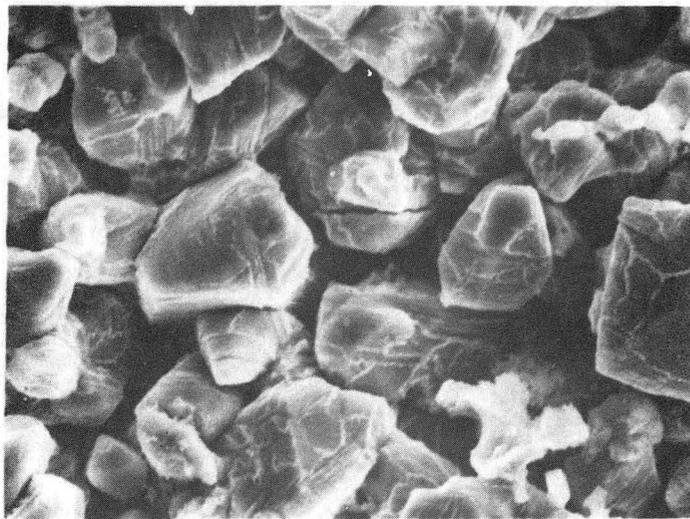
Fig. 4. Surface morphology of scale on 410SS formed at 950°C. XBB 841-101

As the particle size of the erodent is increased, major changes occur in the morphology of the iron oxide scale surface. Figure 5 shows the surfaces of the erosion-corrosion side of 410SS eroded by 5 μ m flyash and 50 μ m and 100 μ m Al₂O₃. As the particle size increase from 5 μ m to 50 μ m dia particles, the diameter of the iron oxide columns decreases and the number increases. The type of column caused by the 50 μ m particles reverts to that which occurs on the corrosion side of

In contrast with the differences in the eroded-corroded surfaces that were shown in Figure 10 when the erodent was 100 μ m Al₂O₃ the use of 50 μ m Al₂O₃ erodent particles resulted in a very similar surface scale morphology for the three alloys of varying chromium content shown in Figure 11. The columns of iron oxide with wrinkled and porous tops are similar in size and shape to the corroded side of the 410SS specimen that was tested with 5 μ m flyash, see Figure 4. The scale

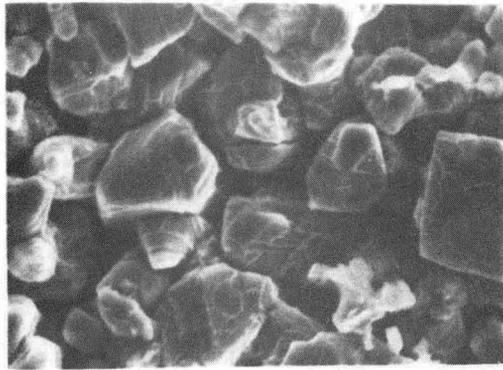
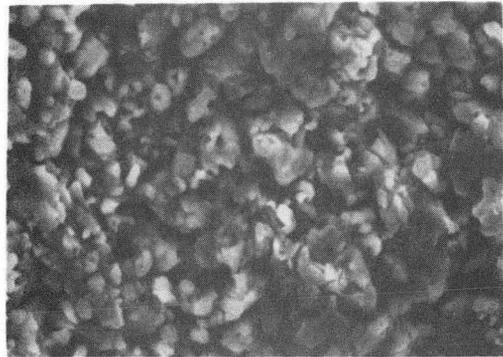
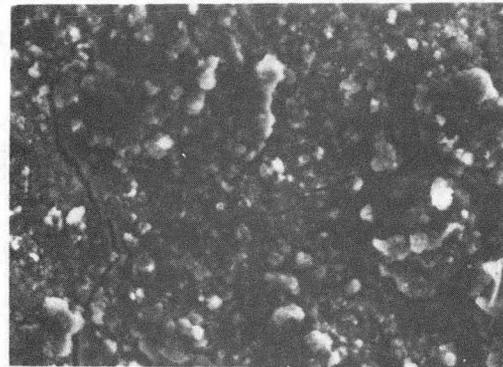
Fig. 5. Morphology of surface scale on 410SS eroded by 5µm, 50µm and 100µm particles.

the specimens in the 5 μ m flyash test, figure 4. A further increase in particle size to 100 μ m dia Al₂O₃ causes a further major change in the topography of the scale surface, as can be seen in the lower photo in Figure 5. There are a minimum number of small nodules rising out of a cracked continuous iron oxide scale layer.

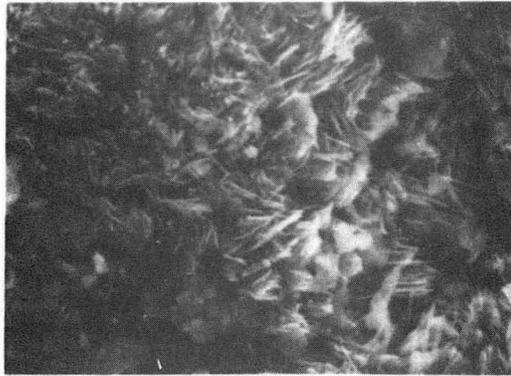
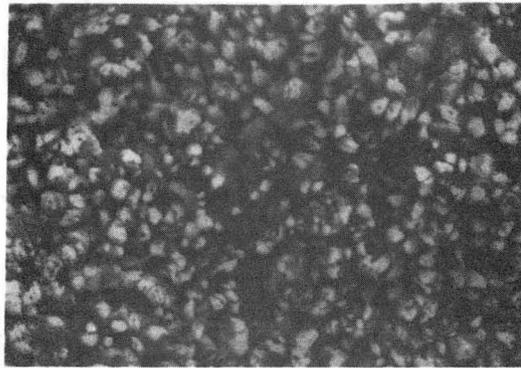
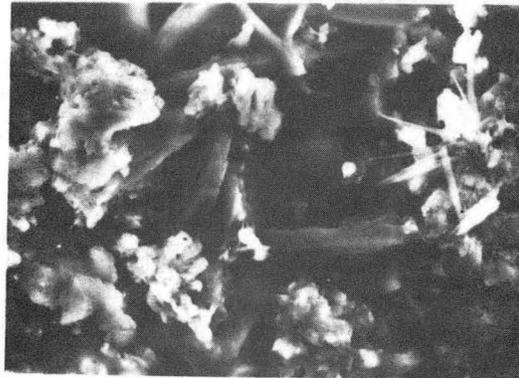
Fig. 6. Morphology of surface scale on 5Cr1/2Mo steel eroded by 5µm, 50µm, 100µm particles.

The variation in surface morphologies as a function of erodent particle size follows a pattern found in all of the other chromium containing steels tested. For example, Figure 6 shows the effect of erodent particle size on the surface scale morphology of the 5Cr 1/2Mo steel. Note that the magnification of the scale on the 100 μ m Al₂O₃ is one-third that of the two photos above it. A major change in the diameter and shape of the needles or blades formed on the erosion-corrosion surface occurred between the 5 μ m flyash and the 100 μ m Al₂O₃ tests. The 50 μ m dia particles resulted in a surface morphology that was similar to that found on the 410SS when it was eroded with 50 μ m dia particles, see Figure 5. This small diameter column morphology was found on almost all of the alloys that were eroded with 50 μ m dia particles.

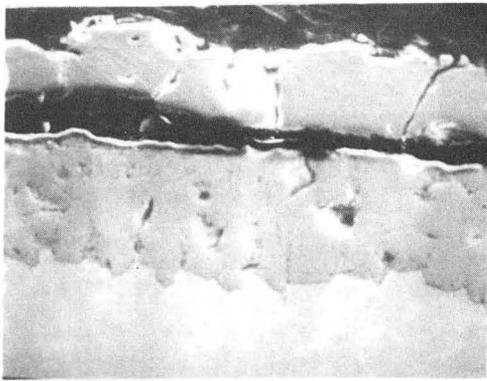
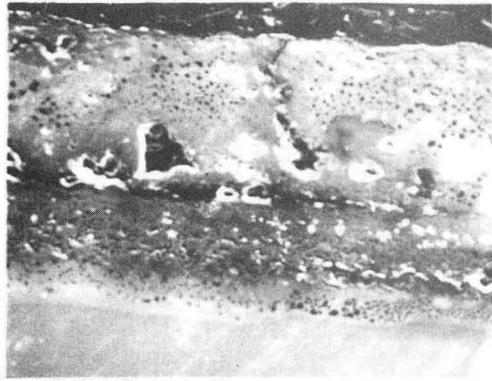
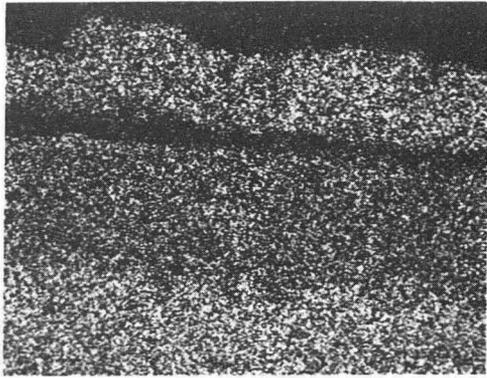
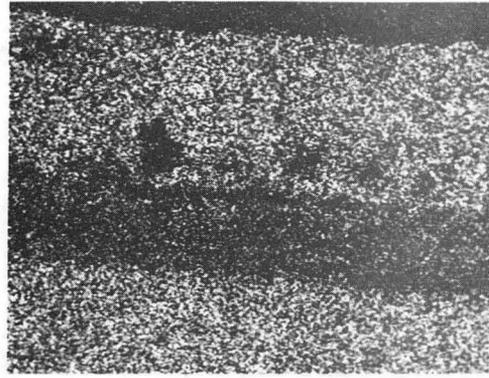
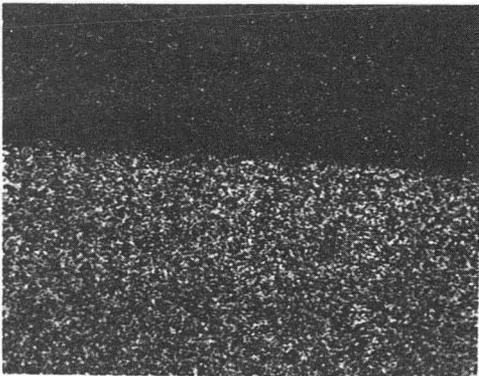
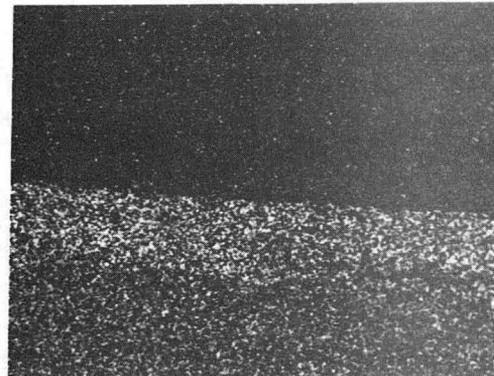
Fig. 7. Cross section of scales on 410SS from 100µm Al₂O₃ tests at 950°C.

The cross section of scales from tests using 100 μ m dia Al₂O₃ particles are shown in Figures 7 and 8. The scales were still multi-layered but differed significantly from those which occurred when 5 μ m flyash was used. In Figure 7 for 410SS, it can be seen that the overall thickness of the scale on the eroded-corroded side is much

greater than that which formed on the corrosion only side of the specimen (note the difference in magnification of the two photos). The erosion process markedly enhanced the growth of the scale.

There is also an internal scale layer that has formed on the eroded-corroded side, below the voids at the scale-metal interface that does not contain chromium. Based on evidence in reference 7, it is probably inward growing Fe₃O₄. The much smoother surface of the 100 μ m particle test scale compared to the 5 μ m particle test scale is also indicated in Figure 7.

diameter pores occurred in the higher chromium content alloys. The same observation was made in this study, but primarily in the scale on the erosion-corrosion side of the specimens. Compare Figure 7 of 410SS with Figure 8 of 2 1/4Cr 1Mo steel.

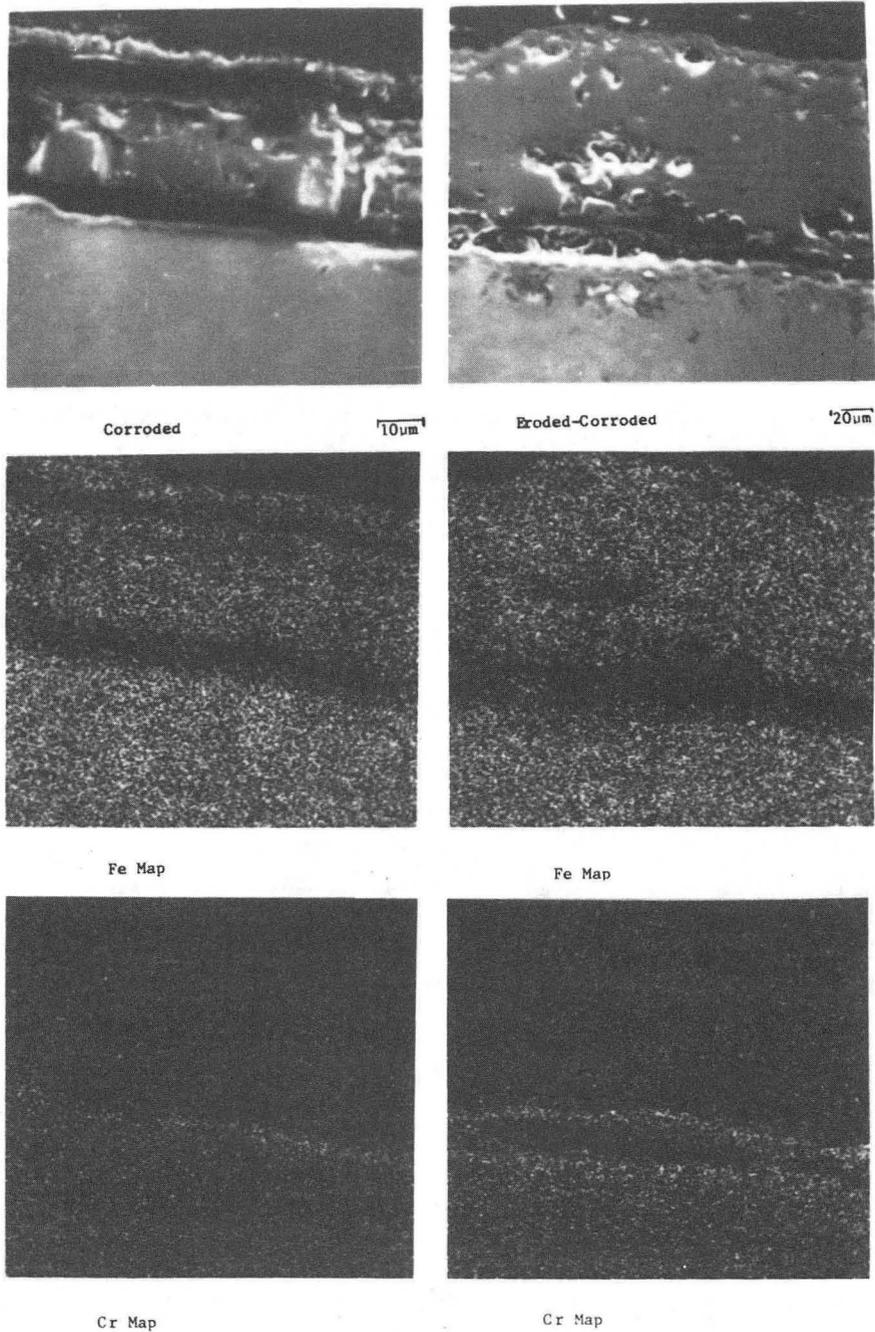
Fig. 8. Cross section of scales on 2 1/4 Cr1Mo steel from 100µm Al₂O₃ tests at 850°C.

Figure 8 shows the cross sections of the scales formed on the much lower chromium content 2 1/4Cr1Mo steel when 100 μ m particles were used at a lower test temperature than was used for the 410SS. The scale is essentially iron oxide. The chromium has concentrated in a thin iron-chromium oxide spinel layer at the scale-metal interface. The scale on the eroded-corroded side is significantly thicker than that on the corroded side, as occurred on 410SS. The scales that formed on both

sides of the specimen were almost completely separated from the substrate, indicating a strong susceptibility to spalling.

The description of the formation of a multi-layer scale on Fe-3% Cr steel by Mitchell in reference 8 matches perfectly with the scale on 2 1/4Cr1Mo steel on the corroded side shown in Figure 8. He described an inner, thin layer of (Fe, Cr) $3O_4$ spinel, a thicker, compact middle layer of Fe_3O_4 and a thin outer layer of αFe_2O_3 . Since positive identification of each scale layer was made by Mitchell and he identified a distinct layer of Fe_3O_4 , it is assumed that layers of Fe_3O_4 are present on some of the other lower chromium content steels, in addition to the scale shown in Figure 8, that are reported on herein. To date, only SEM X-ray maps of the principal elements present have been used in this study to aid in the identification of scales.

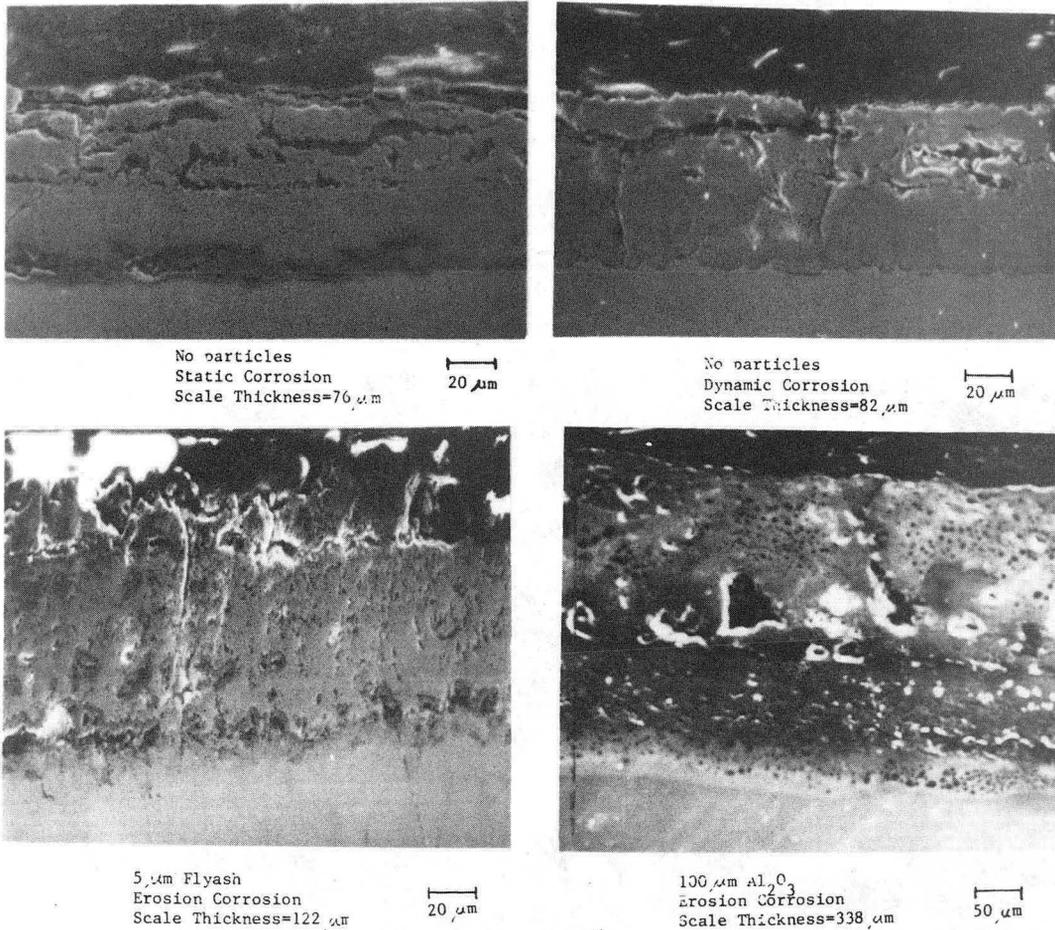
Fig. 9. Cross section of scales formed on 410SS at 950°C at different test conditions.

The consistent effect observed on all of the alloys for the eroding particles to increase the scale thickness on the erosion-corrosion side of the test specimen compared to the corrosion side was checked against the dynamic corrosion obtained by testing specimens in the flowing gases of the ACES burner without injecting any particles. Figure 9 compares the scales formed and their thicknesses for a number of test conditions. It can be seen by comparing the top two photos that static corrosion on the back side of the specimen and dynamic corrosion on the front side (gas flow without particles) results in nearly the same scale thickness with approximately a 10% increase on the dynamic corrosion side. This compares with a 60% increase in the scale thickness on the erosion-corrosion side when $5\mu\text{m}$ particles are used and a 345% increase when $100\mu\text{m}$ particles are used, all compared to the static corrosion side scale thickness.

Cross sections of the erosion-corrosion scales are seen in the lower two photos in Figure 9. The morphology of the static and dynamic corrosion scales are similar while there is a major difference in the two eroded-corroded scales in addition to their thickness difference. This seemingly anomalous behavior of the more erosive (larger size) particles causing markedly thicker scales to form was consistently observed for all of the chromium containing steels tested.

Dynamic corrosion tests were run on all of the test alloys and the results on 410SS, which are typical, are shown in Figure 9. The difference in scale thickness between the corroded and eroded-corroded sides of the same specimen was determined to not be due to dynamic corrosion effects. The ability of the impacting erodent particles to increase the growth rate of the oxide scale without removing it was demonstrated.

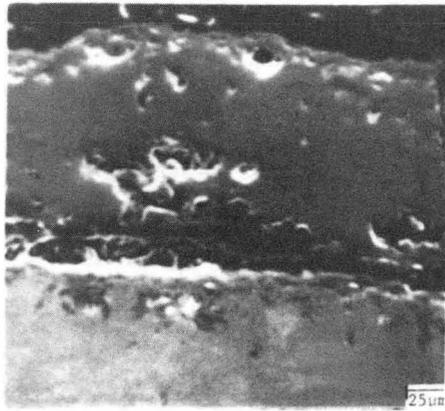
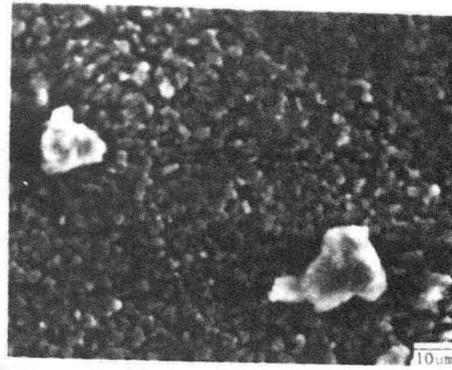
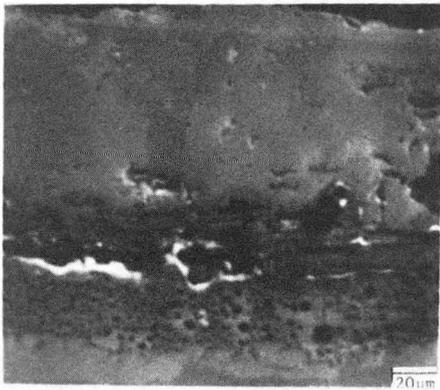
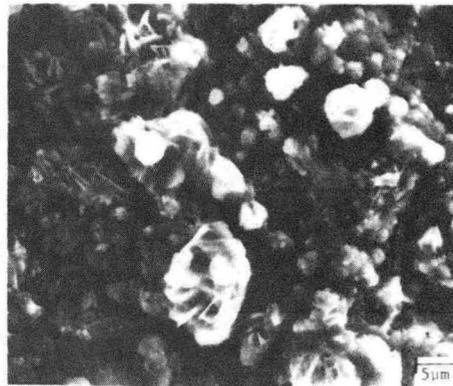
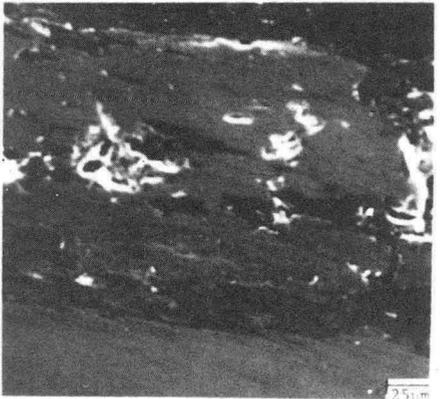
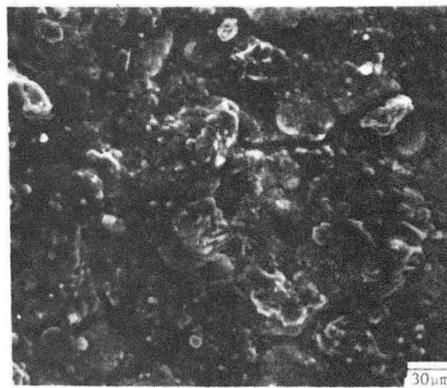
Fig. 10. Cross section and surface morphology of scales of 2 1/4, 9 and 12Cr steels eroded-corroded at 850°C using 100µm Al₂O₃.

The differences in the morphology of the cross section and surface of three of the chromium containing steels tested at the same conditions are shown in Figure 10. These steels were eroded by 100 μ m Al₂O₃ particles. All three had iron oxide outer scales with the two higher chromium content steels having sizeable inner scales of iron-chromium oxide spinel.

morphologies of the three alloys shown in Figure 11 are completely different from their eroded-corroded surfaces when tested using either 5 μ m or 100 μ m size particles, see Figure 4 and 10. The cross sections of the three scales are multi-layered and have generally similar morphologies. The scale thickness of the 9Cr and 12Cr steels was thinner when the 50 μ m particles were used than when the 100 μ m particles were used as can be seen by comparing Figures 10 and 11 (note magnification differences).

For higher chromium content alloys, Mitchell included 9, 12 and 18% Cr steels in reference 7, inward growing iron-chromium oxide spinels are nucleated by the mechanism discussed above. While the study reported on herein found that the outer scale layer was always iron oxide, inner scales of iron-chromium oxide spinels were observed. These spinels, as reported in reference 7, 8, could be either $(\text{Fe,Cr})_3\text{O}_4$ or $\gamma\text{-(Fe,Cr)}_2\text{O}_3$. The light and dark areas shown in the inner, spinel scale layer for the 410SS in Figure 10 could be evidence that both spinels were present.

spinel thicknesses between the corroded and eroded-corroded sides cannot be explained yet. They were a consistently occurring phenomena for all of the alloys tested with the degree depending on the composition of the alloy and the size of the eroding particles. The effects increased with increasing erodent particle size. Figure 3 shows a comparatively minor difference for 410SS when 5 μ m flyash was the erodent while Figure 7 shows a major difference when 100 μ m Al₂O₃ particles were used. An intermediate difference in the thickness is shown for the 2 1/4Cr1Mo steel in Figure 8. Also, the scales on the eroded-corroded side were thicker when 100 μ m erodent particles were used than when smaller particles were used. Compare Figures 10 and 11 for the 9Cr and 12Cr steels.

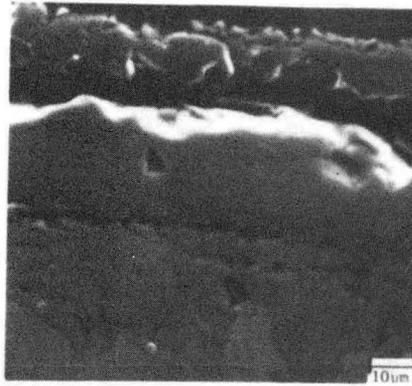
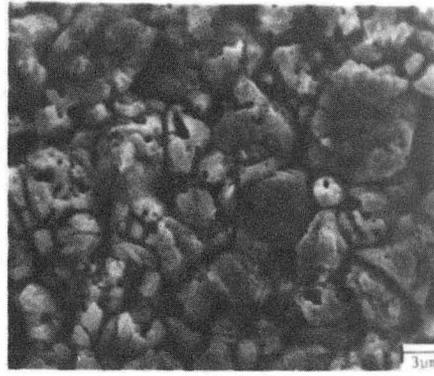
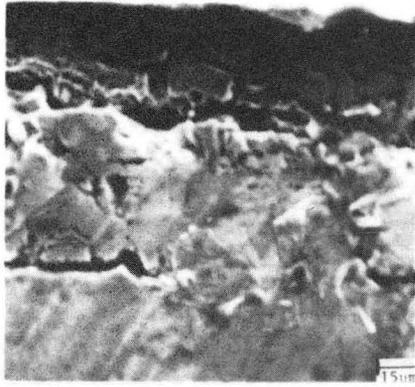
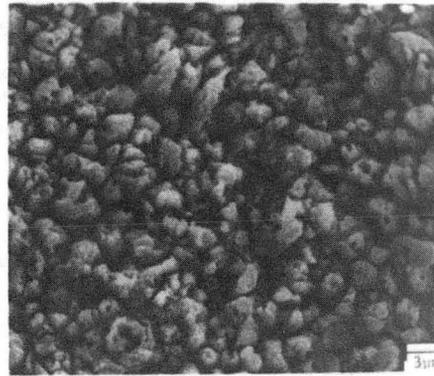
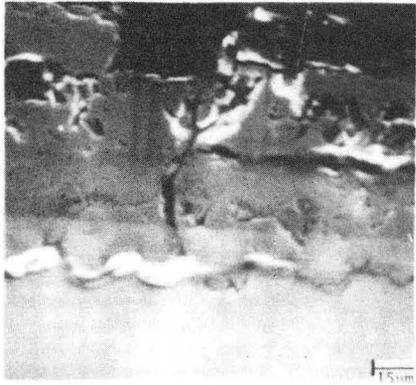
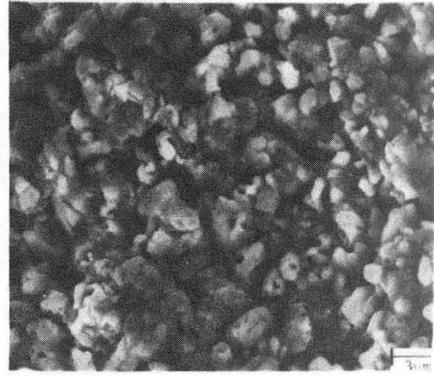
Fig. 11. Cross section and surface morphology of scales of 5, 9 and 12Cr steels eroded-corroded at 950°C using 50µm Al₂O₃.

Figure 11, varying the test temperature resulted in essentially the same type of microstructure for all three temperatures. The morphology was the same wrinkled, porous topped columns that were shown in Figure 11.

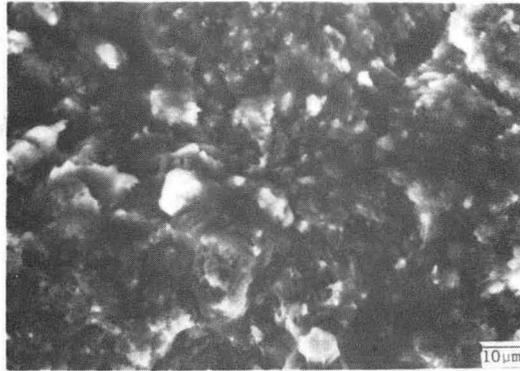
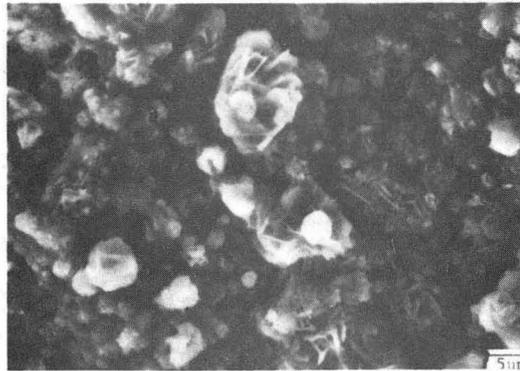
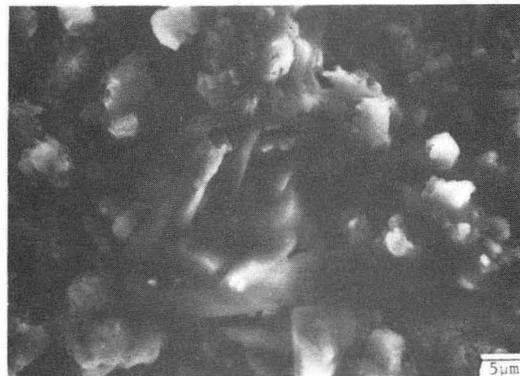
Fig. 12. Surface morphology of eroded-corroded 9Cr1Mo steel at three different test temperatures using 100µm Al₂O₃.

The morphology of the surface iron oxide scale was also affected by the test temperature when 5 μ m flyash and 100 μ m Al₂O₃ erodents were used, but not when 50 μ m Al₂O₃ particles were used. Figure 12 shows the changes that occurred on the 9Cr1Mo steel specimens when the temperature was varied from 800^o to 950^oC and 100 μ m size particles were used. The large diameter needles or blades that grew at 950^oC were very similar to those which grew at 800^oC on the 5Cr1/2Mo steel shown in Figure 6. The increase in the size of the microstructural elements with increasing temperature was expected, but the delicacy of some of the iron oxide crystals on surfaces that were being impacted by 100 μ m size particles as they were growing was unexpected.

The effect of the test temperature on the surface morphology of the scales on the erosion-corrosion sides of the specimens was very pronounced when 5 μ m and 100 μ m particles were used as the erodent, Figure 12 and 14, but caused very little change when 50 μ m particles were used, Figure 13. The reason for this apparent anomaly is not known.

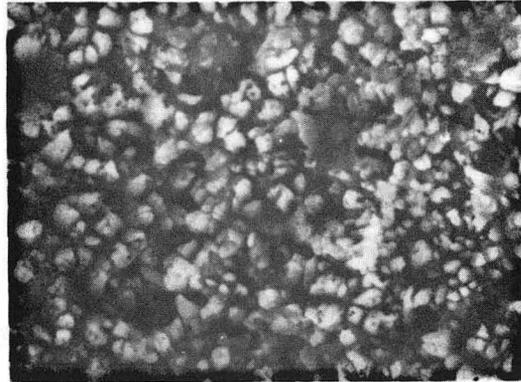
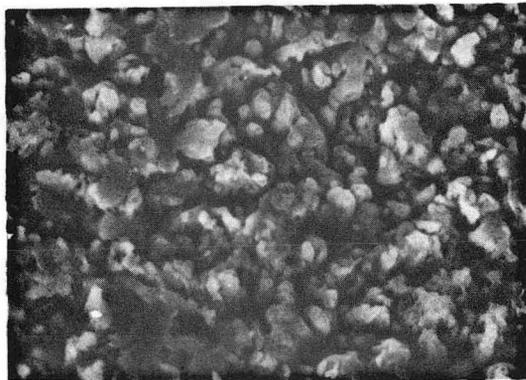
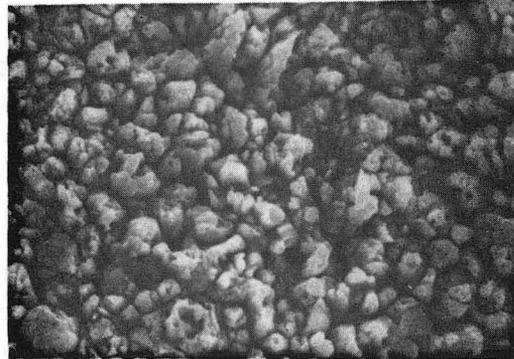
Fig. 13. Surface morphology of eroded-corroded 9Cr1Mo steel at three different test temperatures using 50μm Al₂O₃.

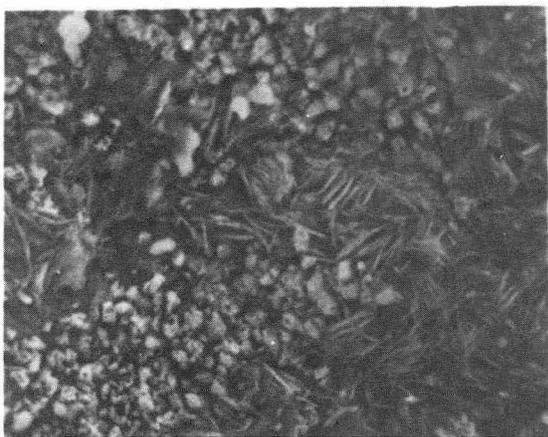
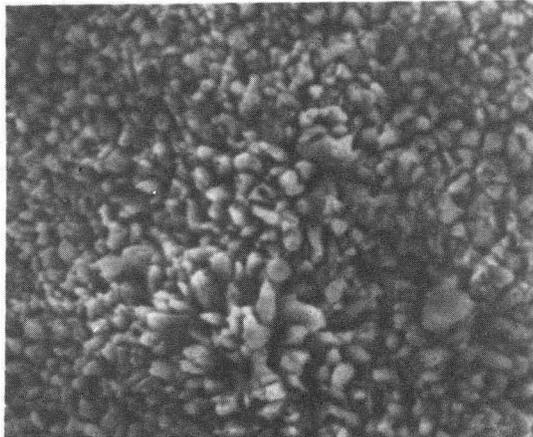
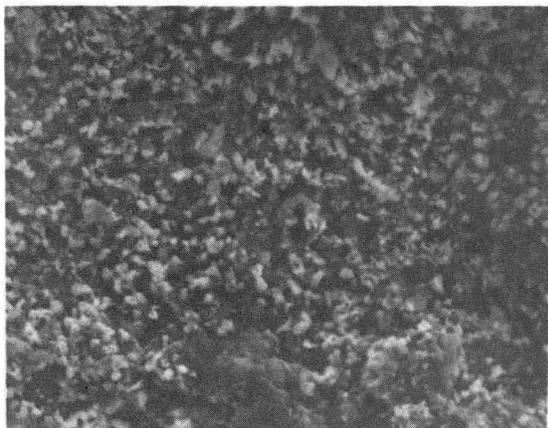
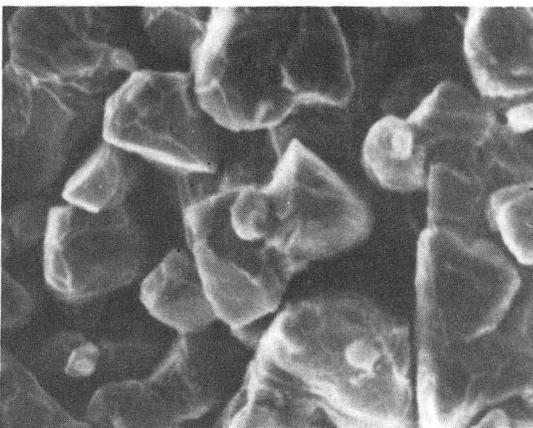
The effect of test temperature on the surface morphology of the alloys tested with the 5 μ m flyash particles was generally more dramatic in the differences that occurred. Figure 14 shows the surface of 410SS tested at 850 $^{\circ}$ and 950 $^{\circ}$ C on both the corroded and eroded-corroded surfaces. At the lower test temperature on the corroded side, some of the needle type crystals observed on the surface of the lower chromium content steels ⁽²⁰⁾ occurred. On the eroded-corroded side at the 850 $^{\circ}$ C test temperature, the needles have been removed and the remaining structure is essentially unaltered. Increasing the test temperature by 100 $^{\circ}$ C markedly changed the morphology of the surface of the iron oxide on both the corroded and eroded-corroded surfaces as can be seen on the right side photos in Figure 14.
