IMPROVED BETA"-ALUMINA ELECTROLYTES FOR  
ADVANCED STORAGE BATTERIES  
Final Report

L.C. De Jonghe

December 1983

The investigations seek to clarify the origin of electrolytic degradation of sodium-beta" alumina solid electrolytes when used in sodium/sulfur cells. Degradation is often observed on the sulfur as well as on the sodium side of the used electrolytes, although for some extensively used electrolytes no signs of any degradation could be detected.

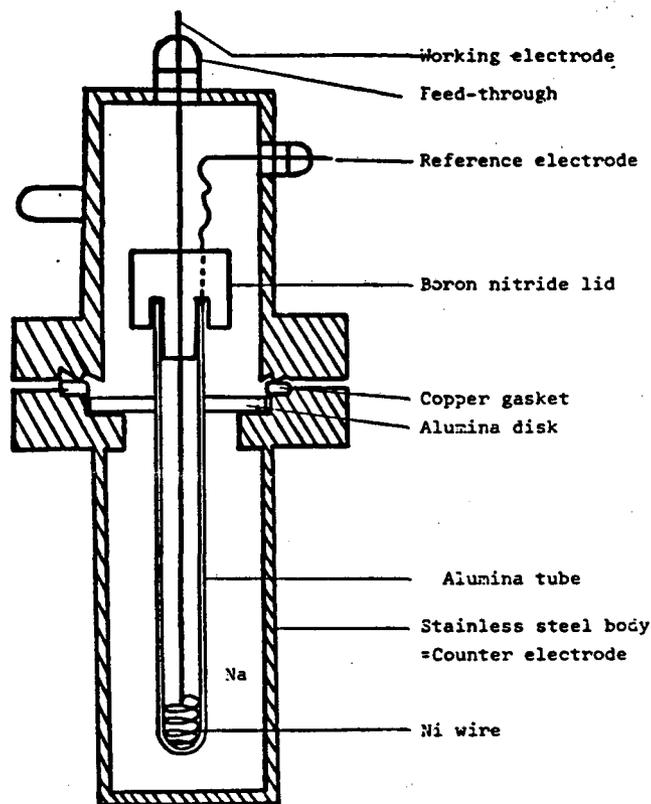
Figure 2. Sodium/Sodium Cell for Electrochemical Measurements

test. The design is shown in Fig. 2. The reference electrode (RE) is a thin nickel wire passing through a boron nitride lid and contacting the top of the electrolyte tube. The wire is sufficiently flexible so that the boron nitride lid is outside of the upper part of the cell during assembly, and slides along the nickel rod into position when the cell is closed. The counter electrode (CE) is the stainless steel body of the cell. The electrolyte tube is attached to an alumina collar with sealing glass.

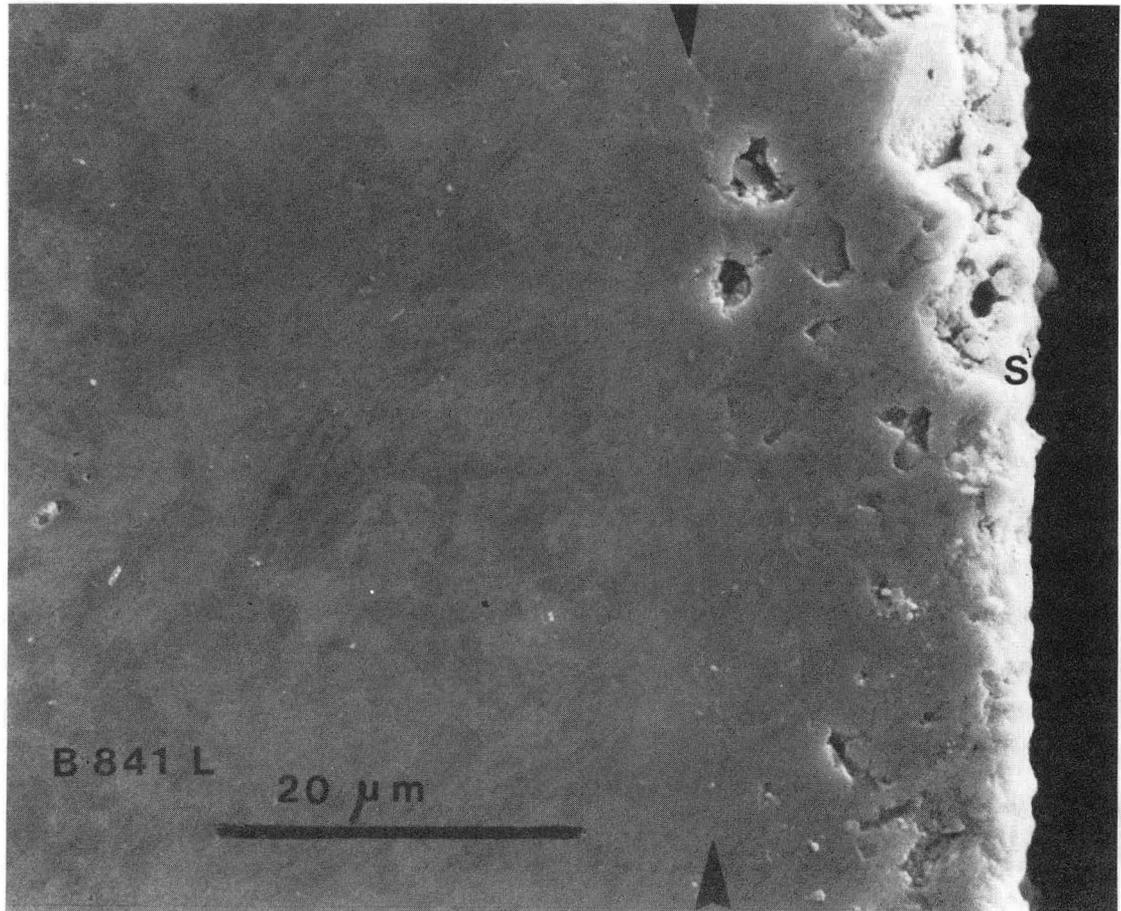
Figure 9. Scanning Electron Micrograph of Layer at Sulfur-Side of Cell B814L

showed some modest attack on the sulfur-side of the electrolyte. In the scanning electron microscope, Fig. 9, a layer with a different microstructure could be observed. This layer had a fairly sharp boundary, as indicated by the arrows in Fig. 9, and appears to have increased porosity. Part of this porosity may be due to pulling out of grains during the polishing operation, where grainboundaries had been weakened by the positive electrode attack. The sharp boundary in Fig. 9 is not clearly a crack, although in the optical microscope it appears as a sharp, darkened line. A similar feature can be observed in the electrolyte in cell A614E, although here the dark line is further away from the sulfur side surface. This feature is shown in Fig. 10 and 11 in optical micrographs, and in Fig. 12 in a scanning electron micrograph. It is thought that these layers may well be the

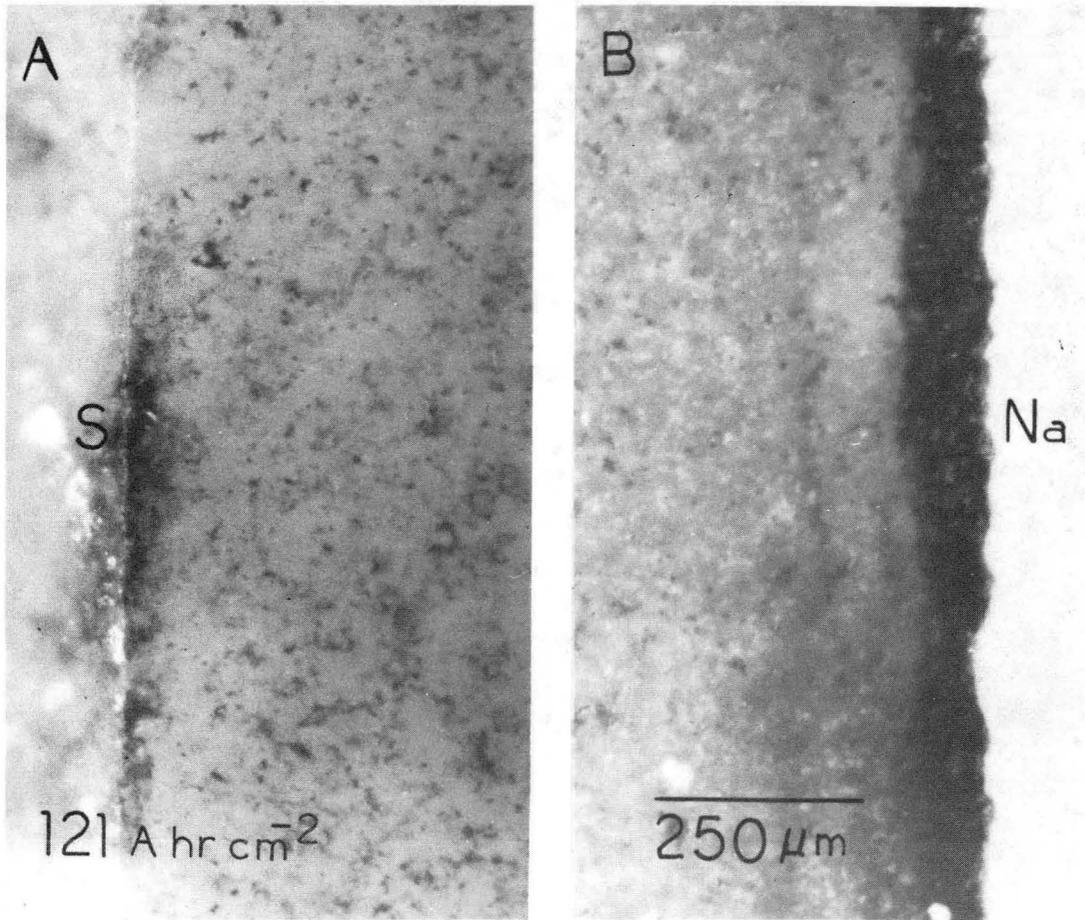
Figure 14. Polished and Stained Cross Section of British Railway Electrolyte Cycled for  $121 \text{ Ah/cm}^2$

Fig. 14 is an optical micrograph showing sulfur side degradation in a British Rail cell cycled for  $121 \text{ Ah/cm}^2$ . A scanning electron micrograph of this degradation is shown in Fig. 15. It appears as if some intergranular corrosion has occurred. In another electrolyte, cycled for  $539 \text{ Ah/cm}^2$  more pronounced degradation on the sulfur side was found, Fig. 16. This time cracks were found in the degradation layer, as clearly revealed by the scanning electron micrograph, Fig. 17.

The British Railways specimen cycled for 121 Ah/cm<sup>2</sup> has a blackened layer at the sodium interface in Figure 14. Figure 25 shows this blackened layer at higher

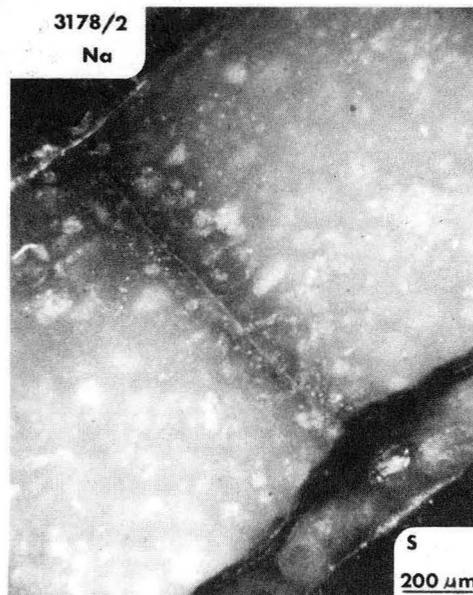
Figure 21. Polished and Stained Cross Section of Cell 3178 Showing a Mode I Crack

Brown Boveri cells 3853 and 2399 show little evidence of sodium-side degradation, and the only feature evident in Figures 3 and 4 is the usual darkened layer. Figure 21 shows a mode I crack penetrating through cell 3178, which was cycled for  $270 \text{ Ah/cm}^2$ . The light spots throughout the electrolyte are subsurface cracks. A gradual increase in resistance was reported for cell 3178, but not for the other cells. This group of cells showed little sign of any degraded layer, and were not examined in the SEM.

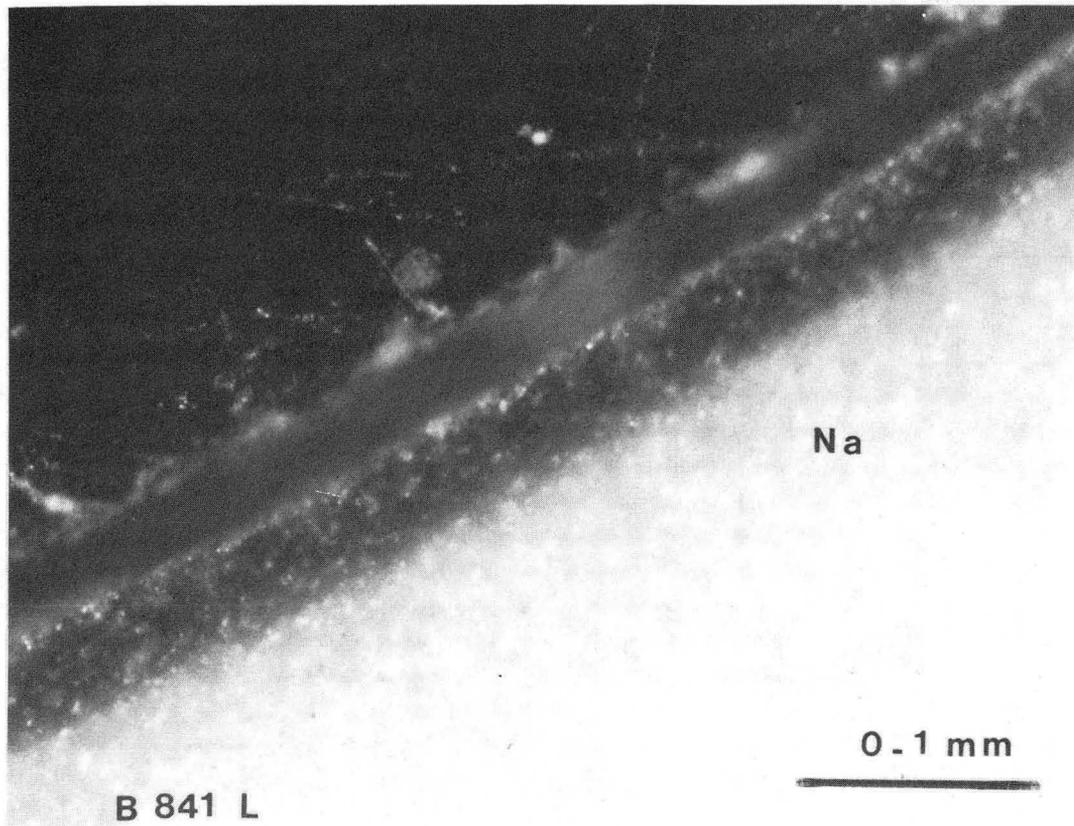
Figure 22. Polished and Stained Cross Section of Sodium Side of Cell B814L Showing "Extra-Darkened" Layer

A second feature appearing in many used electrolytes is a thinner, "extra-darkened" layer at the sodium interface. This layer is not as thick as the darkened layer, and after staining it appears black in the optical microscope. In some cases, careful handling of the specimens is necessary to prevent spalling of this layer, and after polishing on a polishing cloth with diamond paste the layer appears porous due to pull outs. Specimens ground more gently and polished on aluminum or tin with diamond paste reveal in some cases a high density of microcracks at the grain boundaries in this region. During cycling either the grain boundaries may be severely weakened so that they crack during polishing, or microcracks may form in-cell. The usual darkened layer appears in specimens immersed in molten sodium even if no current is passed, but the "extra-dark", layer is only observed after passage of current for extended times. When microcracking is observed, the development of such a surface damage layer can be interpreted as a progressive type degradation that weakens the electrolyte from the sodium side.

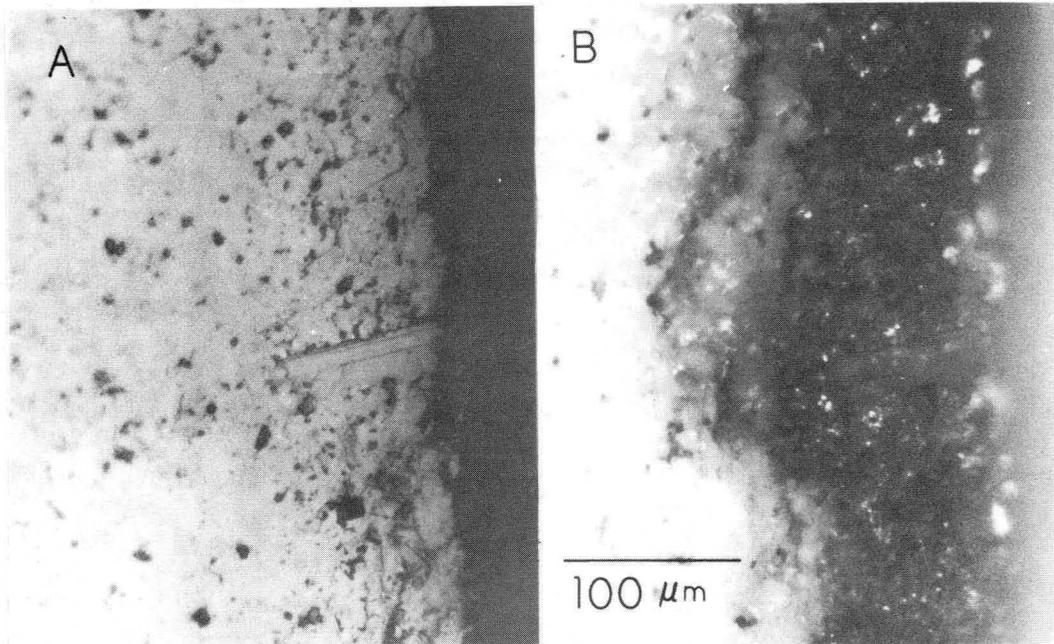
Figure 26. A and B Detail of Sodium Side Degradation of  
Figure 25

- A. Large Grain Visible with Reflected Light
- B. Degradation Visible With Polarized Light

magnification, and in a detail of this area, Figure 26, A and B, a region of enhanced degradation is seen to correspond to a large grain at the surface. In Figure 27 degradation proceeds along the boundaries of large grains in another detail of this region. In the SEM, Figure 28 this surface layer has many microcracks at the grain boundaries. Figure 16 shows a crack parallel to the surface by the darkened layer in a specimen tested for  $539 \text{ Ah/cm}^2$ . A specimen tested to  $414 \text{ Ah/cm}^2$  shows a similar crack in Figure 29. Figure 30 shows the blackened region of this electrolyte in greater detail. A crack runs parallel to the interface, and only in a few places does it meet the sodium interface. It does not seem to be a typical mode I crack. An Auger study of the composition near the surface detected almost two atomic per cent calcium, as shown in Figure 31 along with a micrograph of the surface. The crack is again visible in this micrograph. There was also about one percent silicon in this specimen. These impurities, particularly the calcium, create a layer of lower ionic conductivity

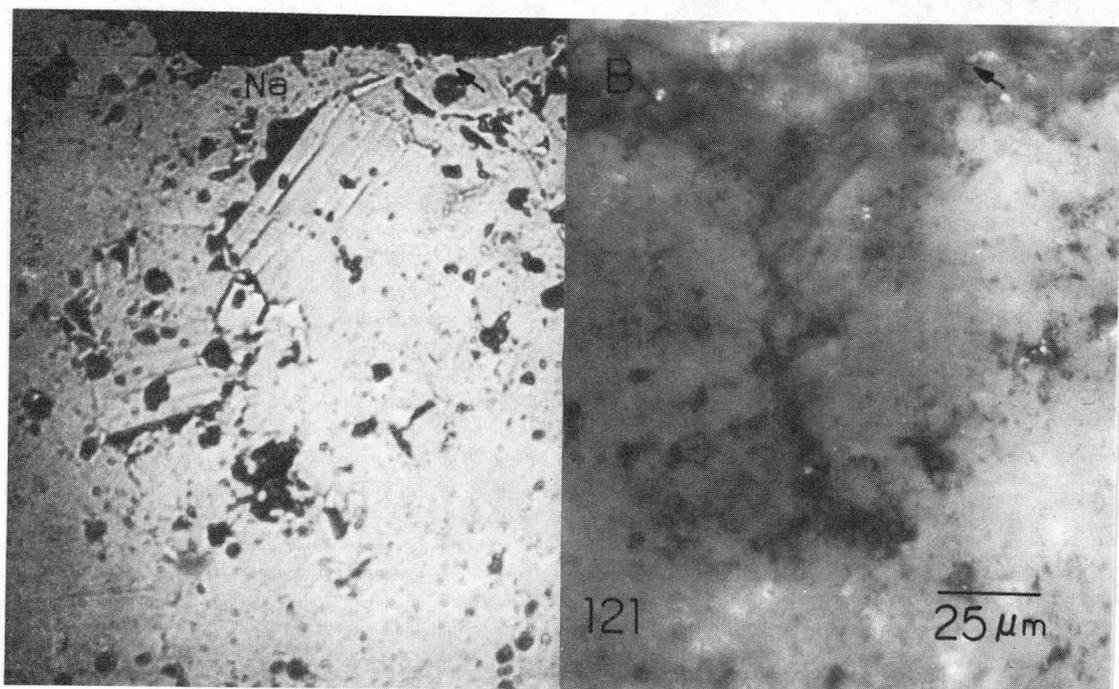
Figure 27. Detail of Sodium Side Degradation in Cell First Shown in Figure 14

- A. Large Grains, Normal illumination
- B. Cracks Following the Boundaries Of The Large Grains, Polarized Light

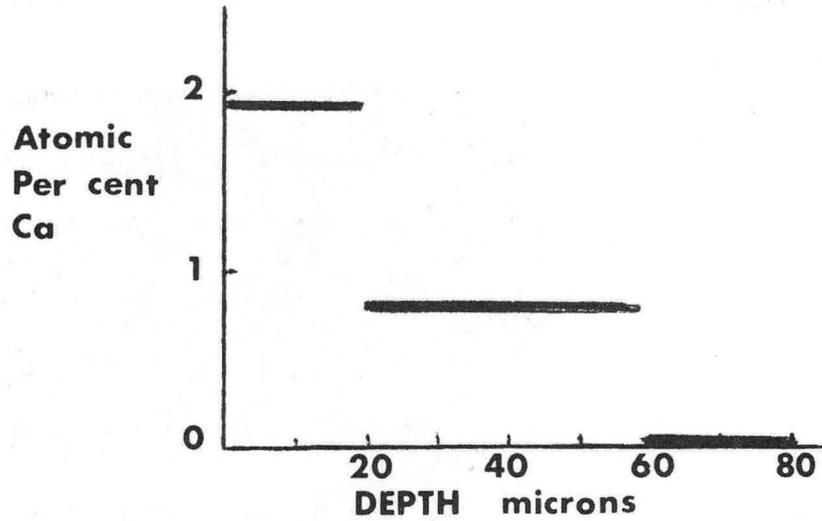
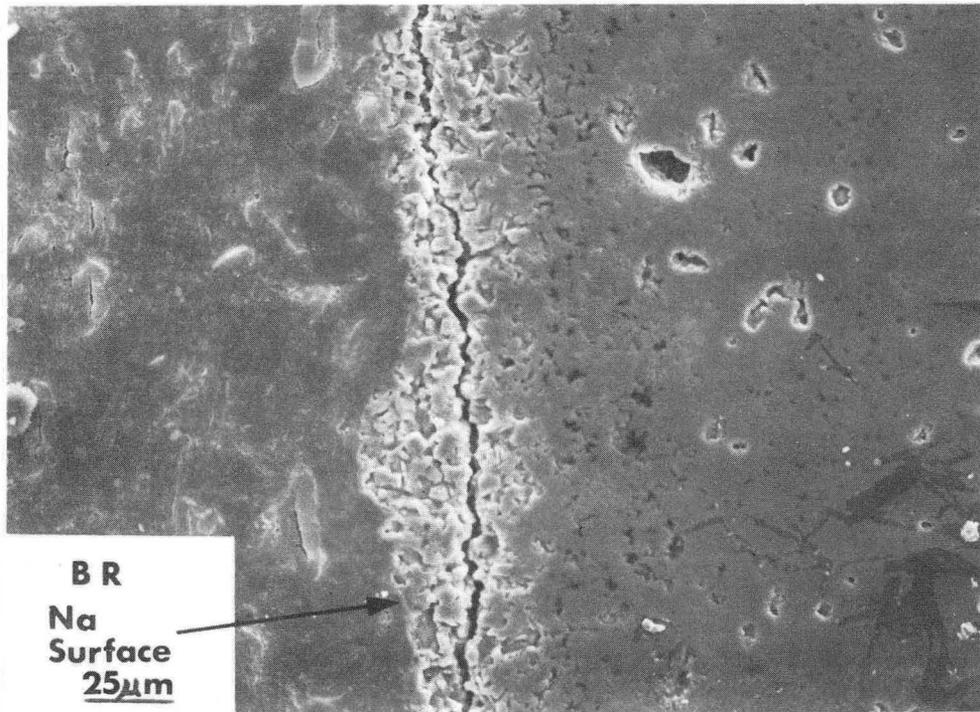
Figure 31. Scanning Electron Micrograph of Na Side Of Electrolyte First Shown In Figure 29 With Crack Parallel To The Interface, And Ca Concentration Near The Surface

and contribute to mode II degradation as described above. The crack may be related to localized mode II cracking caused by the calcium in the surface of the electrolyte.

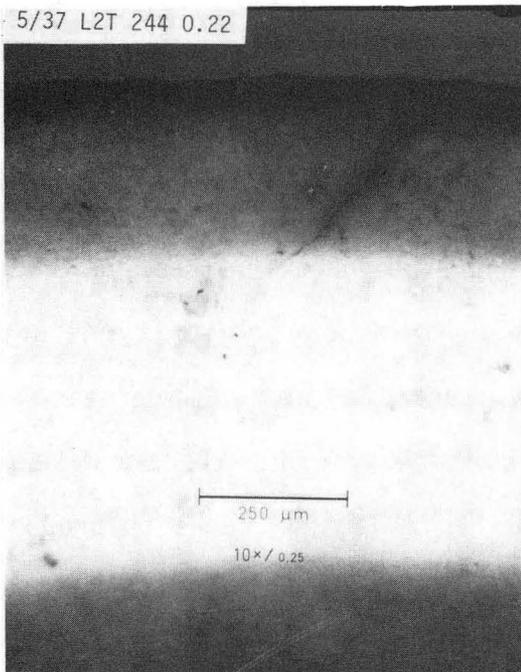
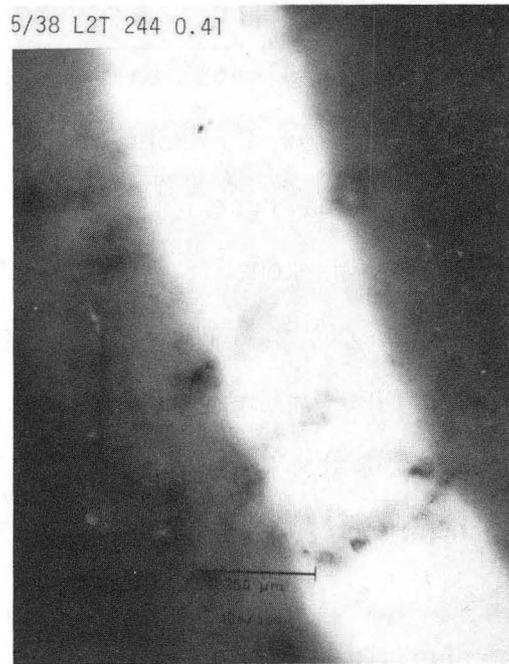
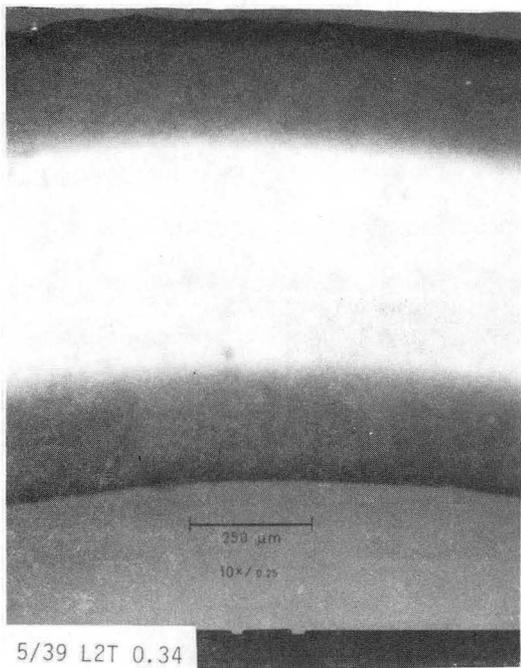
Figure 33. Polished and Stained Cross Sections of CGE Electrolyte

Cells from Compagnie Generale d' Electricite had been tested for 1,000 hours at  $100 \text{ mA/cm}^2$ , for a total charge passed of  $100 \text{ Ah/cm}^2$ . The tubes were operated unidirectionally with the inside as the sodium entrance surface and the outside as the sodium exit surface. Three typical results are shown in Figure 33. The crack

in cell 5/37 is similar to a mechanical crack, but the more intense darkening around the crack indicates that it was present while the cell was being tested. Cell 5/38 has several cracks penetrating throughout the electrolyte, but the staining is more diffuse. Cell 5/39 shows no evidence of mode I cracking. The cells also have darkened layers on both the entrance and exit sides, and blackened layers on the exit sides. In figure 34, there is a crack which turns and runs parallel to the surface of the cell. Such cracks may be fed more readily with sodium than cracks perpendicular to the surface, or the electrolyte may be weakened near the surface but not in the middle, allowing cracks to propagate in this direction at lower stress intensity factor. Figure 35 shows a narrow spot in the darkened layer on the sodium exit side. Figure 36 shows another uneven darkened layer in the electrolyte from cell 5/46. The darkening did not penetrate as far in one spot on the sodium exit side, and in this spot is a large crack, seem to be traversing the entire electrolyte, but without a stained region

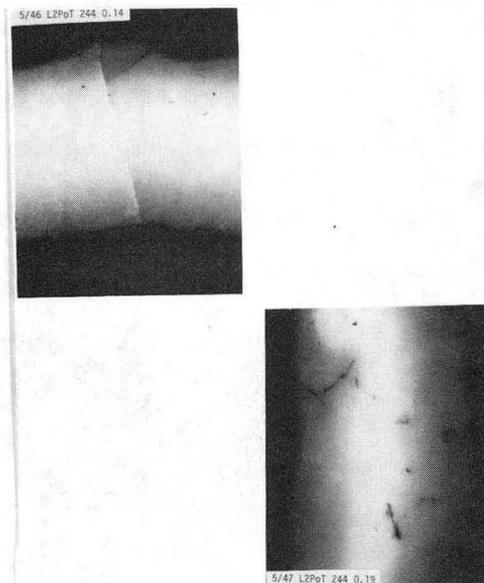
Figure 36. Polished and Stained Cross Section, Cells 5/46 and 5/47 Mode I crack in 5/46 originates in narrow spot in darkened layer.

around it, meaning that it was not exposed to molten sodium, but was formed during sectioning or grinding of the electrolyte. Thus this region is a preferential site for mode I degradation and for mechanical cracking. Cell 5/47 also shows mode I degradation in Figure 36. Near the bottom and on the upper left side of the picture a mode one crack passes through the plane of sectioning. These cracks are long and narrow, ribbon-shaped, taking an irregular path through the electrolyte. In Figure 37 another mode I crack in electrolyte 5/37 appears to end at the end of the darkened region, but it may only leave the plane of sectioning. A specimen from cell 5/37 was repeatedly ground, polished, and photographed to determine the path of cracks through the electrolyte. In Fig. 38 the upper crack appears to end in sections 1, 3, or 4, but in section 2 it penetrates entirely through the electrolyte. Fig. 39 shows the darkened layer at the sodium exit surface and a crack running through the plane of sectioning for electrolyte 5/37. Fig. 40 evidences degraded region with a few grains pulled out

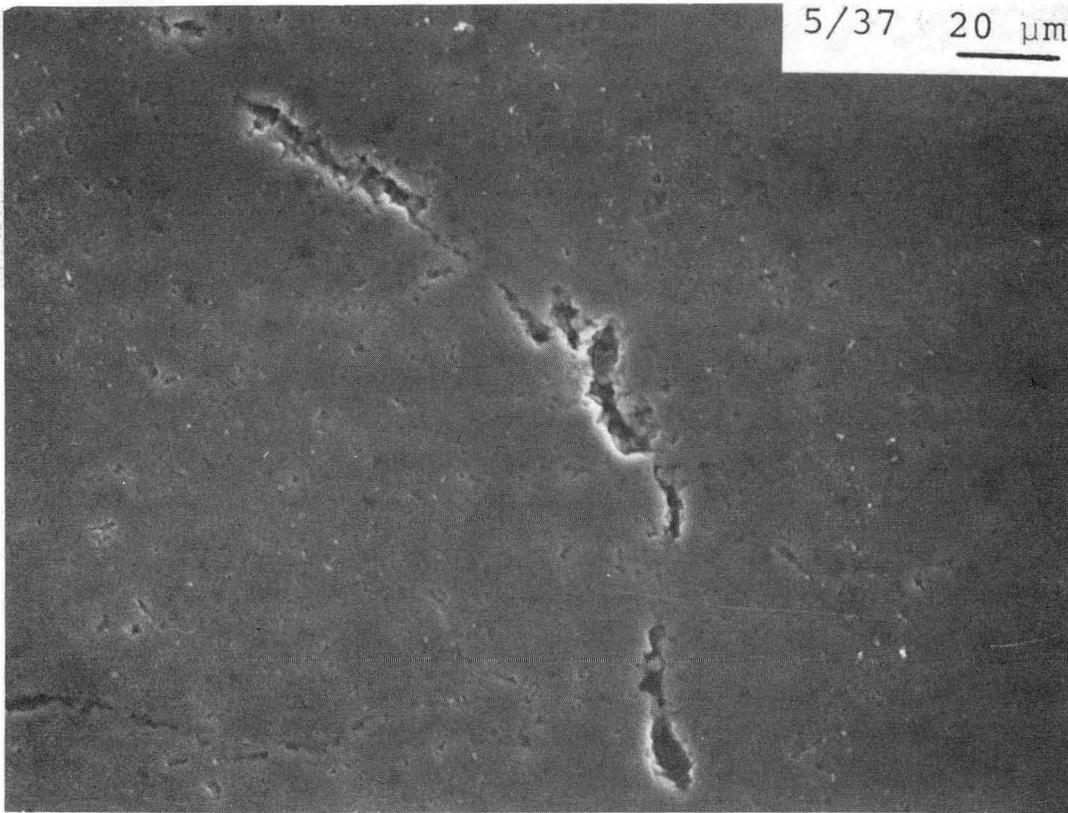
Figure 41. Higher Magnification Of Crack First Shown in Figure 39

polishing. The crack is shown at a higher magnification in Fig. 41, and over most of its length has a width of around one micron. The lower right of the crack, Fig. 42, at higher magnification, shows clearly that material has been removed from the inside of the crack.

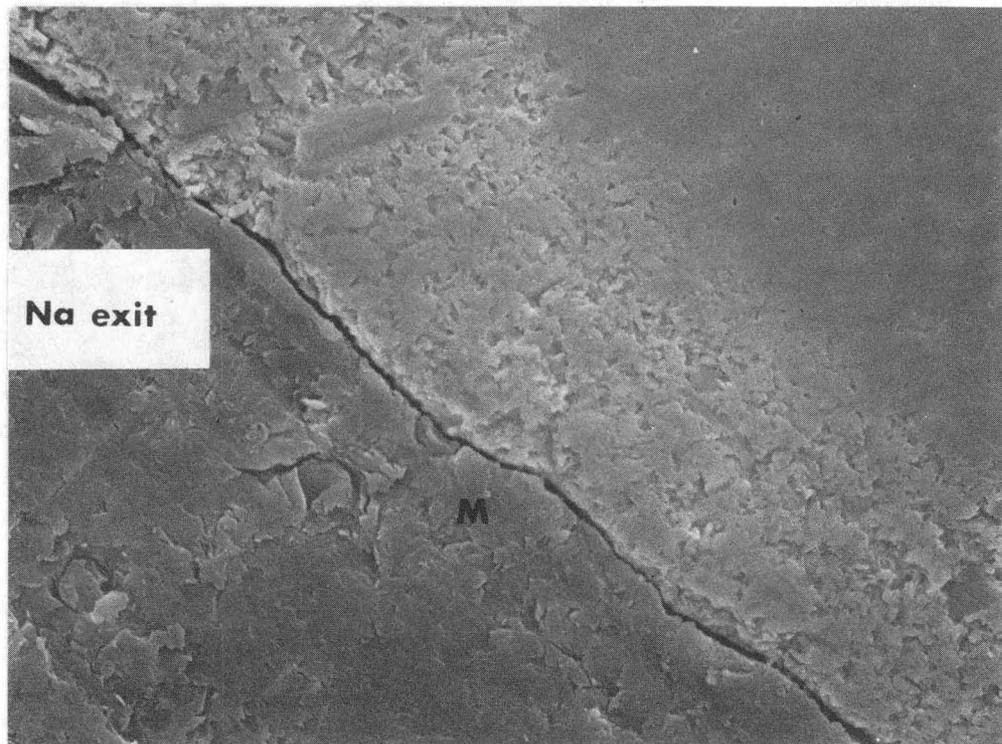
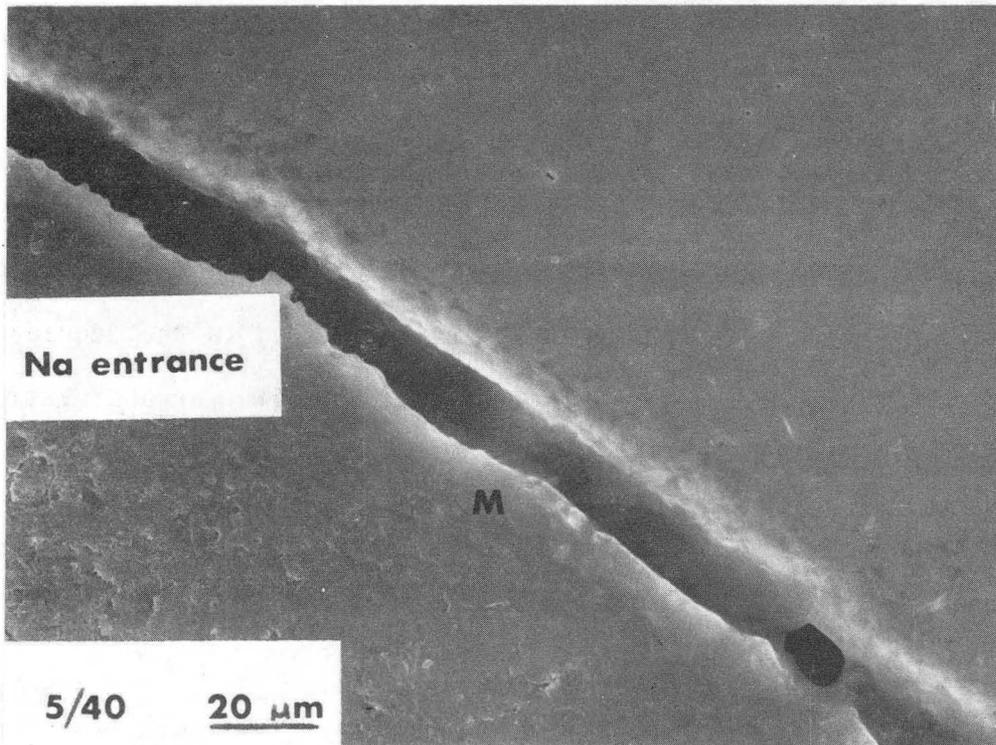
Figure 44. Scanning electron micrograph of cell 5/40 showing intergranular attack on the sodium exit side but not on the sodium entrance side.

Examination of the "extra-darkened" layer in the scanning electron microscope, Fig. 43, shows intergranular attack, as was observed in some of the sodium/sulfur cells. The sodium exit and entrance surfaces of cell 5/40, tested unidirectionally, are compared in Fig. 44. While there is substantial intergranular attack on the exit side, there is little or none on the sodium entrance side. This observation excludes the argument that atmospheric corrosion after removal of the electrolyte from the cell and subsequent storage would have caused the degraded layer, since the degradation is different for both sides.

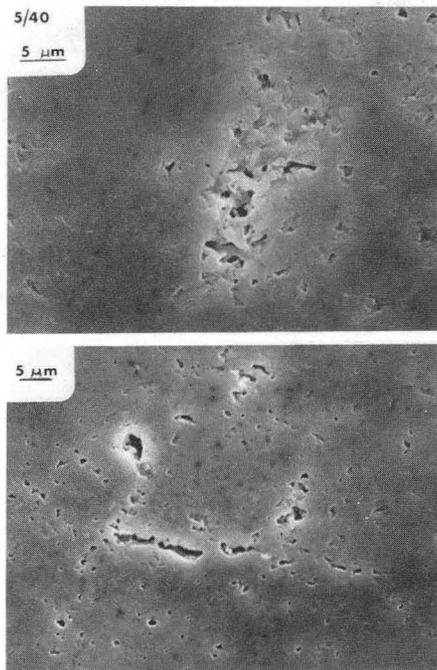
Figure 48. Porous Regions in Cell 5/40

Regions of high porosity, such as Figure 48 were found in cell 5/40 in the SEM. It was not possible to correlate these regions with degradation of the electrolyte. Figure 49 shows a silicon rich inclusion in cell 5/37, and analyses of the inclusion, the light colored ring around it, and the bulk of the electrolyte are given in Table 1. X-ray analysis indicates that the region around the inclusion contains no silver, indicating no exchange occurred, and it does not appear dark in the optical microscope, Figure 50. Also there are cracks in this region connecting to the silicate phase inclusion. Thus it may be similar to the unstained regions of cells 5/73 and 5/46 in Figures 35 and 36. Further grinding of cell 5/73 revealed an inclusion similar to that in Figures 49 and 50 but much larger. Clearly, inclusions can be failure origins.

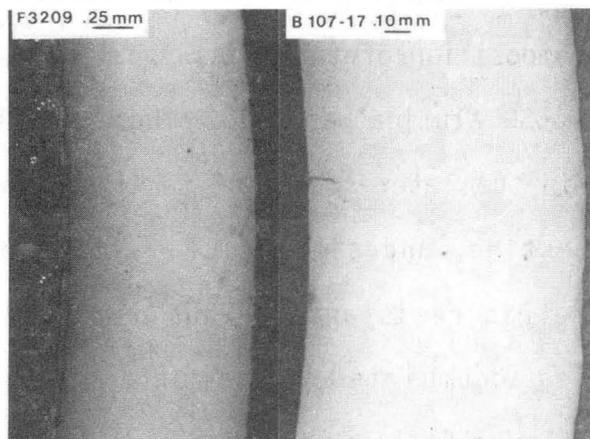
Figure 52. Polished and Stained Cross Sections, Electrolytes F3209 and B107-17

Two cells that had no electrolyte failure, but in which glass seals in the cell failed, are shown in Figure 52. Cell B10717 had  $15 \text{ Ah/cm}^2$  charge transfer, and cell F3209 had  $920 \text{ Ah/cm}^2$ . Neither electrolyte has cracks visible in the optical

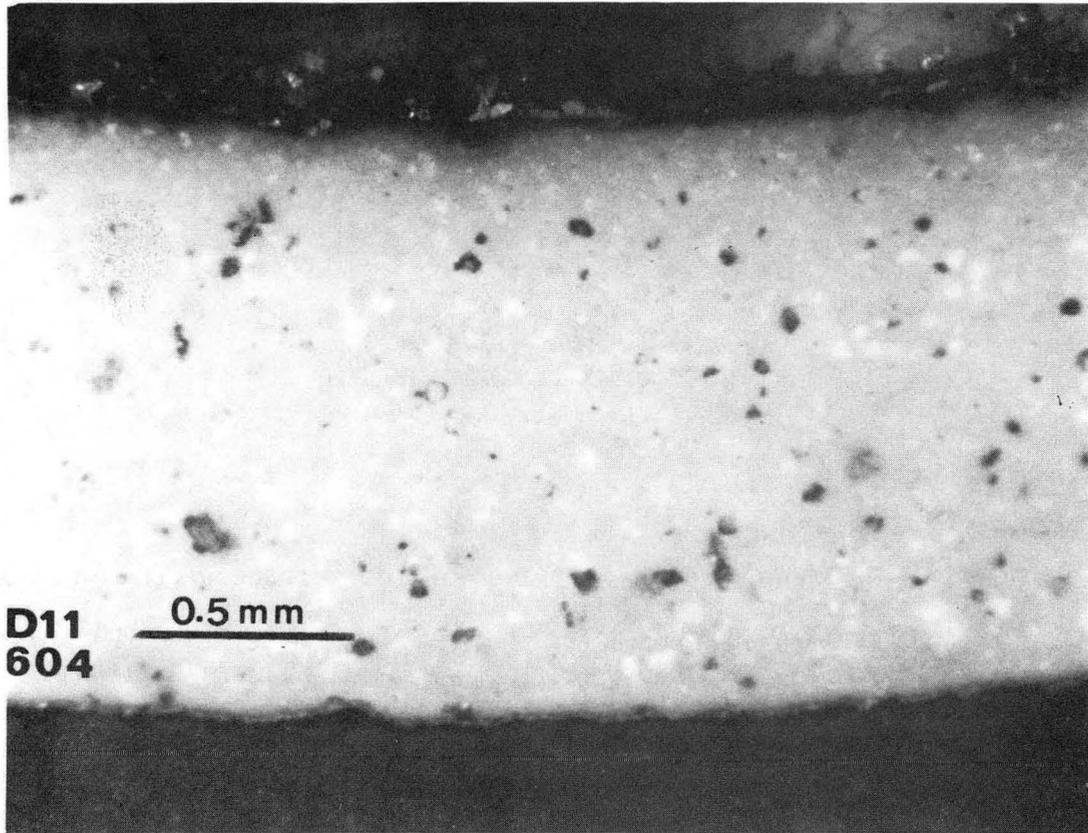
Figure 54. Polished and Stained Cross Section, Cell D11604

microscope. Figure 53 shows a degraded layer at the surface of cell F3209 in the SEM. Cell D11604, Figure 54, had a total charge transfer of  $3610 \text{ Ah/cm}^2$ , and after 2200 hours of operation it was disassembled because of seal rupture. After this it was reported to have a 40% asymmetry in cell resistance. The electrolyte shows some evidence of degradation, but no mode I cracks were found. Cell E6123, Figure 55 had increasingly asymmetric resistance during operation. It was operated for a total of  $1140 \text{ Ah/cm}^2$ , and at the end of operation, the resistance during emptying was 70% higher than the resistance during filling. There is some darkening at the surfaces, indicating degradation. Figure 56 shows surface degradation in the SEM. After a charge transfer of  $690 \text{ Ah/cm}^2$ , many cracks through the electrolyte are visible in cell V69 F206, Figure 57. The surface degraded layers of electrolytes from cell F206 and E6123 have been compared in Fig. 58, It is clear that the poorer performing electrolyte, F206, had more extensive surface layer damage after  $690 \text{ Ah/cm}^2$  than the better performing one, E6123, after  $1140 \text{ Ah/cm}^2$ . It is likely that the MgO contents had a role in this difference.

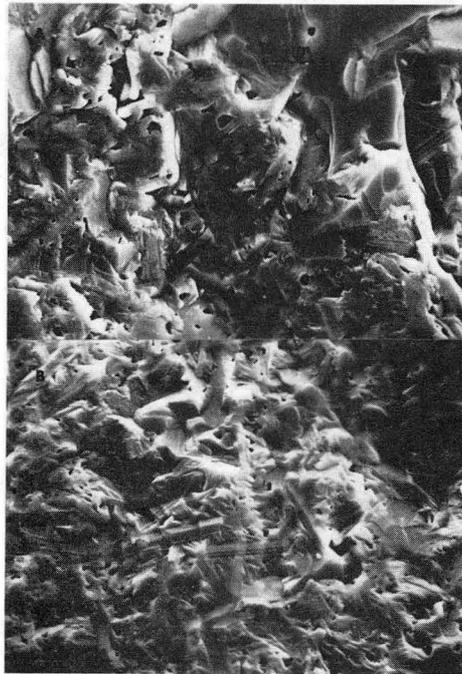
Figure 60. Scanning Electron Micrographs of Surfaces Produced by (A) Electrolytic Degradation and (B) Mechanical Fracture

then stained in silver nitrate solution, coloring the surface that had been exposed to Na dark brown. Then the electrolyte was broken, revealing stained surface that had been produced by mode I degradation, Fig. 60A and unstained surface produced by mechanical fracture, Fig. 60B. In both cases in Figure 60 fracture is largely intergranular or follows the 00.1 conduction planes of the grains, and the surface produced by Mode I degradation at high current density does not differ from that produced by mechanical fracture. It is difficult to distinguish between these two possibilities from the investigation of fracture surfaces.

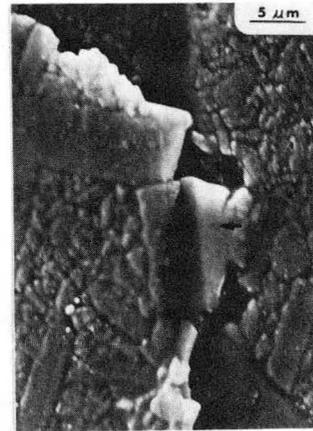
Figure 62. Higher Magnification of Grain Cleaved on the Conduction Plane

The crack of Figure 61 was produced by a Vickers hardness indenter in a specimen of electrolyte that had been thermally etched to reveal the microstructure. Most of the crack seems to follow the grain boundaries, but the arrowed grain in figure 62, enlarging a crack detail on the indented surface, is cleaved on the conduction plane.
