X-RAY EXAMINATION OF SQUARE WATER-COOLED COPPER MAGNET-CONDUCTOR BRAZE JOINTS

International Symposium on Magnet Technology
Stanford University, Calif. Sept. 8-10, 1965

Richard A. Nickerson

September 1, 1965

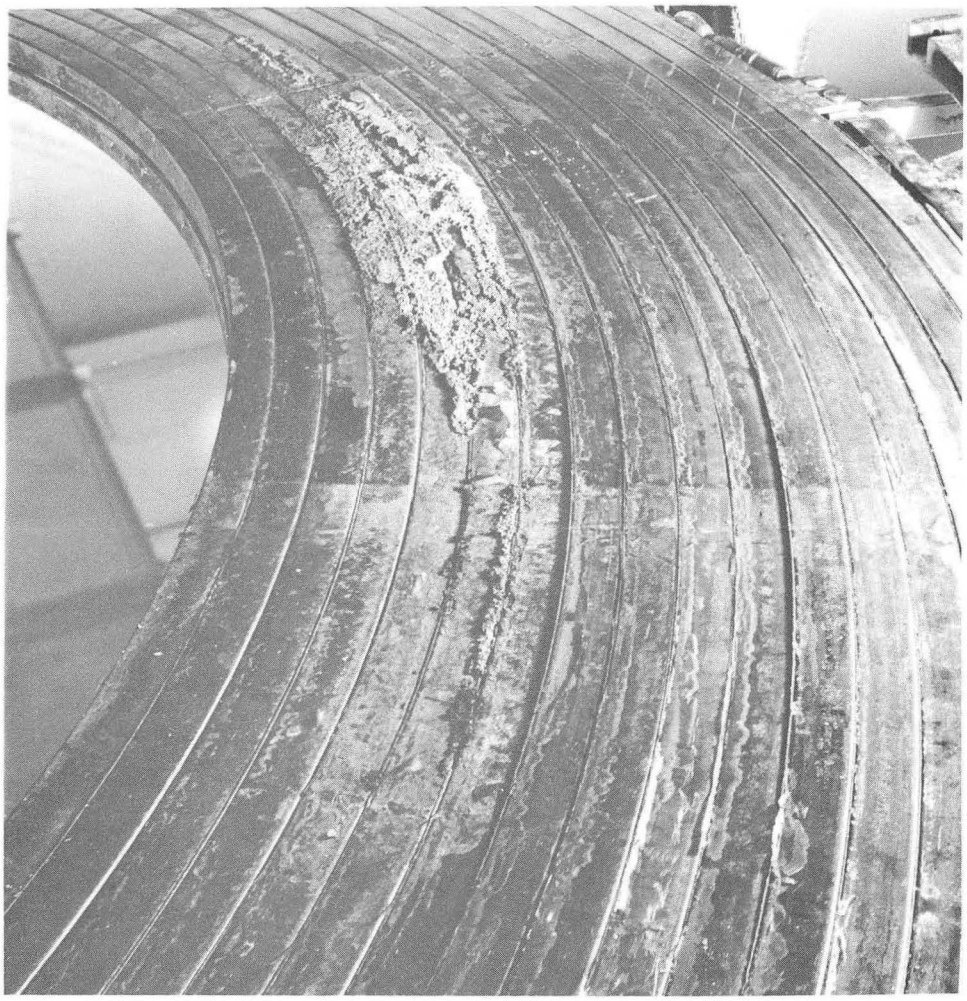
The failure of these splice joints to withstand the plastic deformation required to wind them into coil structures, or the possible leakage of cooling water either into the coil insulation or to vacuum systems, has forced careful consideration of their design, fabrication, and inspection.

Fig. 1. Magnet Conductor joint failure.

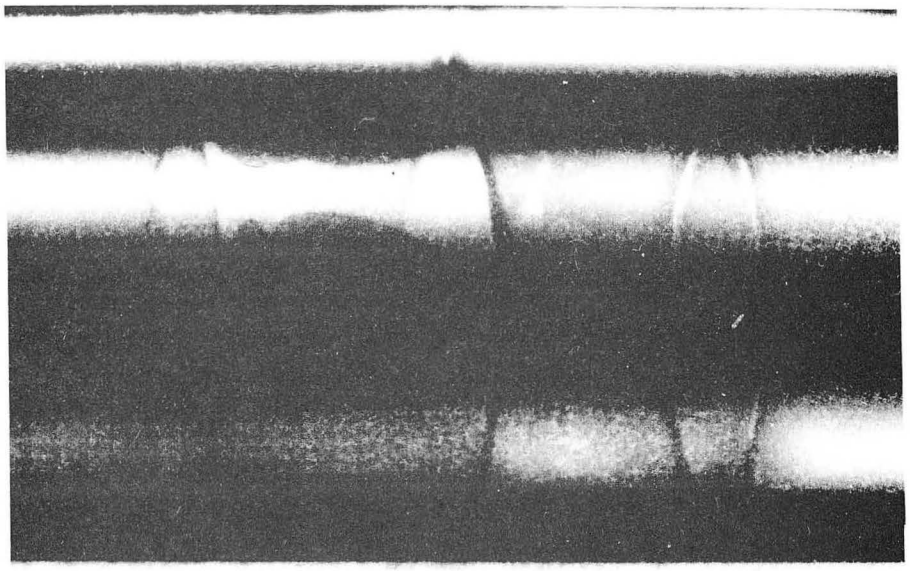
ZN-5104

What happens in all too high a percentage of the time is that instead of our ideal surface-tension picture we have rivers of alloy flowing through the capillary, leaving voids which are more easily by-passed than caused to be wetted, resulting in a joint as seen in Fig. 5.

The boiling (caused by exceeding 1200°F for ASTM Type 4) need not cause defective joints--but, if the technician does not appreciate that the phenomenon is taking place, it most certainly will cause defective joints. When boiling occurs the cadmium vapor expels liquid solder from the joint and produces a vapor-filled bubble. As the temperature falls below 1200°F where these bubbles are, the cadmium vapor will condense. The bubble will attempt to contract but a frozen surface may prevent liquid feed. The result will be voids (containing a vacuum), which are readily observable in radiographs, occurring on the upper surface of cylindrical areas, since the bubbles rise through the molten solder to the top of the cylinder.

Fig. 5. Radiograph of improperly made joint.
(positive print from radiograph)

More careful withdrawal of heat from the finished joint through the range 1200°F to 1145°F will assure a supply of liquid solder to these contracting bubbles and a sound, void-free joint can result.
