UCRL-19465
Preprint

ENGINEERING STUDY OF RADIOLOGICAL FIRE PREVENTION AT LAWRENCE RADIATION LABORATORY, BERKELEY, CALIFORNIA

January 1970

LAWRENCE RADIATION LABORATORY
UNIVERSITY of CALIFORNIA BERKELEY

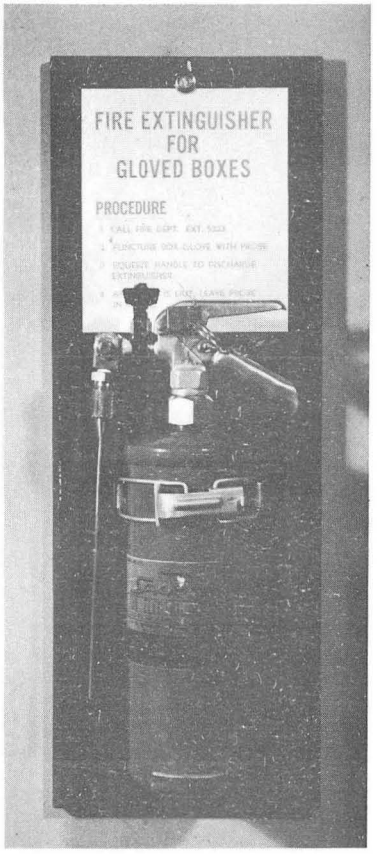
Fig. 1. Glove box fire extinguisher.
(XBB697-4673)

Fire extinguishers for glove boxes were tested and one was selected and modified for use. This unit does not cause adverse pressurization of the glove box, nor is recovery of rare radioisotopes hindered.

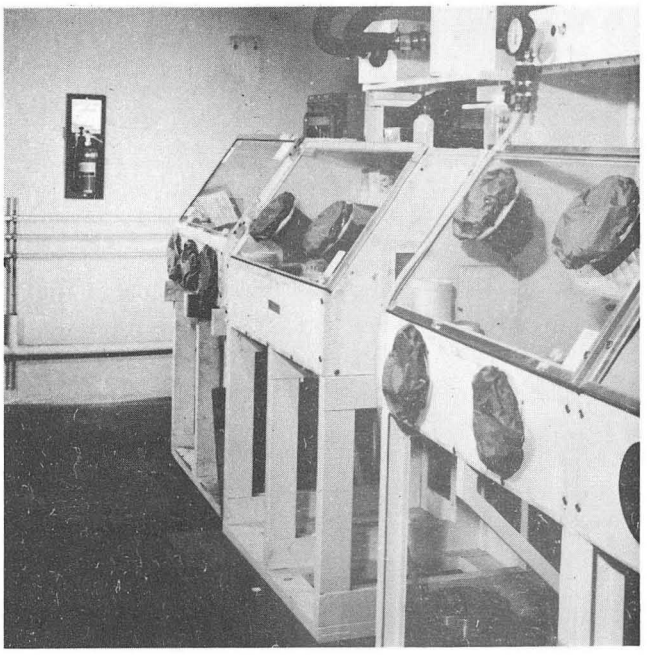
Fig. 2. Extinguisher near glove boxes.
(XBB697-4673)

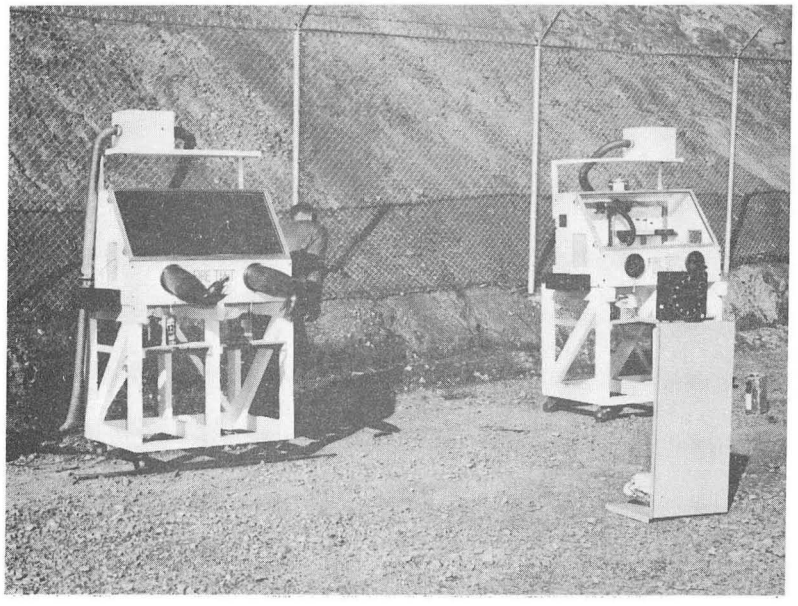
In the early portion of the tests, difficulty was experienced in trying to maintain a fire inside the enclosure (see Fig. 3). The low air flow rate used (5-15 cfm) was inadequate to keep a fire burning. After several false starts, a fire was sustained by partially opening a side door on the enclosure, and thus increasing the air flow.

Fig. 3. Setup for fire tests, internal fire just started. (Health Pro 805)

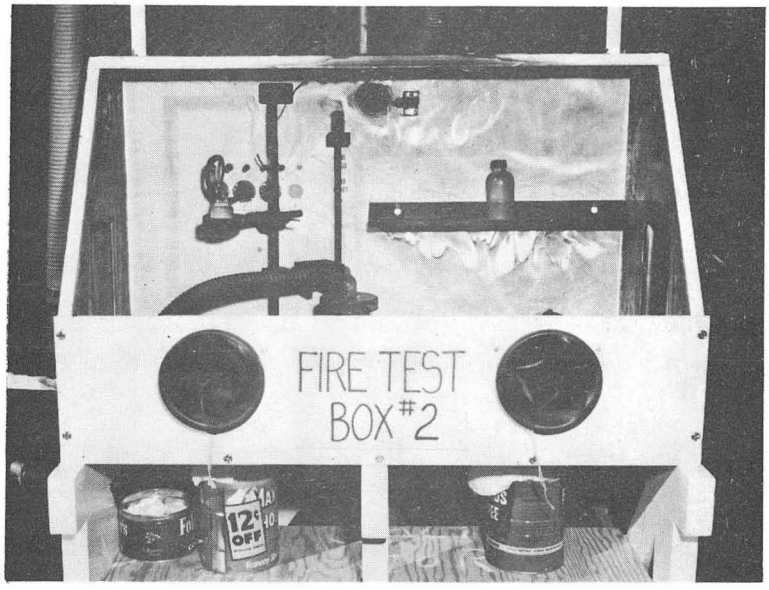
Results of the test are shown in Figs. 4 and 5. The asbestos-millboard box was almost intact.

Fig. 5. Asbestos-millboard box after internal fire. (Health Pro 803)

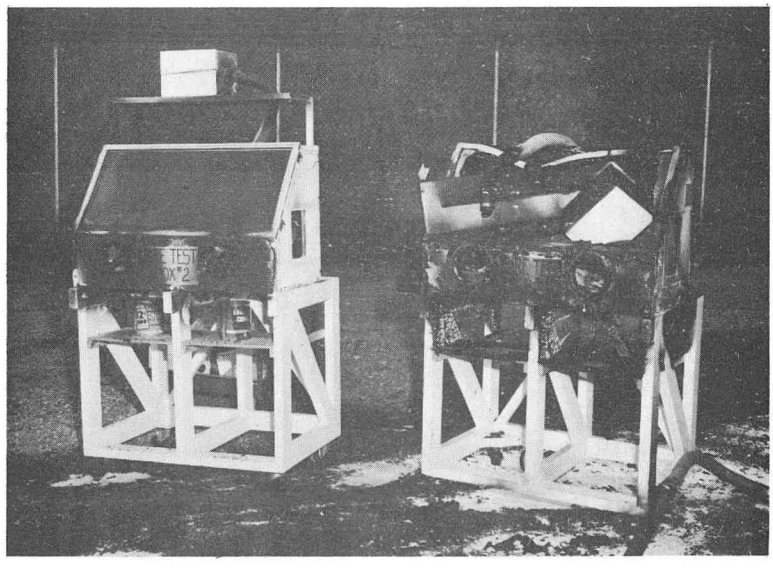
Thereafter, external fires were started on each of the boxes. The results are shown in Fig. 6.

1. Under normal air flow conditions (5-15 cfm), an internal box fire could not sustain itself.
2. An internal or external box fire did not materially damage a box constructed of asbestos millboard.
3. The box gloves were destroyed in an external fire.
4. The safety-glass window (box No. 2) was damaged.

Fig. 6. Asbestos-millboard box (left) and standard plywood box (right) after external fire test. (Health Pro 811)

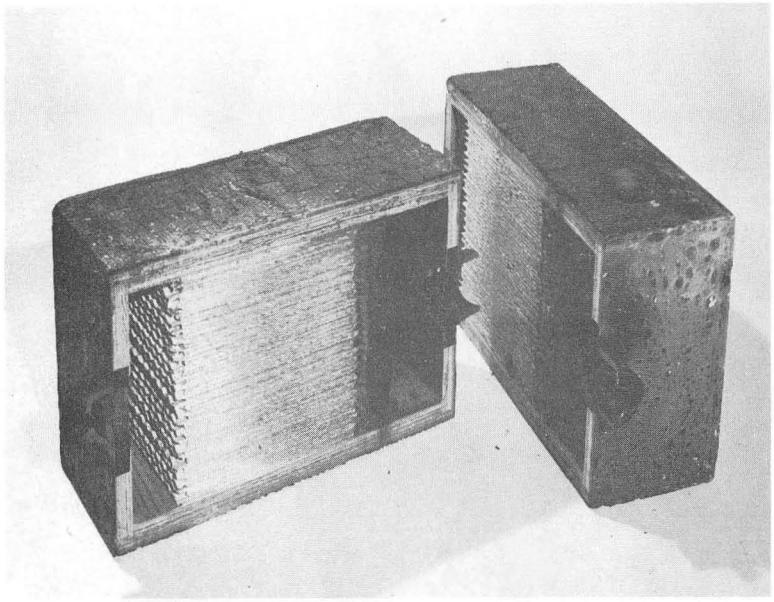
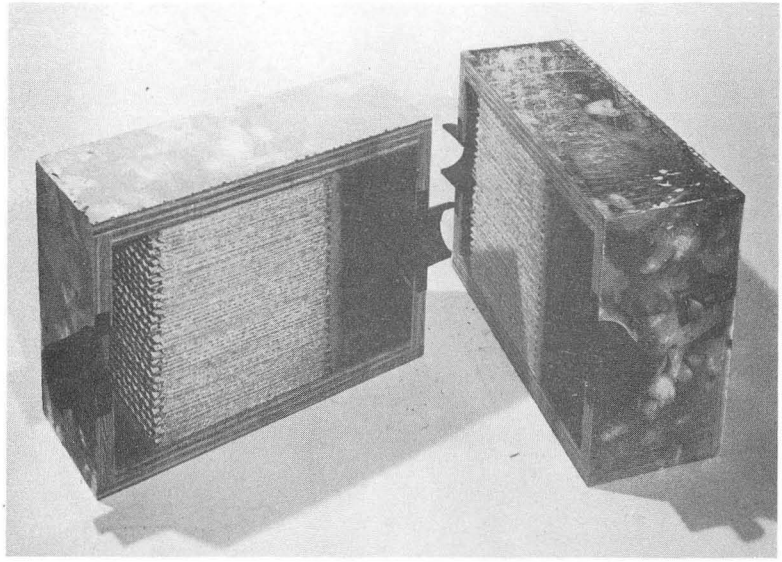
Filter units were used to ventilate the glove boxes in the first fire tests. Figure 7 shows Filter 1 (upper) used with box No. 1--standard plywood; Filter 2 (lower), used with box No. 2--asbestos-millboard.

Note that the interiors of both filters appear to be in good shape. DOP filter testing was not done, since the equipment was not available at that time.

Fig. 7. High-efficiency filter from:
(upper) standard plywood box, (Health Pro 815)
(lower) asbestos-millboard box. (Health Pro 816)

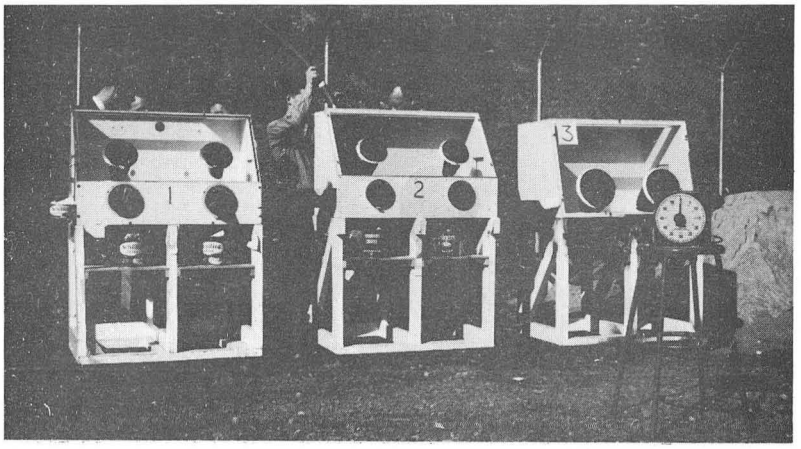
(upper: Health Pro 818)

The sequence of events is shown in Figs. 8 and 9. Note in Fig. 8b that the rubber gloves rapidly ignited and formed the first breach in the enclosures. Note in Fig. 9 that the surface of the Plexiglas windows ignited.

1. Rubber gloves were the first component to fail.

Fig. 8. Box 1: Standard plywood construction, unframed Plexiglas window

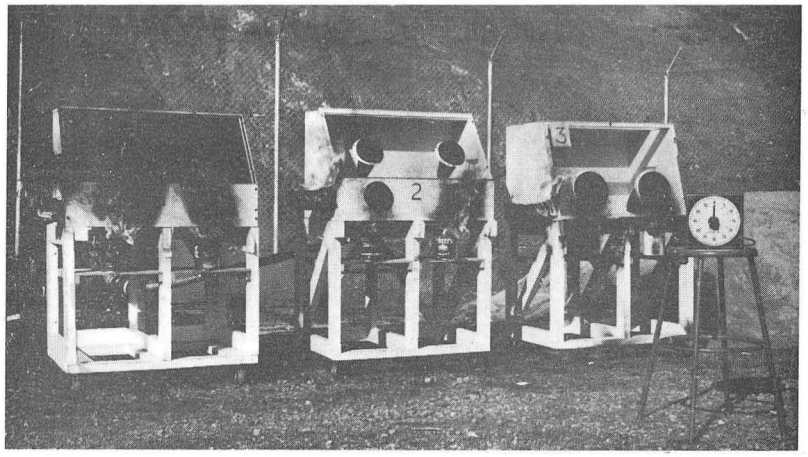
(middle: Health Pro 821)

2. Plexiglas windows burned on the surface (boxes 2 and 3) but did not burn through after 20 minutes' exposure to fire.

Fig. 8. Box 2: Asbestos-millboard box with metal-framed Plexiglas window

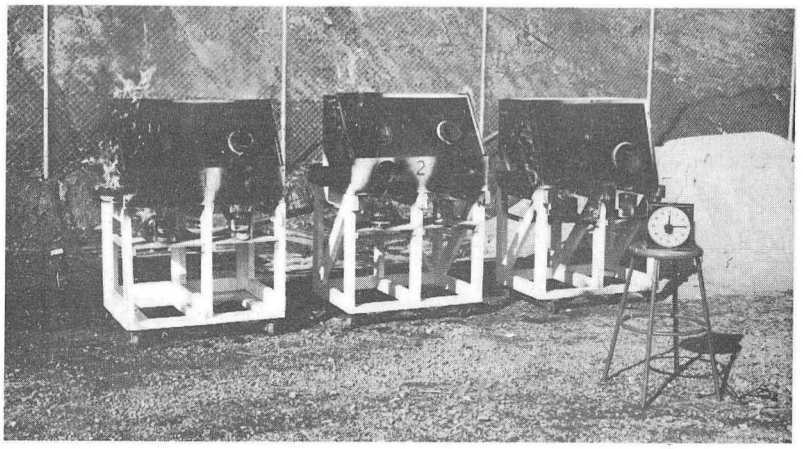
(lower: Health Pro 822)

Fig. 8. Box 3: Full-view box constructed of asbestos-millboard.

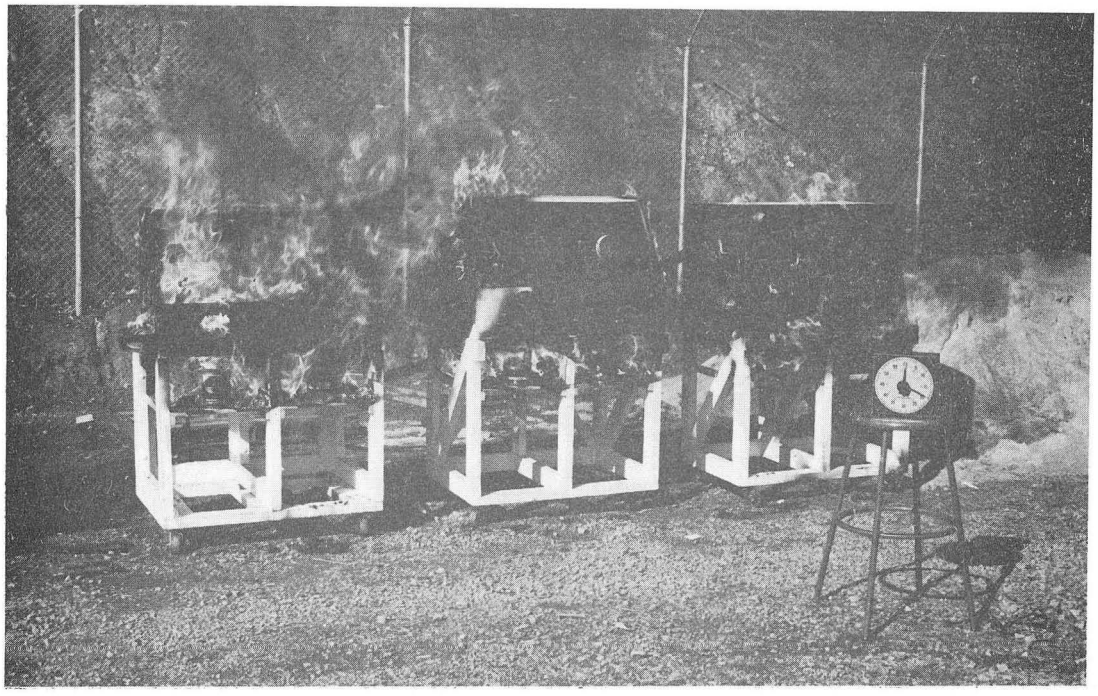
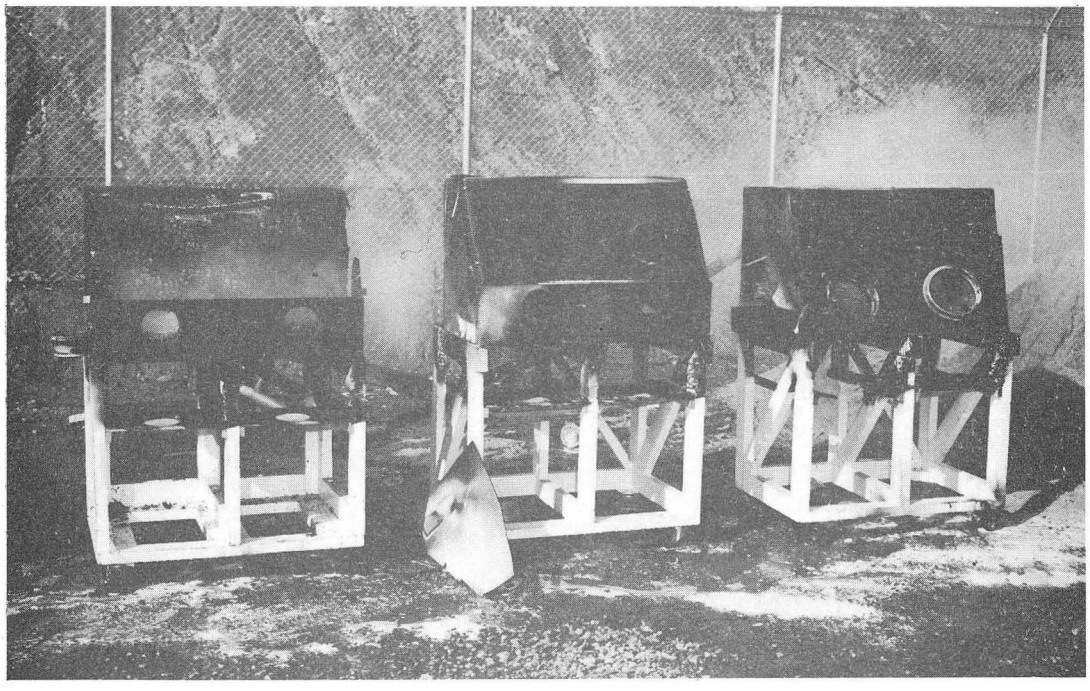
Fig. 9. Conclusions of external fire tests. (upper: Health Pro 823)

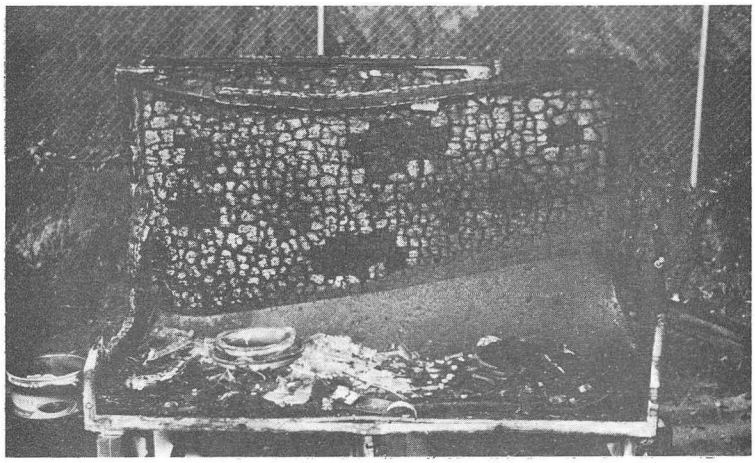
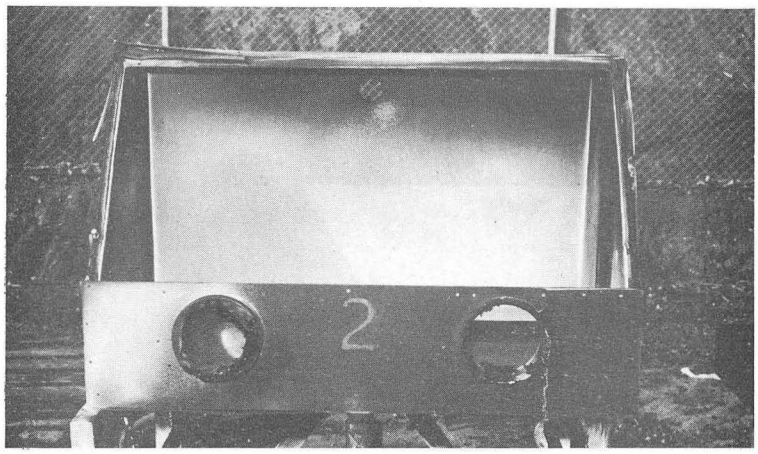
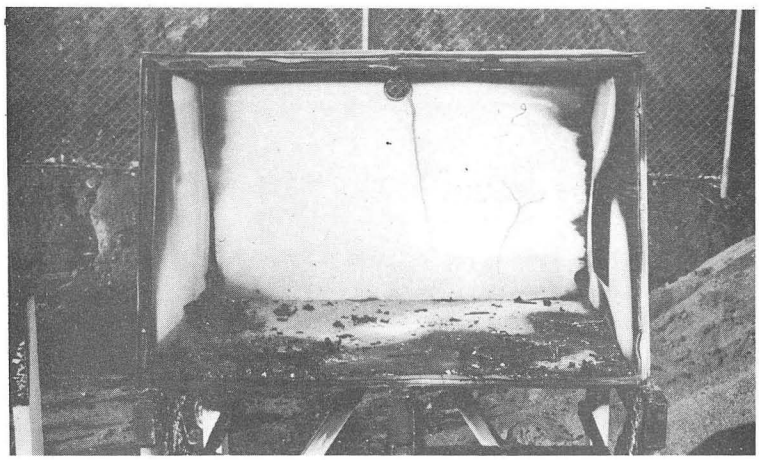
Fig. 10. Results of external fire on (a) standard plywood box, (b) asbestos-millboard box, and (c) full-view box.

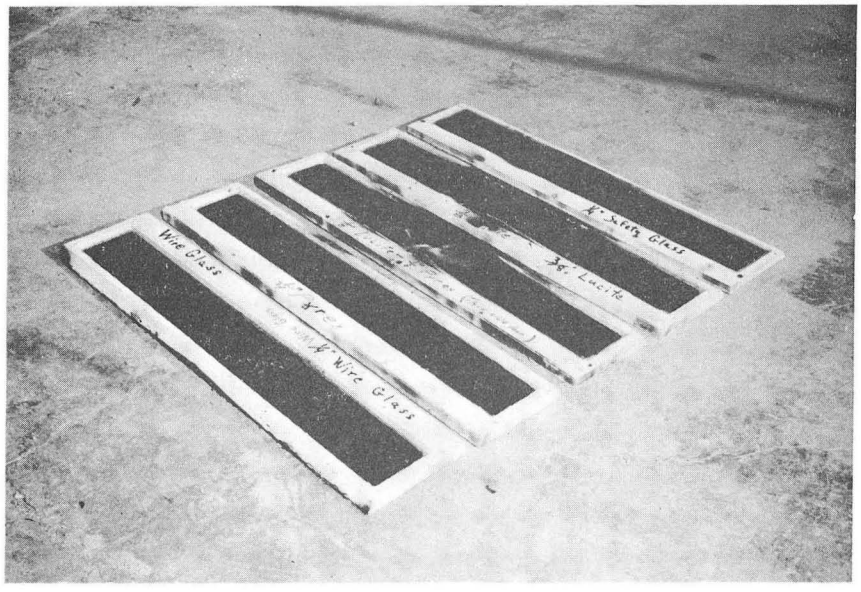
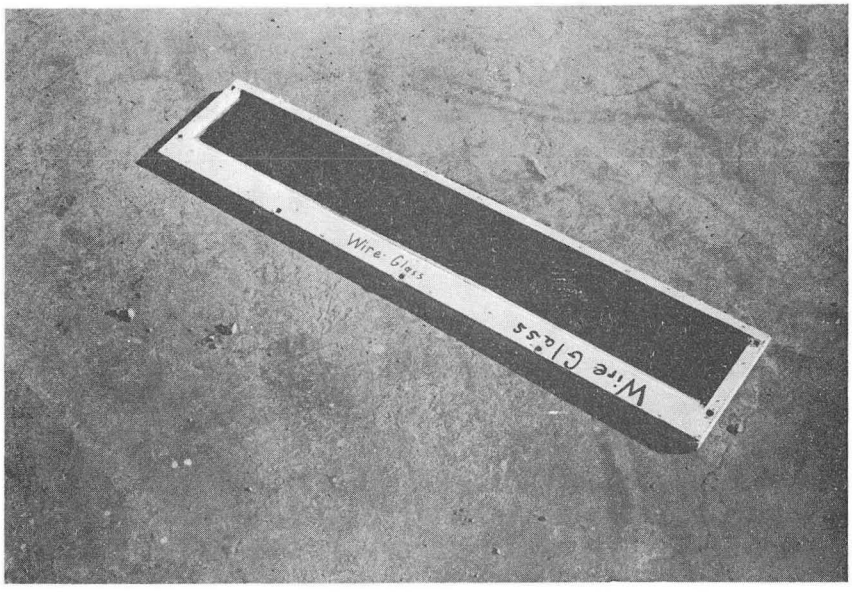
Wire-glass window (Fig. 11b) held up best. It cracked, but it maintained its shape. All other materials cracked or bowed much more.

Fig. 11. Lighting windows after exposure to flames: (upper: Health Pro 836) various materials, (lower: Health Pro 837) wire-glass window.

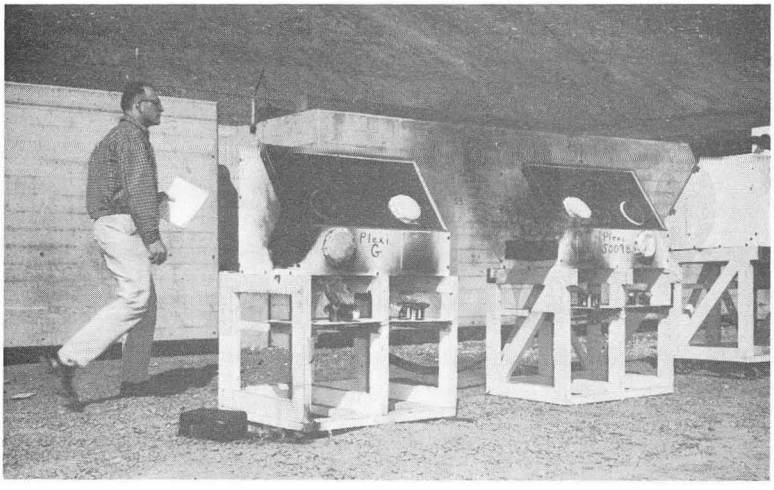
(upper: Plexiglas G, Health Pro 839)

Conclusions: Both types of Plexiglas burned completely through.

Fig. 12. Front window test:

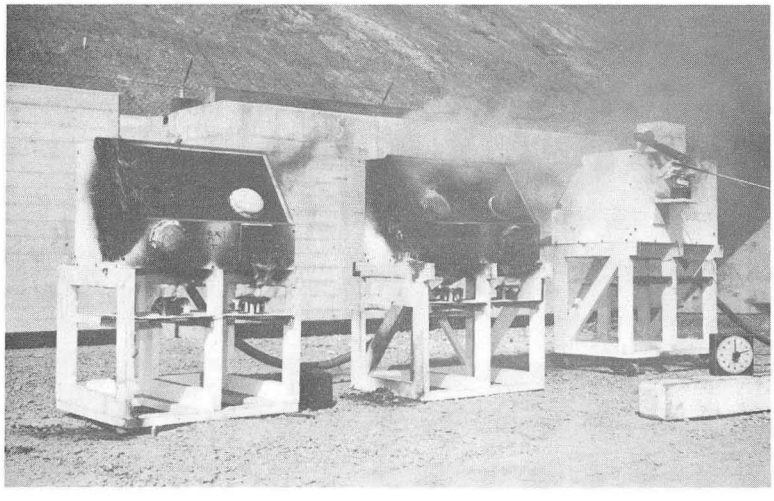
(middle: Plexiglas 5009, Health Pro 840)

Type 5009: Fire-retardant Plexiglas. See Figs. 12 and 13.

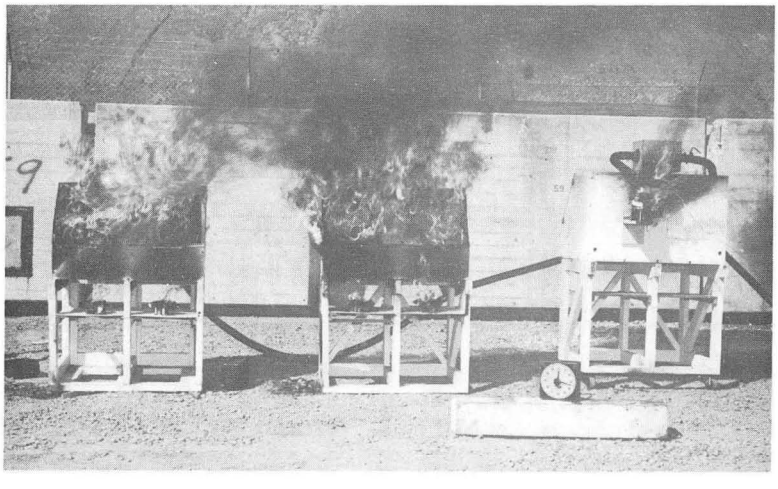
(bottom, Fire sequence, Health Pro 841)

The flexible tubing (neoprene-Fiberglas laminate over wire convolutions, and resin coated) used to ventilate glove boxes was exposed to fire, as shown in the far right-hand side of Fig. 12. Results are shown on Fig. 14.

Conclusions: The resin burned off, exposing the Fiberglas, but the duct retained its shape and functional capacity.

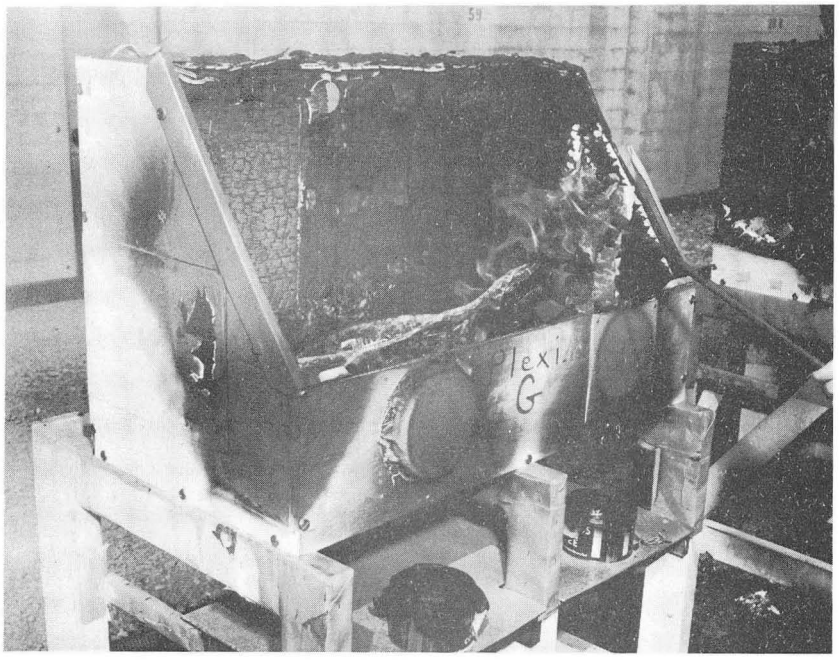
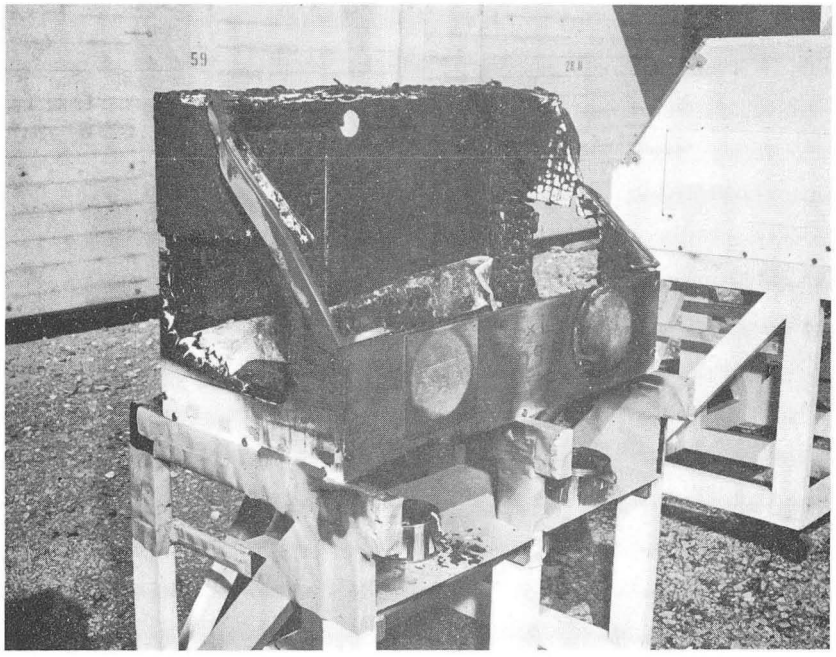
Fig. 13a. Plexiglas G window. (Health Pro 842)

Fig. 13b. Plexiglas 5009 window following test. (Health Pro 843)

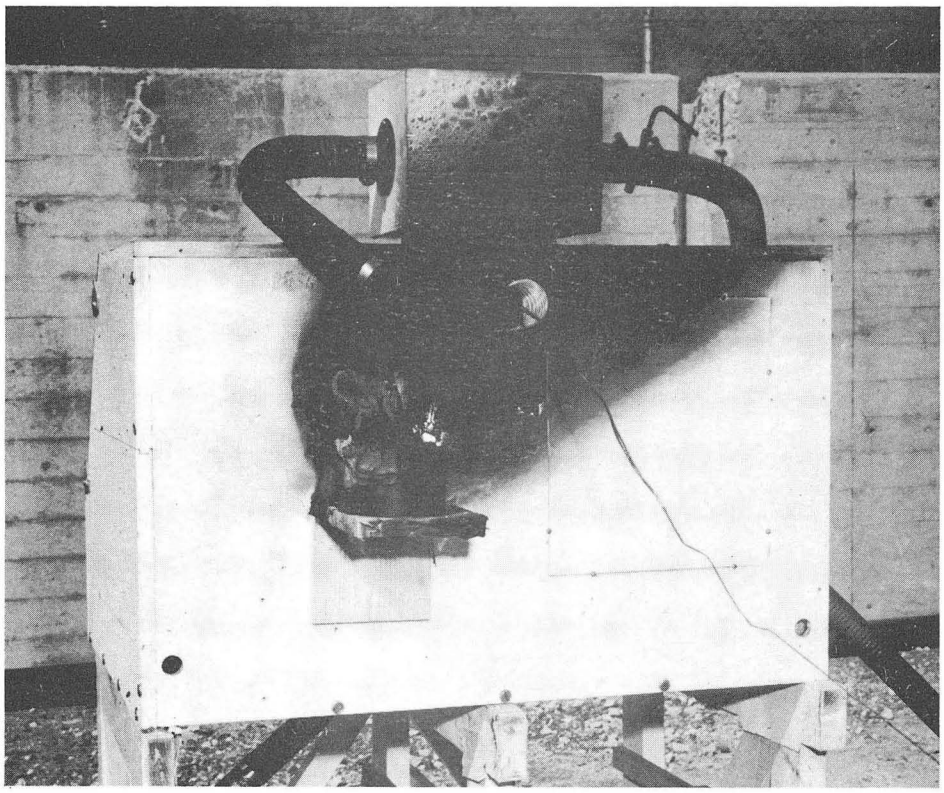
Fig. 14. Flexible tube after fire test. (Health Pro 844)
