To be presented at Windows in Building Design and Maintenance, Gothenburg, Sweden, June 13-15, 1984

OBSTACLES TO THE USE OF EXTERIOR FENESTRATION AND DAYLIGHTING CONTROL SYSTEMS IN THE U.S.

G. Sweitzer and R. Johnson

March 1984

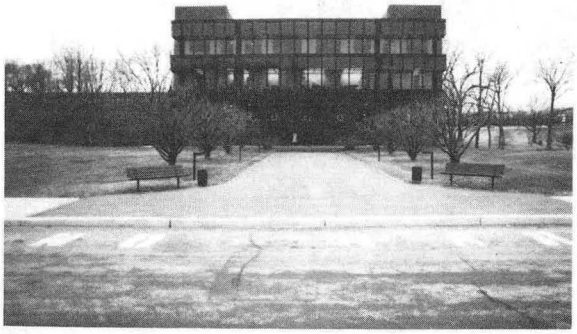
Fig. 2 Building view from east entrance.

After three to four years of weathering, the planned uniform, protective patina covering the steel surfaces was incomplete; corrosion continued, not only giving the building an uneven, streaked, and discolored appearance, but also damaging facade elements, including the sunshade frames.

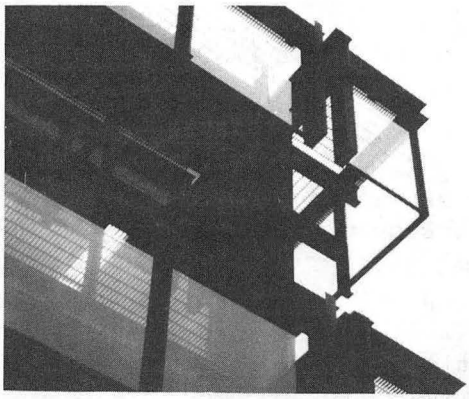
CBB 843-2232

Fig. 3 Sunshade framing at northwest glass atrium roof.

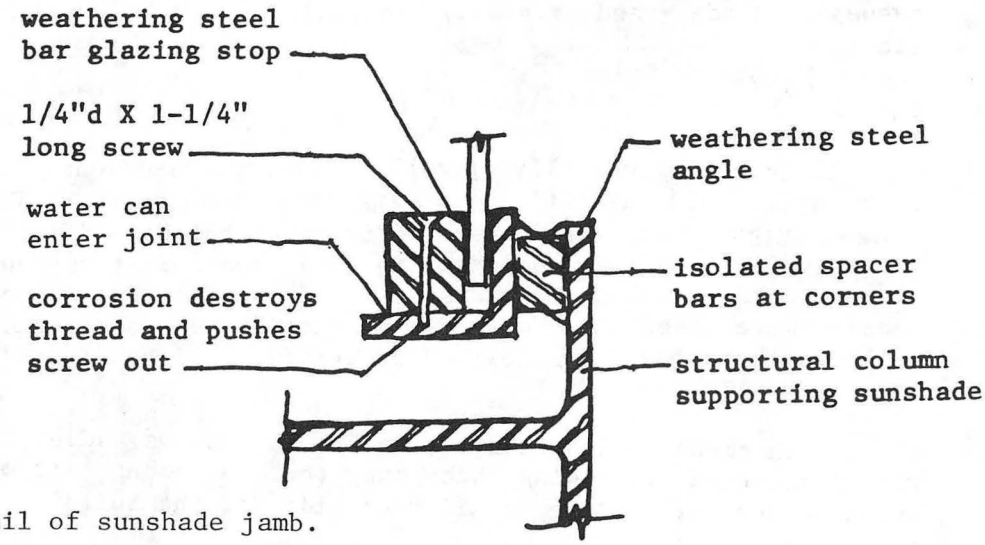
Fig. 4 Detail of sunshade jamb.

The original glass sunshade frames, hung from outside the catwalks, supported 3/8-inch-thick tinted glass panes measuring about 4 feet by 5 feet, and supported by welded angles and bar glazing stops, both made of weathering steel. The steel stops were fastened by screws to both vertical and top and bottom horizontal angles. The total shade frame was supported by a short weld at the top and bottom of each vertical angle (Fig. 4).

To better assess total damage, the window walls, catwalks, and shading systems were evaluated by an independent team of building consultants (headed by a Danish-American). Their report confirmed the weathering damage to the shading system. Many screws were missing or falling out and many fillet welds to the angle frame were cracked and allowed moisture to penetrate.

This extensive damage to the weathering steel elements led to resetting the glass for all window walls and to redesigning glazing fasteners for resetting the tinted glass for all sunshades.

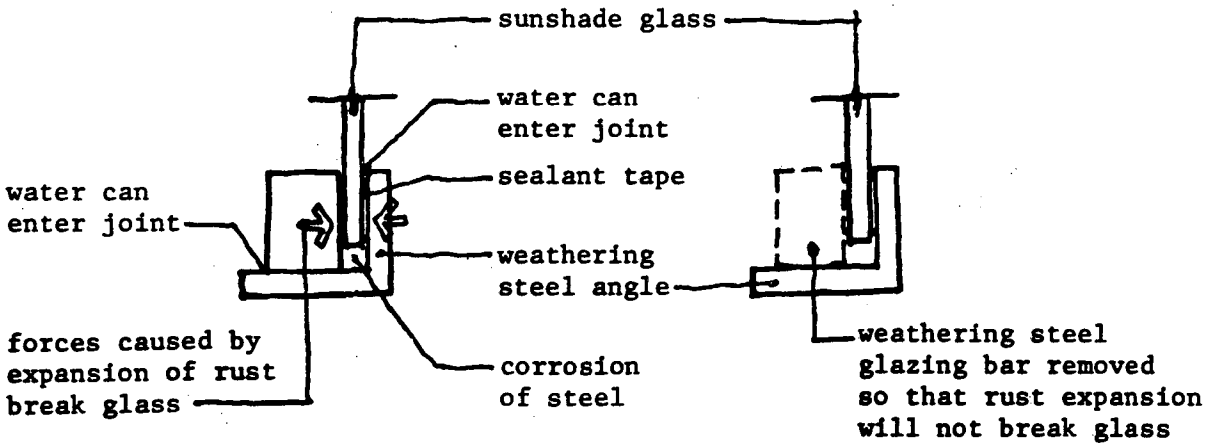
Fig. 5 Detail of sunshade sill.

Corrosion caused many of the screws to loosen and sever at horizontal sill joints, which exerted pressure to break the glass panes, as shown in Fig. 5a. To remedy this, all sill bar stops were removed, as shown in Fig. 5b.

a) Section through sunshade frame showing cause of glass breakage

b) Section with bar removed

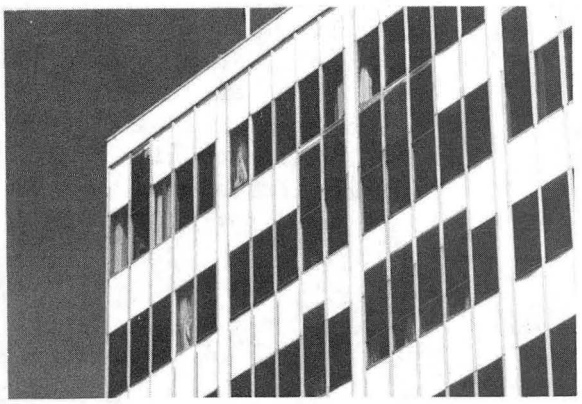
CBB 843-2228

Fig. 7 Detail of south elevation.

Screen adjustment occurred seasonally along with window washing, and included cleaning the mullion tracks and repositioning screens over the windows. However, during recent years, successive operators have allowed individual tenant preferences to determine screen locations. Further, screens damaged by window washers or wind have been periodically removed but not replaced. The building elevations now appear irregular, with some screens up, some down, and others missing. To improve appearance, current management has decided to remove all screens and provide shading with interior venetian-type blinds. Over time, weathering has contributed to exposing the system limitations, preventing easy adjustment or replacement of screens. Had the system been integrally designed as part of a building retrofit, it might have continued in operation, avoiding the unaesthetic conditions that will cause its removal.

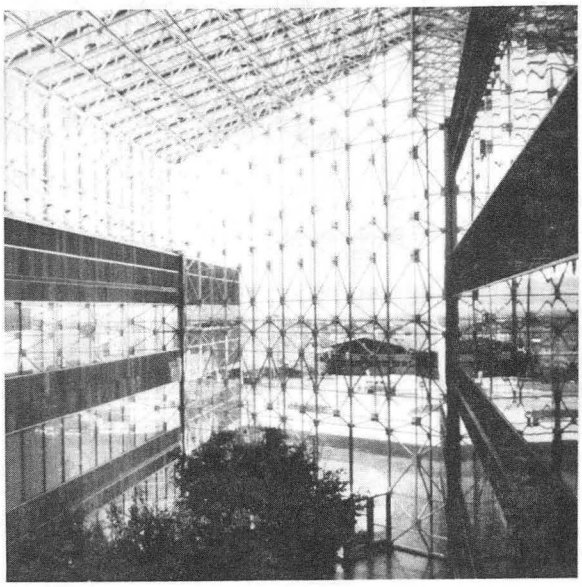
Figure 8. View of atrium interior.

Case 3, involving an automatically controlled operable exterior louver system, concerns a two-year-old building complex located in a surburb of Denver, Colorado. The all-aluminum louvers cover a glazed circulation atrium with a south-facing vertical wall and sloped-glass roof (see Figs. 8 and 9). The system automatically tracks the sun during daylight hours to optimize shading and daylight control, and closes at night to reduce heat loss.

The louver system, installed by an electrical contractor unfamiliar with the system, began operation without a recommended snow dumper option that would provide quick open/close action. (The snow dumper had not been fully developed when the system was ori-

ginally installed.) During the first winter, which included record snowfall, the system operated satisfactorily, aided by snow melting from heat transmitted through the atrium's single layer of laminated glass. However, last winter's record cold caused icing in faulty conduit connections, halting louver operation. This time atrium heat was insufficient to aid thawing, which then required portable heaters.

In this case a product already proven in other outdoor applications was applied for the first time as a sloped fenestration/daylighting control system. Operation was halted only by an extreme icing condition. Since then the recommended snow dumper option and new, waterproof conduit connections have been installed and checked by the louver system supplier. These changes should satisfy any remaining concerns about further winter operation of this system.
