RELIABILITY IMPROVEMENT OF BART TRAIN CONTROL

David B. Turner
Lawrence Berkeley Laboratory
University of California

RELIABILITY IMPROVEMENT OF BART VEHICLE TRAIN CONTROL*

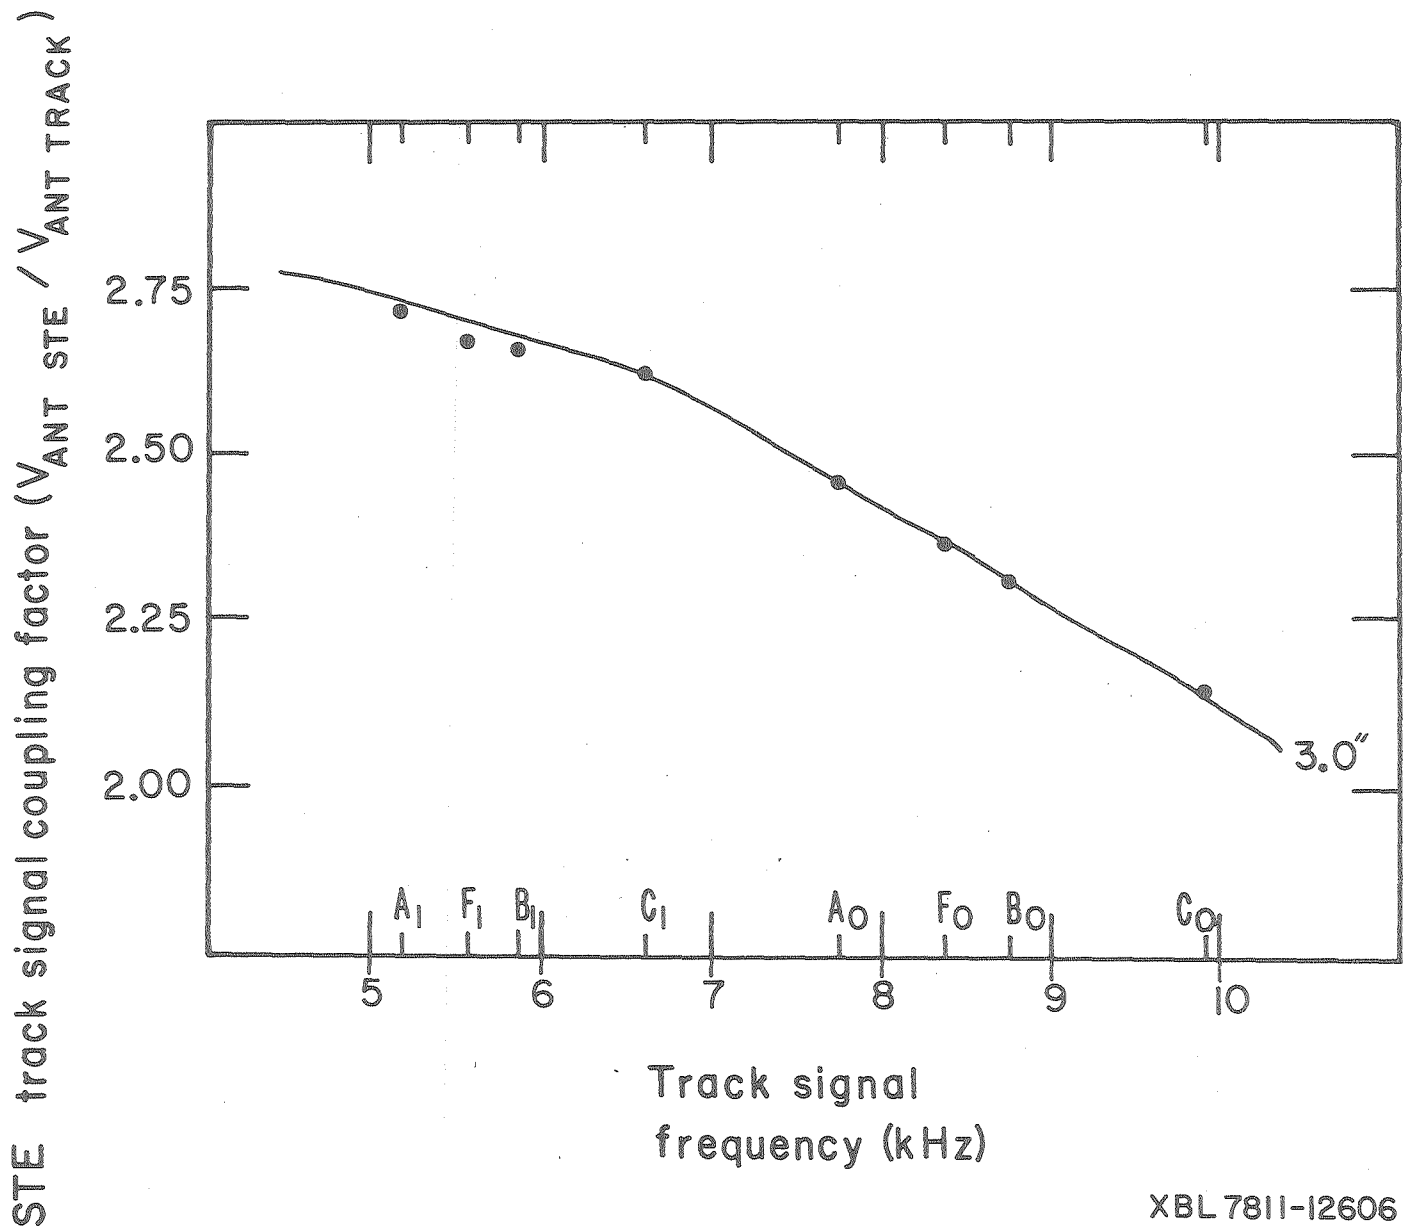
The second problem which complicates the coupling relationship is a frequency-dependent variation in field generated by the rail. Comparisons of data between Test Track and the shop floor at a fixed height revealed a frequency-dependent coupling ('K') factor shown in Figure 12. This newly noted effect is nulled by correct choice of the R_{METER} resistor

Figure 11. Vehicle antenna voltage vs. wheel height, test track vs. shop.
