Presented at the Symposium on Electron Microscopy of
Materials, Boston, MA, November 14-17, 1983

HIGH RESOLUTION TEM STUDIES OF DEFECTS NEAR Si-SiO₂
INTERFACE

J.H. Mazur and J. Washburn

November 1983

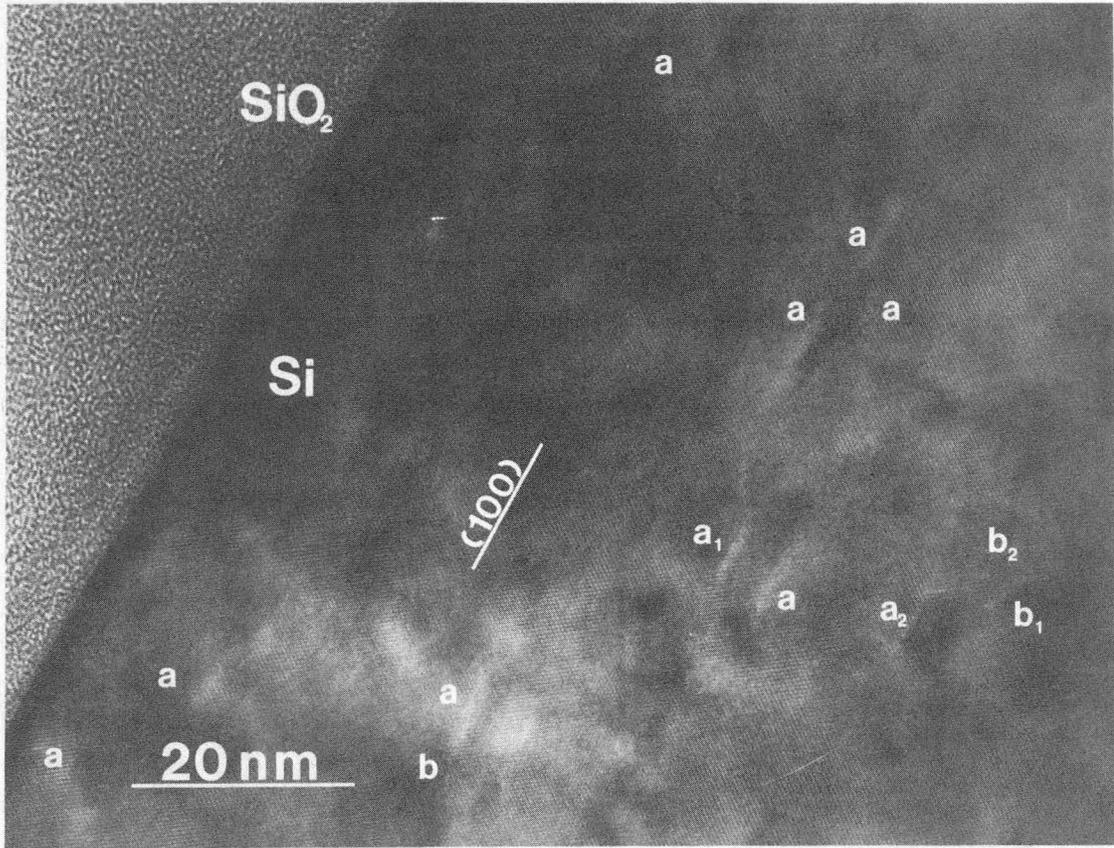
- Fig. 1 HREM image of the defects near Si-SiO₂ interface after 900°C oxidation.
- Fig. 2 Higher magnification HREM image of {100} defect marked a₁ in Fig. 1.
- Fig. 3 Higher magnification HREM image of {100} and {311} defects marked a₂ and b₁, b₂ in Fig. 1.
- Fig. 4 HREM image of the {100} defects near the Si-SiO₂ interface (after 1000°C oxidation).
- Fig. 5 HREM image of the {311} defect near the interface (after 1150°C oxidation).
- Fig. 6 HREM image of the defect in as-supplied wafer.

Observations in the vicinity of the Si-SiO₂ interface within a distance of about one micron were performed on the first set of specimens with about 200 nm of oxide grown at 900°C for 120 minutes. Two characteristic classes of defects were observed and are shown in Fig. 1. The defects marked "a" in Fig. 1 are tentatively interpreted as silica precipitate platelets growing on 100 matrix planes. Larger defects having similar contrast have been observed in plan view silicon specimens prepared from CZ silicon crystals after anneals at 870°C and 650°C and are commonly known as "black dot" defects [8,9]. Figs. 2 and 3 show higher magnifications of platelet defects marked in Fig. 1 by "a₁", and "a₂" respectively. The observed dimensions varied from 4 nm to 10 nm. The thickness was estimated to be 0.3 - 0.6 nm. A second type of defects which appeared occasionally near the platelets are indicated by "b" in Figs. 1, 3. These defects are parallel to {311} matrix planes. They also have been previously observed in CZ silicon and have been called {311} stacking faults [10]. Other authors [8,9] have considered them to be

precipitates growing on the {311} matrix planes. They may be elongated in the $\langle 110 \rangle$ direction parallel to the beam and thus observed as a cross section 3-4 nm in width [11]. The density of the {311} defects appeared to be lower than that of the platelets and the distribution of both types of defects appeared to be random within about 100 nm from the Si-SiO₂ interface.
