BEVATRON OPERATION AND DEVELOPMENT. 55

July through September 1967

Kenneth C. Crebbin and Robert Frias

January 31, 1968

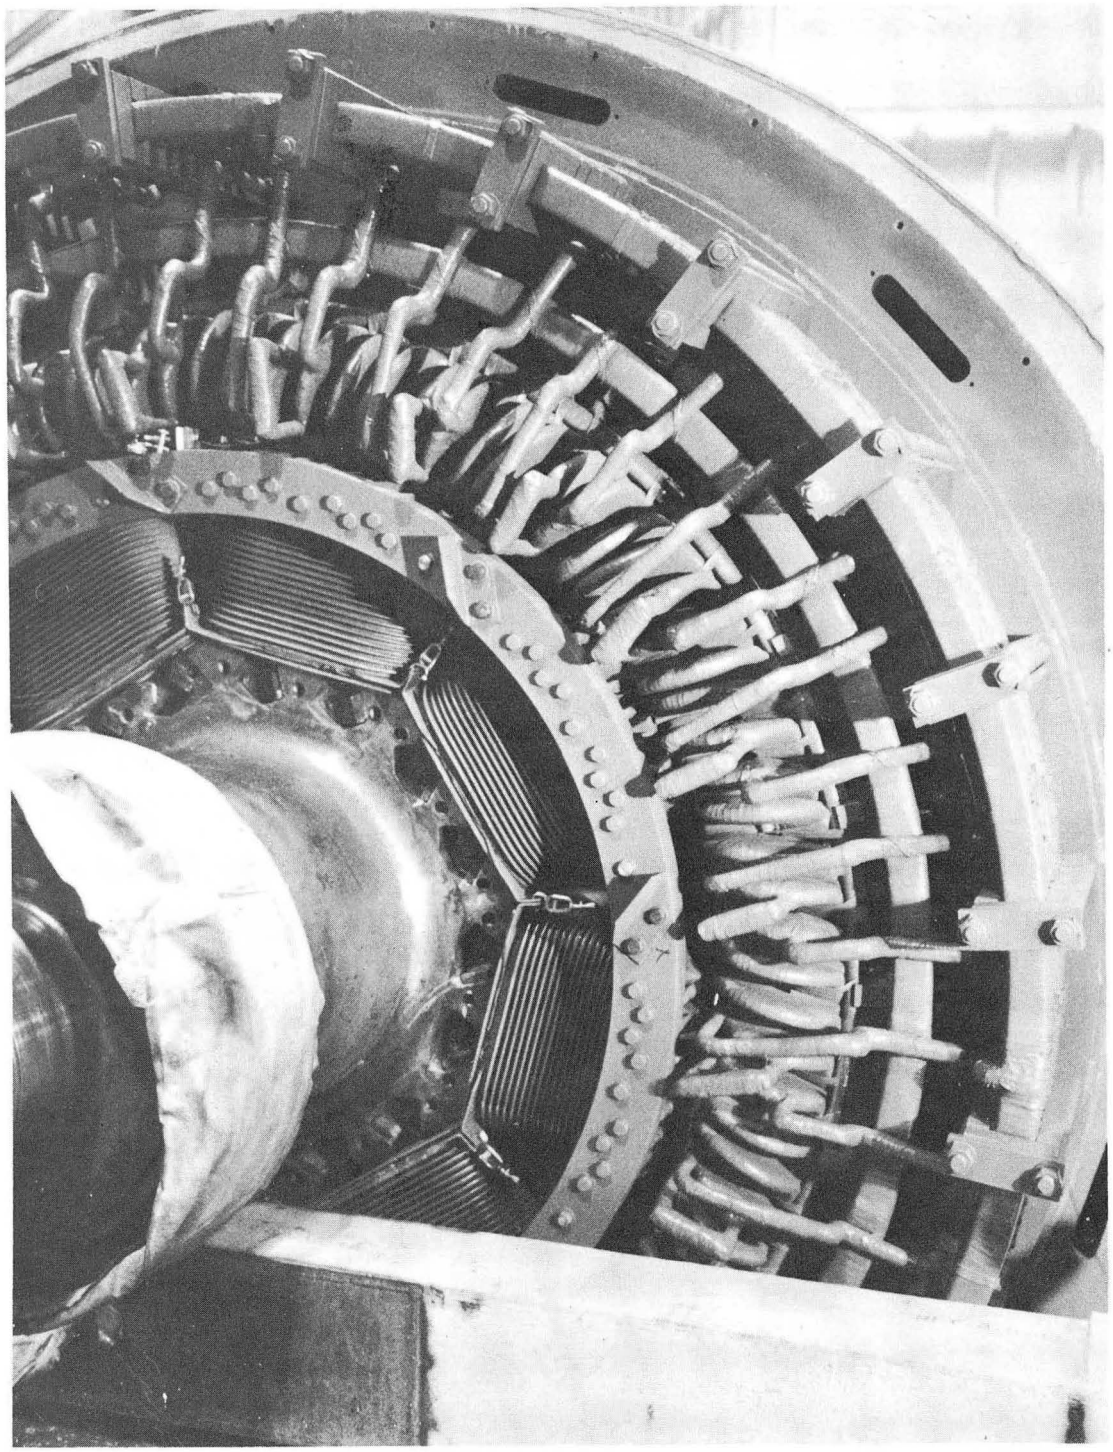
XBB 683-1006

At 0120, 24 September 1967, the field of the east generator was relayed off the line, with an indication of a ground on the field excitation power supply. In attempting to locate the problem, we found by visual inspection that the electrical connection between poles No. 3 and No. 4 had parted and that there was a splattering of copper over the adjacent area. An insulation test of the field to ground was taken; it read 500 000 ohms. A megger test was made on the field on the west machines, and showed 80 megohms. Figures 5 and 6 show the broken brazed connections and their location on the generator rotor.

The field electrical connections on both machines were cleaned, visually inspected, and "Zyglo" checked. The results of these inspections showed, in addition to the original trouble, cracks in the welds between poles 5 and 6 and between 7 and 8, on the east machine. Cracks were detected on the west machine between poles 3 and 4, 5 and 6, and 7 and 8.

x Rays were taken of numerous connections, and showed a high porosity in most of the brazed joints. The electrical connections (all) were cut open on both machines; this revealed that the brazed connections were poorly bonded. The electrical connections were then cleaned and fitted in preparation for rebrazing. The burned and smoked areas were cleaned and the damaged areas eventually attained an insulation level of more than 200 megohms.

Fig. 5. The location of the brazed coil connection on the 46-MVA generator. The connectors are pointed out by the battery clips.

On October 7, after careful consideration of the accumulated data, it was decided to proceed with a technique of brazing on the generators using "Easy Flo" alloy. The connections were made on the west machine and considered to be satisfactory. All brazing was completed by the evening of October 9. The machines were then started and the magnet was pulsed until 0800, 16 October, when they were shut down for normal scheduled maintenance. At this time, all field electrical connections were "Zyglo" inspected and no

faults were found. Voltage drop tests of all connections were made, and considered essentially the same as those made before running. These tests will be continued on a weekly basis until it is assured that the problem has been completely solved.

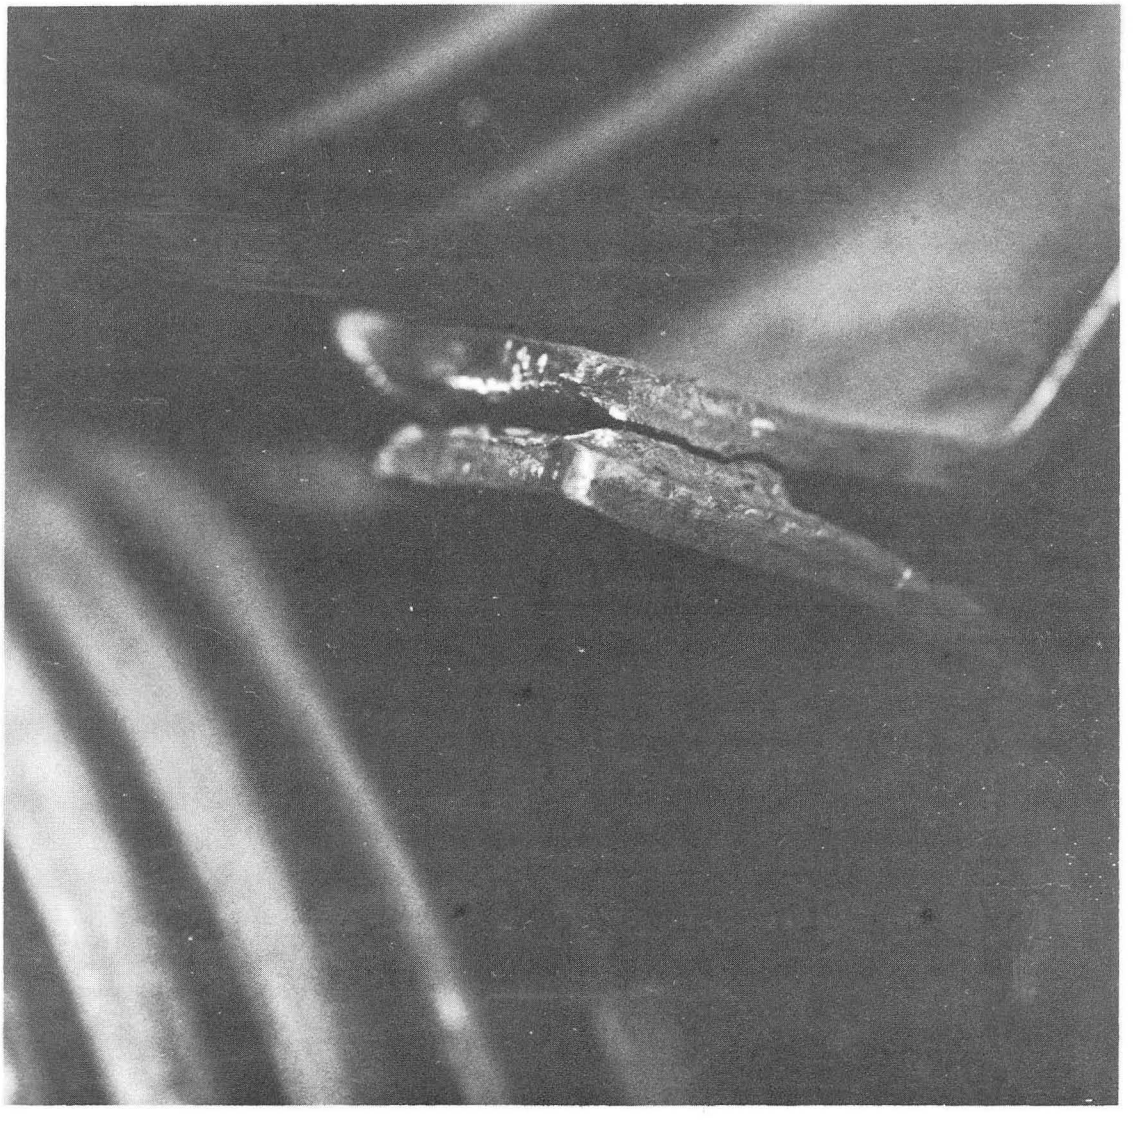
XBB 683-1005

Fig. 6. The break in the pole connection.
